## MEASURING ARMOUR LAYER EROSION IN SCALE MODEL TESTS

RUTE LEMOS (1), JOÃO ALFREDO SANTOS (2)

*Keywords:* Rubble mound breakwaters, Prediction of armour layer damage progression, Scale model tests. Stereo reconstruction.

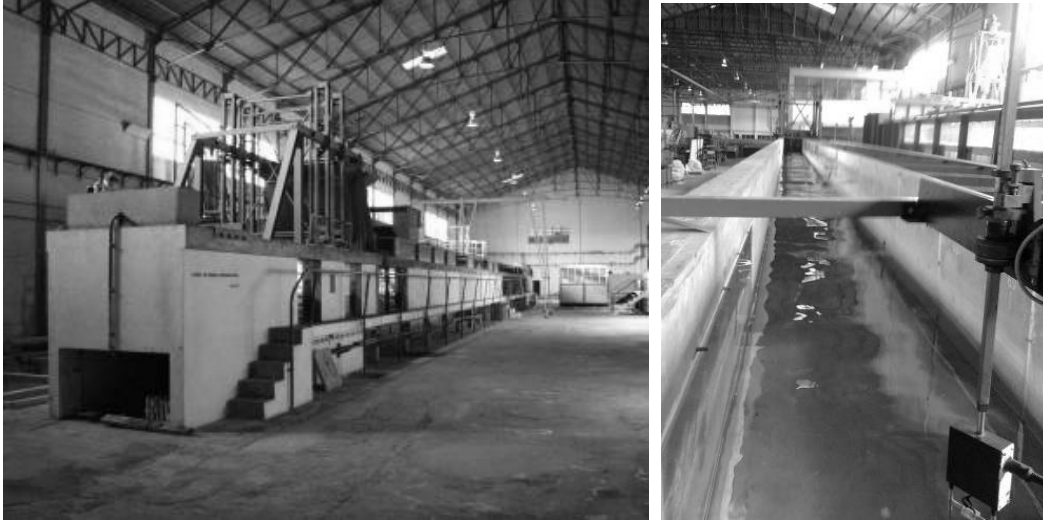
Figure 1. Irregular Wave Flume COI1

The scale model tests were conducted in one of the LNEC's irregular wave flumes, named COI1. The COI1 flume is approximately 50 m long and it has an operating width and an operating water depth of 80 cm. It is equipped with a piston-type wave-maker and an active wave absorption system, AWASYS, (Troch, 2005), which allows the dynamic absorption of reflected waves.

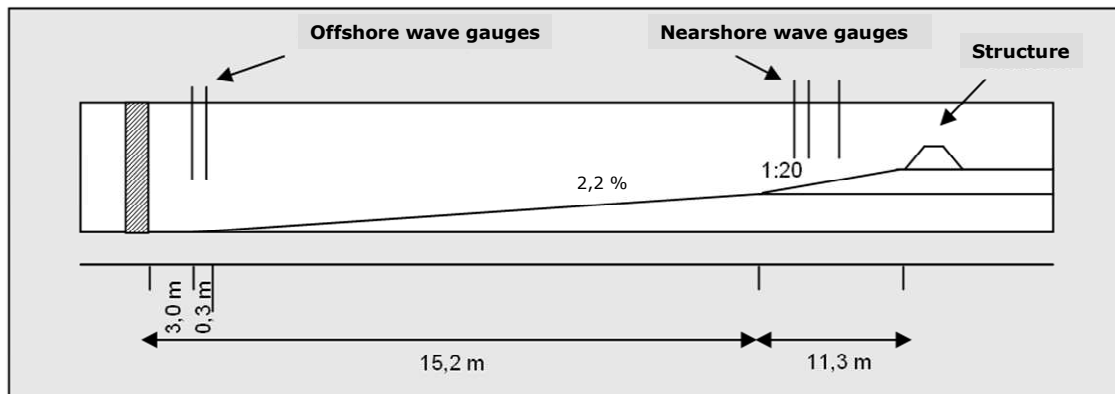
Figure 2. Flume Profile

The flume profile consisted in a 11.3 m offshore beach, comprising a 1:20 slope that ended on a flat bottom where the structure was built (Figure 2).

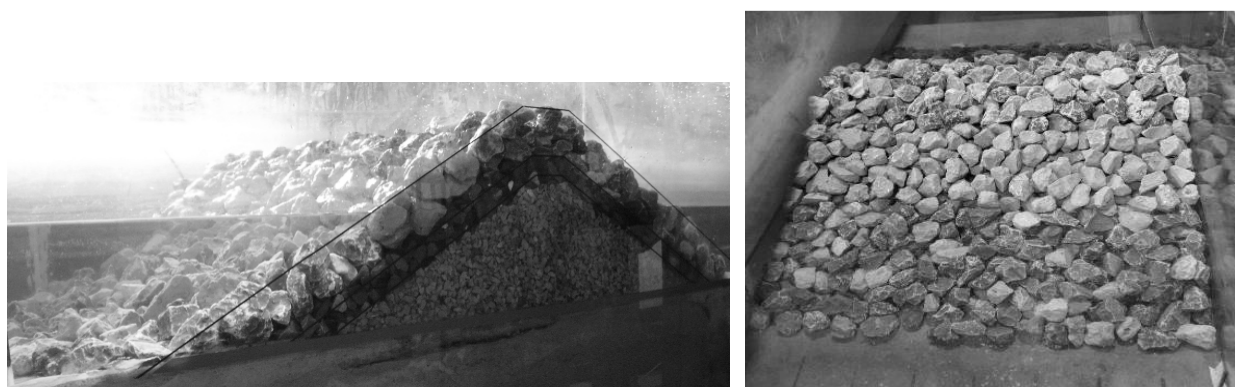
Figure 4. Tested structure

The armour layer consisted of stones with  $M_{50} = 128$  g. Since the stone density was of  $2.7 \text{ g/cm}^3$ , the stone nominal diameter,  $D_{n50}$ , was of 3.64 cm. The tested structure is illustrated in Figure 4.

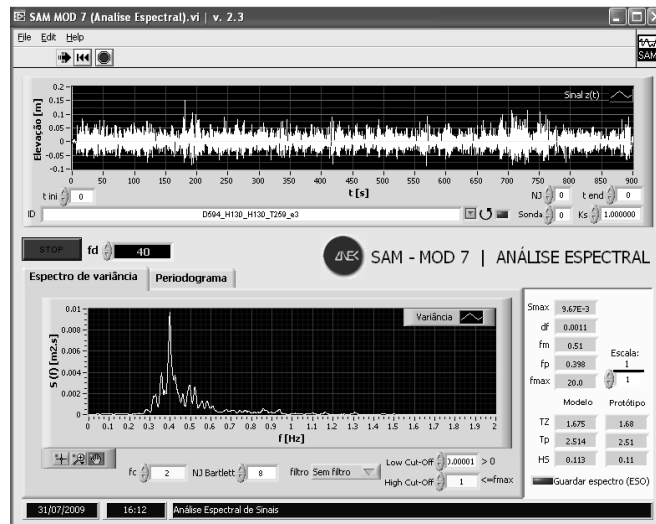
Figure 6. Spectral analysis using the SAM software

Figure 6 illustrates the spectral analysis for a 15 minutes test run.

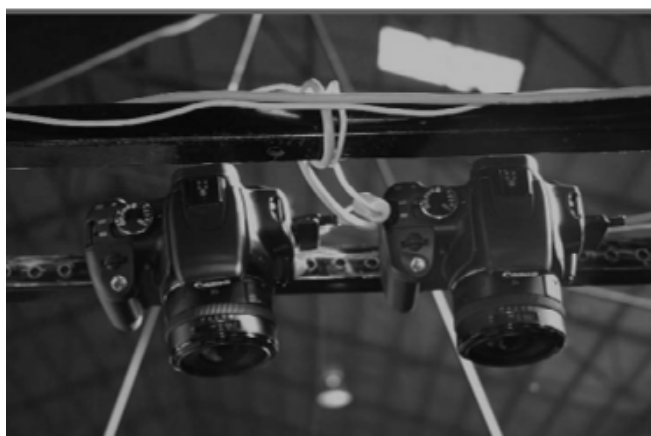
Figure 8. Photographic equipment

The photographic equipment consisted of two cameras mounted side by side in a support structure and able to photograph simultaneously the same scene (Figure 8).

Throughout the tests herein described, we used two digital SLR cameras (Canon EOS 350D) fitted with fixed focal length lenses (Canon EF 35mm  $f/2$ ). This setup is capable of acquiring images with 3456 by 2304 pixels (8.0 megapixel), as well as images with 2496 by 1664 pixels (4.1 megapixel) and 1728 by 1152 pixels (2.0 megapixel).

Because the photographic equipment is made of two separate cameras, the separation between the lenses centre can be larger than before, and customizable.

In the present study, the profile surveys were carried out with a fixed separation of 16 cm between the camera lenses centre.

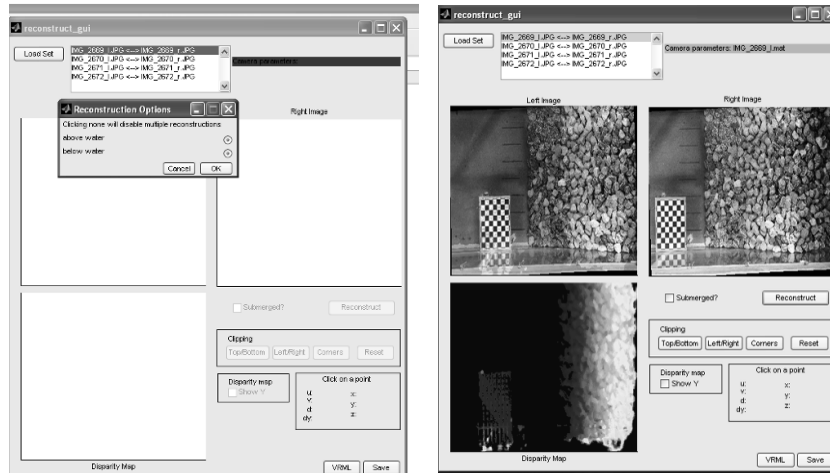
Figure 11. Reconstruction of a partially submerged scenery

Reconstruction consists of identifying depth from two different views of the scenery (Figure 11). It is possible to reconstruct both above water and/or submerged armour slope.

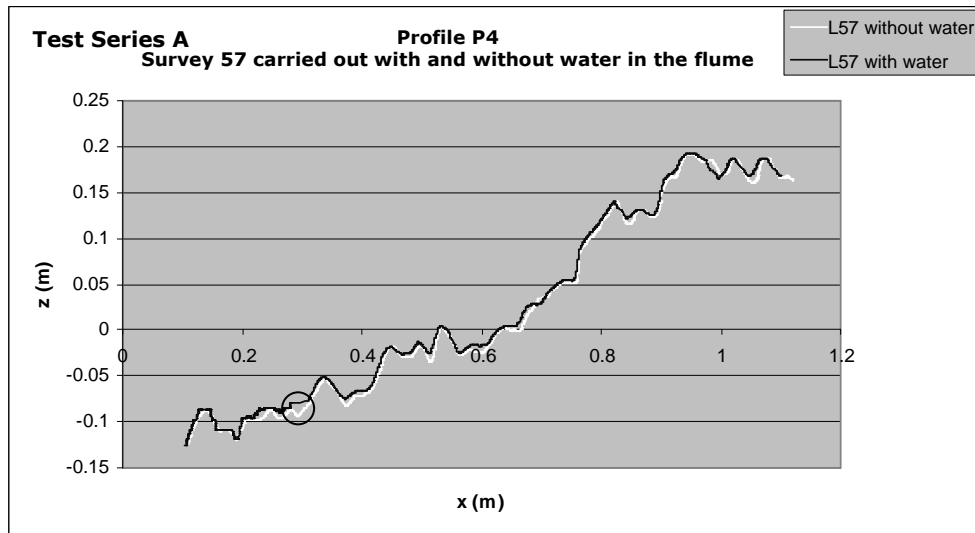
Figure 15. Testing the refraction correction. Survey 57 carried out with and without water

In order to test the software refraction correction, several surveys with and without water in the flume, were performed. It was observed that the highest difference estimated was of 1.9 cm at the toe (Figure 15). Considering that the stone nominal diameter was about 3.64 cm, it can be assumed that the refraction correction for the submerged part of the armour layer was reliable.

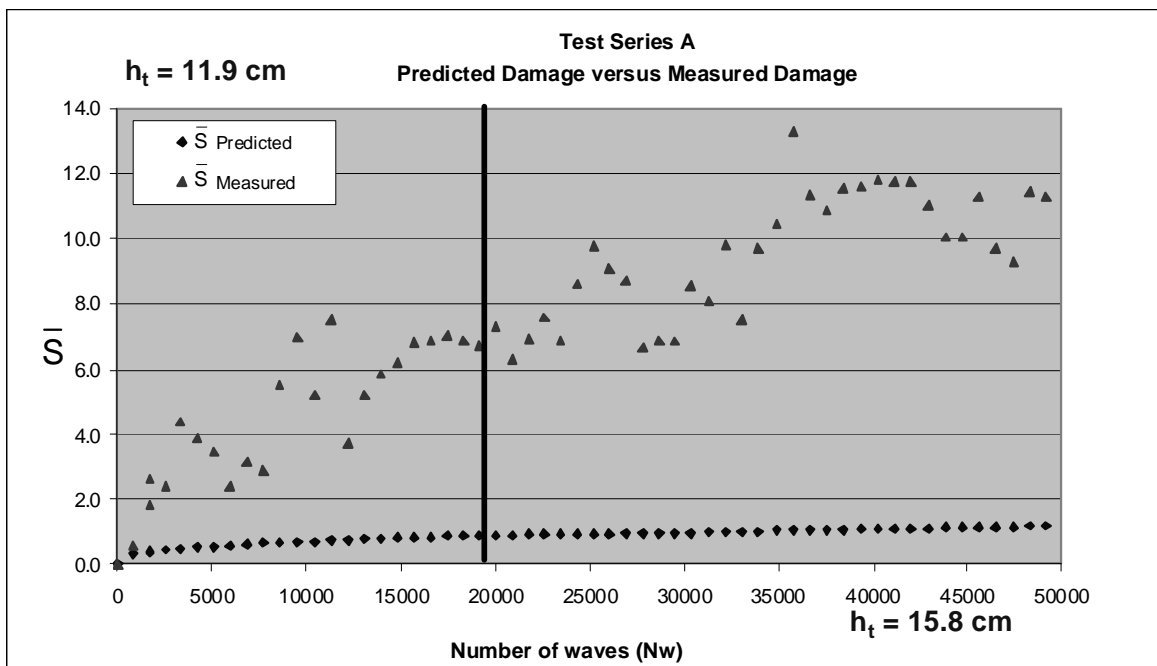
Figure 16. Test Series A. Predicted damage versus measured damage

The mean damage predicted values, estimated upon those wave conditions, did not converged to the mean damage values measured during the model tests.

Figure 16 compares the damage measured during the test series with the predicted damages using Melby's formulation.

It was observed that the reproduced wave conditions in the present study were lower, in what concerns to wave height, than those used in the test that led to the formulation, as well as the wave breaking location, which, in the present study, occurred on the breakwater's slope.
