Clay roofing tiles under salt mist atmosphere

Abstract

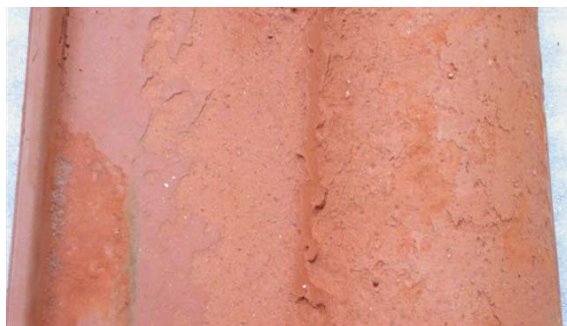
Fig. 1 Natural damage

Four cases of natural degradation in coastal zones are presented. According with the terminology used in stone and rendering architectonic surfaces (Henriques *et al* 2004), the types of degradation observed were: Efflorescence, pitting, granular disaggregation, peeling, bowing, plaques and exfoliation. Figure 1 shows one of the degraded tiles.

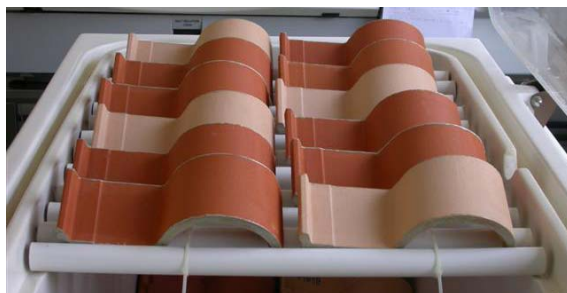
Fig. 2 Specimens in the climatic chamber

specimens from 8 different types of tiles have been subjected, in a climatic chamber (figure 2), to sets of 10, 20 and 30 cycles of wetting with a salty mist and subsequent drying. These tests caused different types and levels of alteration and degradation in different kinds of clay tiles (examples in figure 3). Hydrophobic specimens don't show immediate defects but they can suffer huge degradation (bowing and plaques) if the solution can pass through the protected surface. Non-hydrophobic tiles, both red and white, show low to medium degradation level characterized mainly by pitting, some disaggregation and peeling.

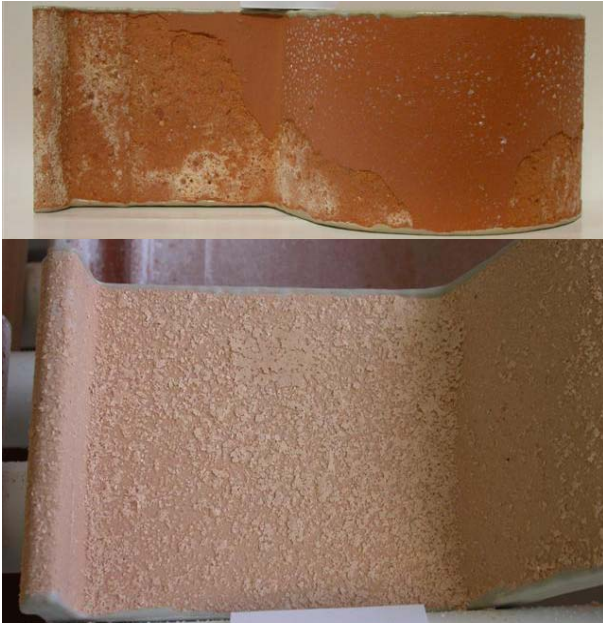
Fig. 3 Accelerated tests damage

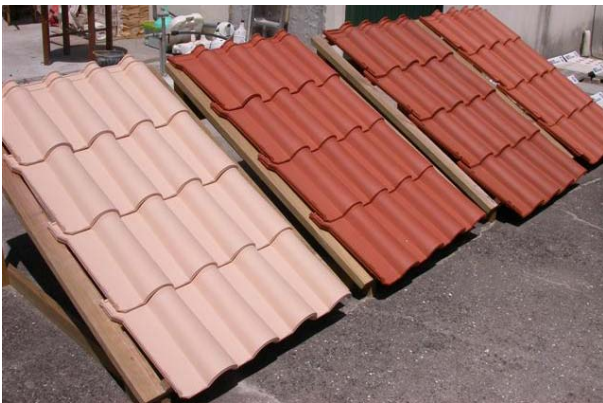
Fig. 4 Natural weathering tests

Some tiles are exposed to natural weathering in the Portuguese west coast, under predominant North winds, on the centre of Portugal (figure 4). They are from the same batch than some of the tiles that were subjected to artificial accelerated weathering tests. After 12 months the tiles do not show any degradation.
