LABORATÓRIO NACIONAL
DE ENGENHARIA CIVIL

SALT DEGRADATION OF HISTORIC PORTUGUESE AZULEJOS

Plano de Investigação Programada do LNEC

RELATÓRIO 203/2011 – DM/NPC

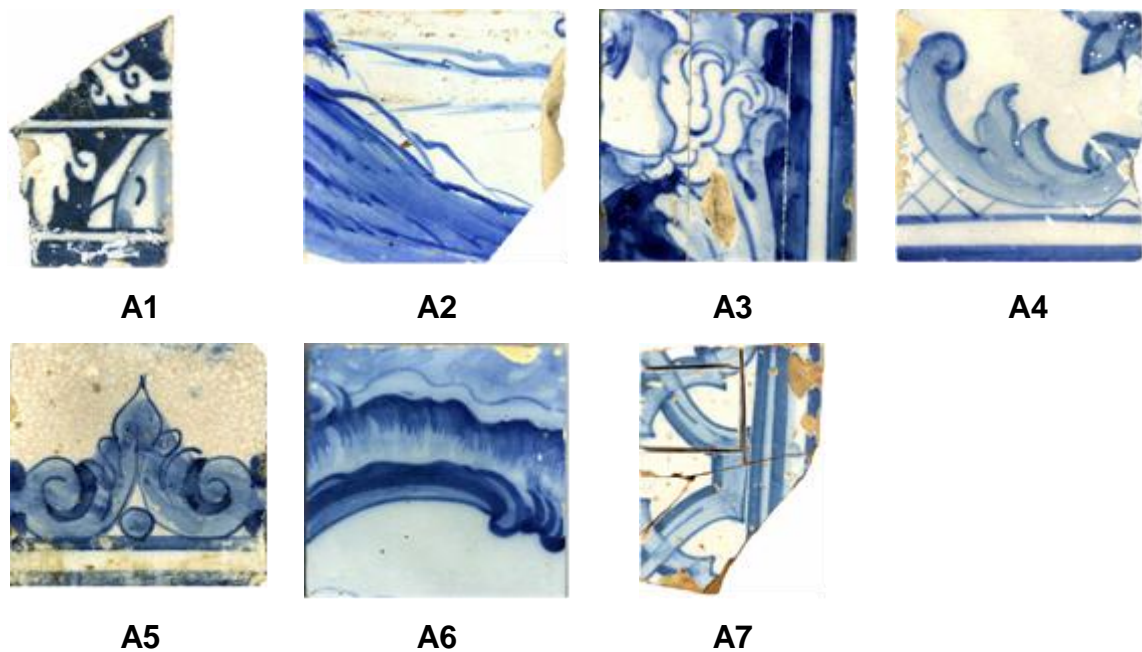
Figure 1. Ceramic tiles studied

A tile of the 17th and a set of tiles of the 18th century (Figure 1, Table 1) in principle produced in the Lisbon workshops were selected due to the presence of distinct characteristics and glaze defects (Table 2).

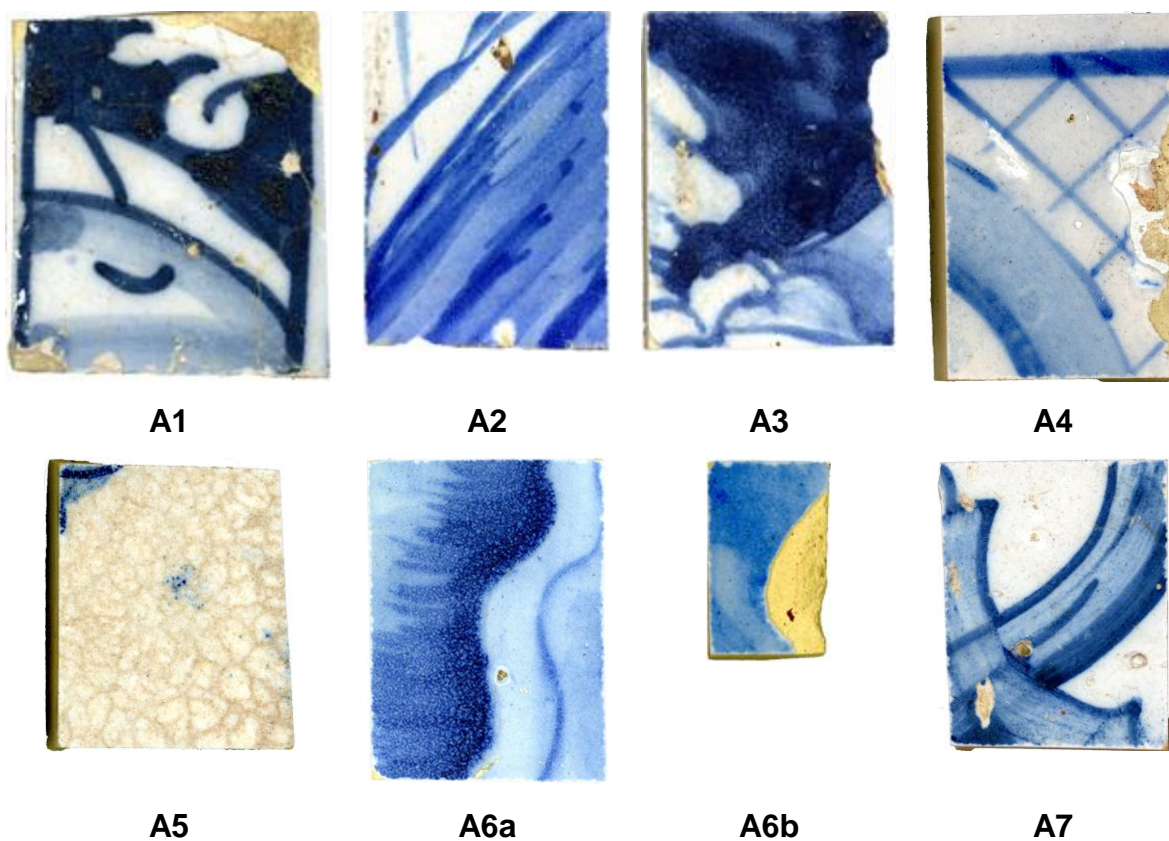
Figure 2. Azulejo fragments studied.

Fragments of the tiles (Figure 1) were cut (Figure 2) and their lateral sides isolated with a layer of epoxy resin to waterproof them and allow the water to be absorbed by capillarity only from the back. The top right corner without glaze of Sample A1 (Figure 2) was also covered with epoxy resin in order to promote the evaporation through the crack network of the tile. Artificial damage in the form of a saw incision (Figure 3a) and puncture (Figure 3b) have also been inflicted to sample A2.

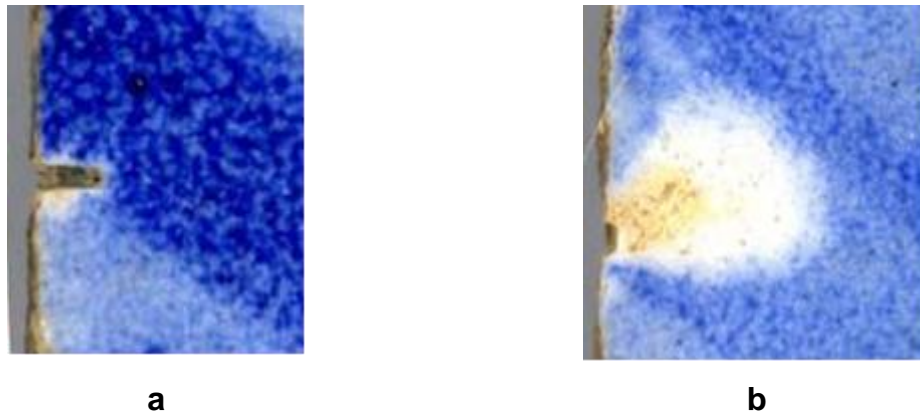
Figure 3. Artificial damage inflicted to tile A2. A) Saw cut, b) Puncture

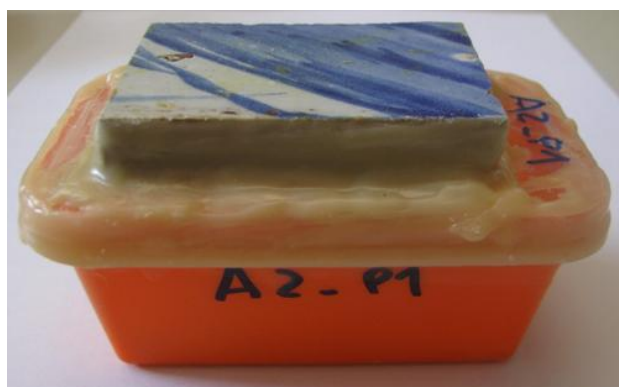
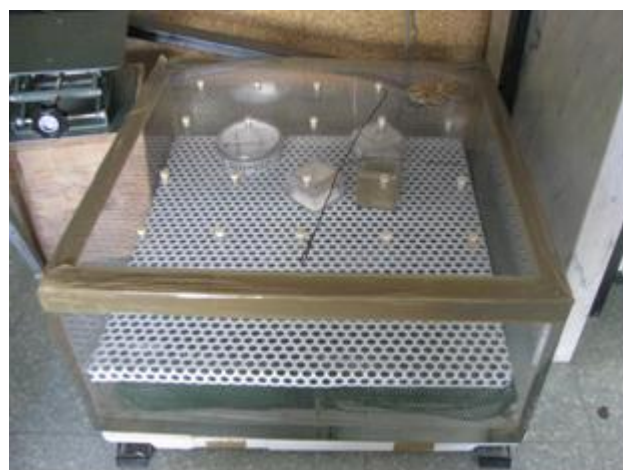
Figure 4. Water vapor permeability. a) Sample A2 sealed, b) Vapor permeability chamber set-up.

The water vapor permeability has been measured after the salt ageing treatment of the samples (Section 3.3). On the lid of an impermeable plastic box an opening was made with the shape of the back of each sample minus one millimeter. The sample was laid on the top of the box and sealed with a 1:1 weight mixture of honey wax and golden pitch resin. The connection between the lid and the box was also sealed with this mixture (Figure 4a). The sealed samples were placed inside a box where NaCl brine maintained a relative humidity of about 75% (Figure 4b) and were time wise weighted for a period of 15 days.

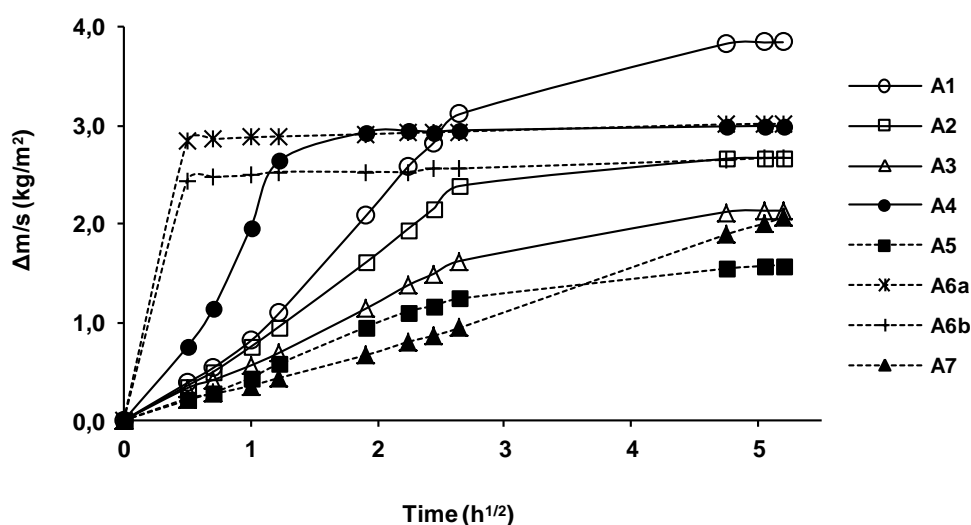
Figure 5. Ci0 capillary water absorption curves.

The water absorption coefficient and imbibitions capacity (Figure 5, Table 4) are correlated to the pore structure of the materials and are indicative of the tiles fluids transfer characteristics. These characteristics can influence the degradation mechanisms of the porous materials such as *azulejos* and can be important parameters to assess their durability. As mentioned in the introduction water is considered the main cause of tiles degradation and the water flow characteristics and drying kinetics can govern the crystallization locations. Generally, the porous materials with a very slow capillary rise are less sensitive to decay since water is less prone to enter and circulate easily in the porous network. The porous materials with a quick capillary flow are usually more affected due to the ease of circulation and fast evaporation kinetics (Angeli 2007). In the case of glazed ceramic tiles however, since they are a composite material constituted by a porous ceramic layer and a less porous and largely impermeable glaze layer, the evaporation kinetics is highly dependant on the permeability and evaporation areas extant on its glaze layer. The crystallization is considered to be mainly governed by the evaporation kinetics allowed by the glaze layer and probably less by the capillary flow.

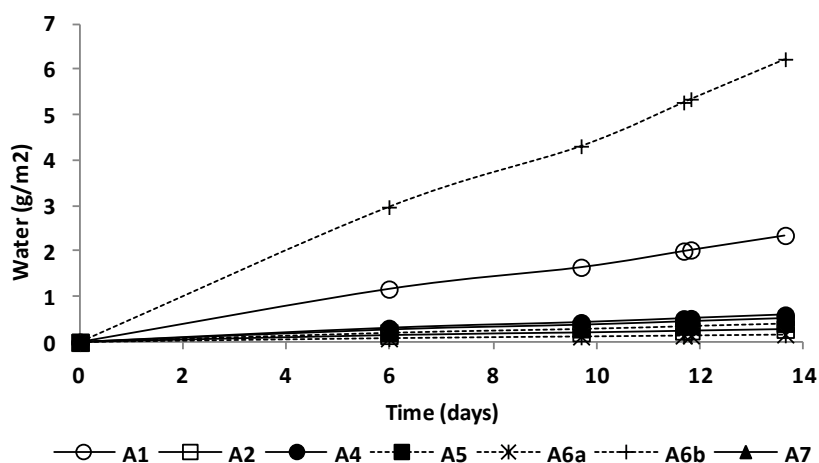
Figure 6. Water vapor permeability.

The results of the water vapor permeability measurement (Figure 6 and Table 5) make evident the high level of impermeability of the glazed tiles except those that present relatively large unglazed areas such as sample A6b and A1. Sample A4 has, however, a large unglazed area but its permeability coefficient is relatively low. The unglazed area in this sample was caused, not by decay, but rather by the crawling of the glaze during firing. It has previously been noticed on sites that such cases do not depict the decay (e.g. sanding) that is expected on the unglazed areas even if exhibits decayed parts somewhere else on the surfaces. It may be hypothesized, as an explanation and a subject for future research, that notwithstanding the crawling, the raw glaze components have permeated the biscuit to the point of altering its permeability.

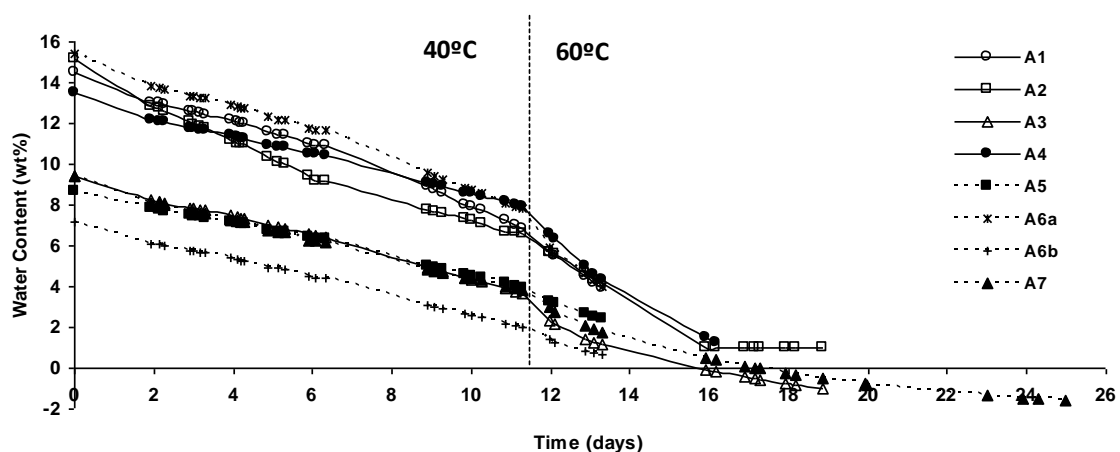
Figure 7. Drying cycle Ci1 where drying temperature was changed from 40 to 60°C.

The increase of the drying temperature allowed faster drying curves as can be seen in Figs 7-9 and Table 3.

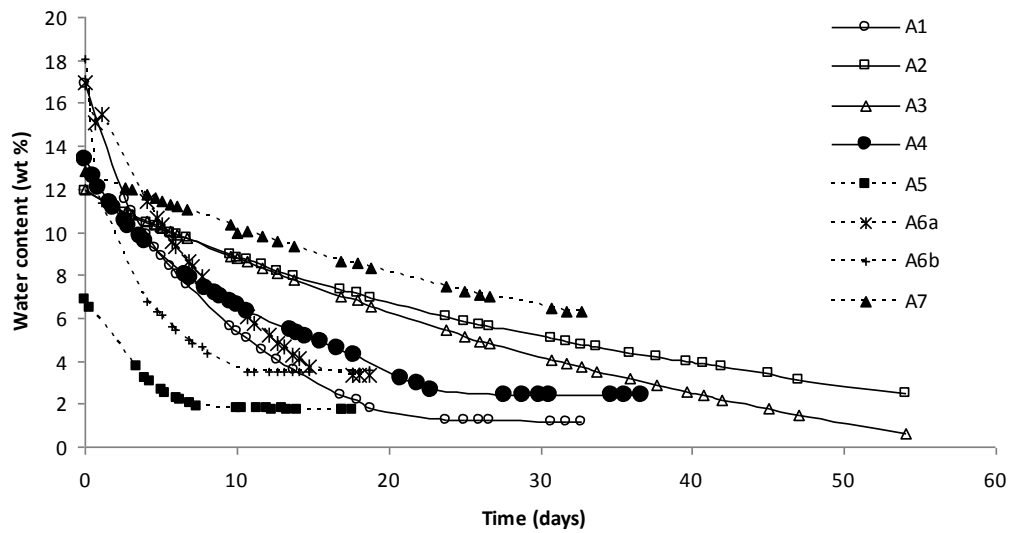
Figure 8. Drying cycle Ci2 at 60°C.

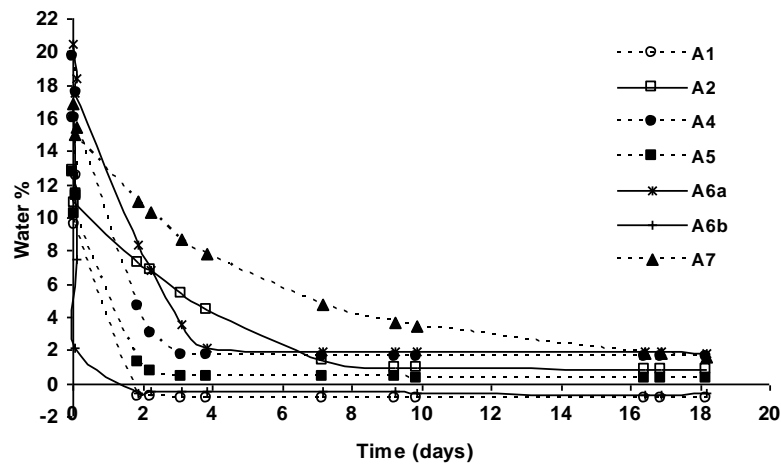
Figure 9. Drying cycle sample A2 and A7 Ci5, A1, A4 and A5 Ci7 and A6a and A6b Ci7 at 100°C.

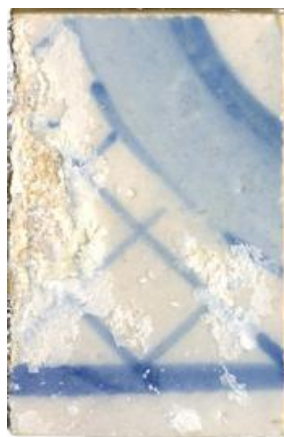
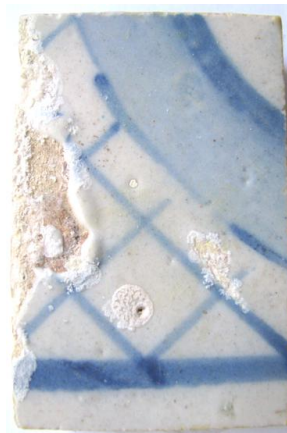
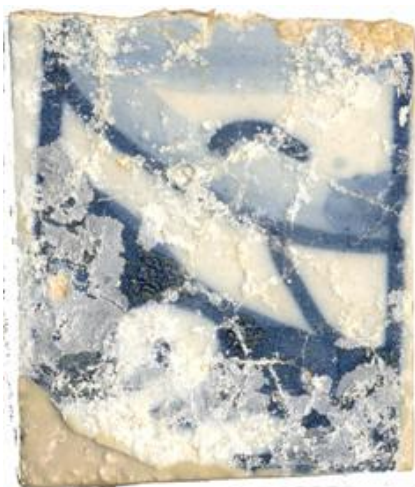
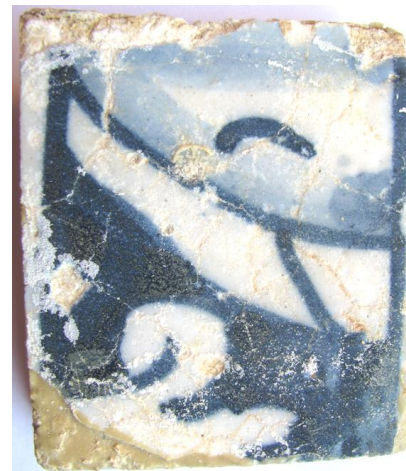
Figure 10. A4 and A1 samples with efflorescence after drying at 60 and 100°C.

The effect of the temperature on the degradation mechanisms of salt contaminated *azulejos* and its influence in the effectiveness of damage simulation could not be completely asserted from these results. A test campaign where several samples of the same tile would be subject to different drying temperatures would be necessary for a robust conclusion. We can only mention that the samples that exhibited efflorescence at 40°C (sample A1, A4 and A6b), also exhibited them at 60 and 100°C (Figure 10). This suggests that for these samples the capillary water supply was still faster than evaporation at any temperature allowing efflorescence to form at the surface.

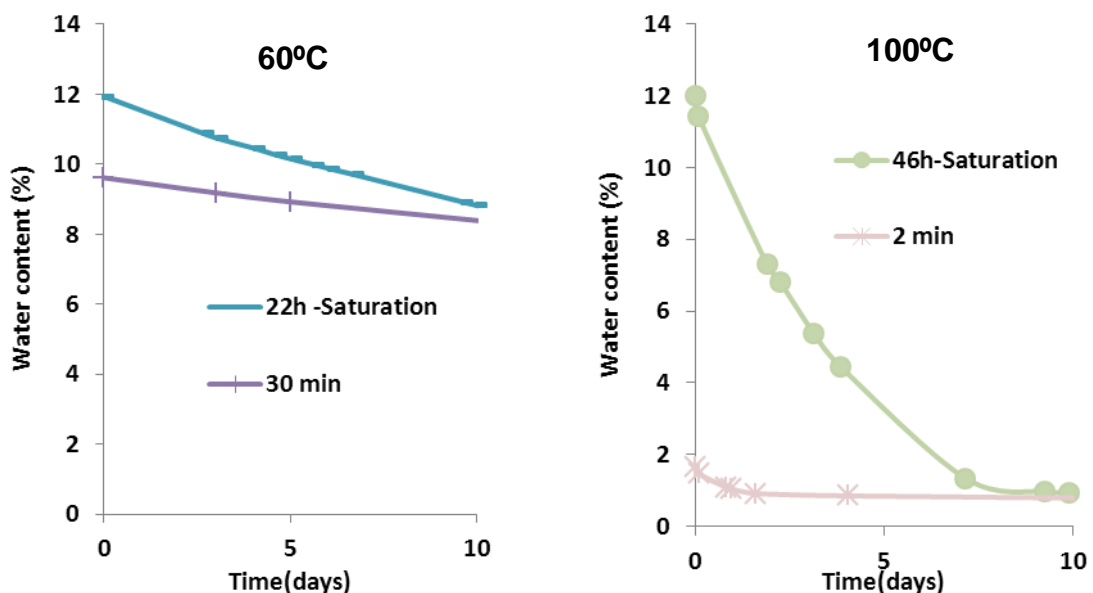
Figure 11. Drying curves of the A2 sample when imbibed for different time durations to obtain different water contents and dried at 60° and 100°C.

Decreasing the imbibition water content shortens the drying time needed, shortening also the total cycle time (Figure 11). With the current experimental set-up the effect on the drying and salt damage mechanisms could not be completely ascertained. Equal or similar individual samples subjected to repeated cycles each imbibed to different water contents would be necessary to observe the effect of this parameter. However, from the observations made, the samples imbibed with lower amounts of water and hence with lower water content did not show efflorescence after the drying cycles, indicating that the water supply to the evaporation areas was slower than the evaporation rate, leading probably to crystallization fronts inside the ceramic mass.

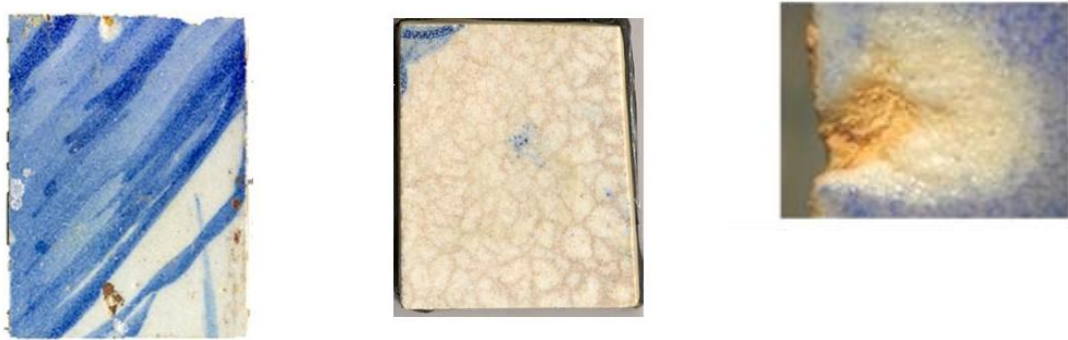
Samples A2 and A5 did not present any visible signal of glaze layer deterioration after 5 and 7 cycles respectively (Figure 12). Efflorescence was not largely observed during any of the cycles.

Figure 12. Samples A2 and A5 after 5 and 7 cycles: a) A2 at final cycle Ci5; b) A5 at final cycle Ci7 and c) detail of unglazed area without efflorescence at A2.

The observation of lack of efflorescence on glaze uncovered areas of sample A2 indicates that the evaporation/crystallization could be located at a lower level inside the sample, below the glaze-biscuit interface on the ceramic matrix. The low glaze permeability (Table 5), low capillarity coefficient and relatively low porosity (Table 7) could justify the slow drying rate and longer durability of the samples. The low permeability of sample A5, despite its glaze craquelure structure could be explained because the tile was removed from a kitchen and is probably impregnated with fat organic matter.

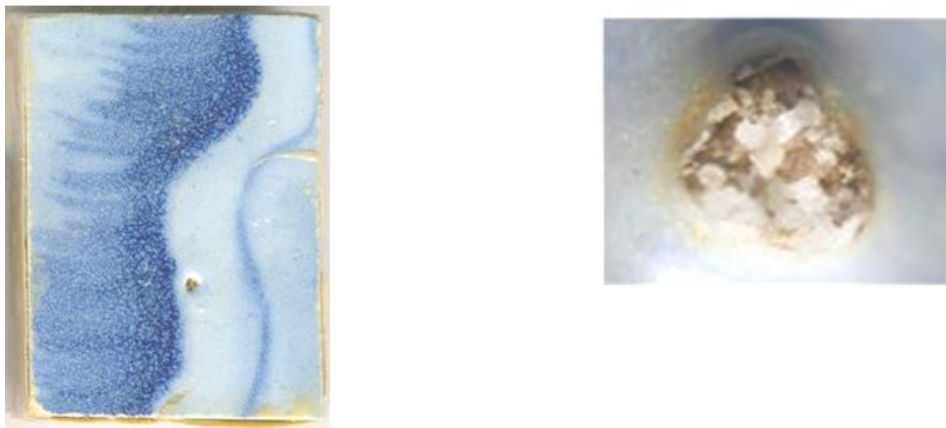
Sample A6a did not present any visible deterioration of its glaze layer and only a small efflorescence on a pore through the glaze (Figure 13). Sample A4 however, presented large efflorescence in all cycles except cycles Ci3 and Ci4 where saturation has not been reached during imbibition (Figure 14). No visible deterioration was observed in the sample except the loss of a white restoration mortar (Figure 12c).

Figure 13. Sample A6a: a) after 8 cycles and b) a detail of the efflorescence's in the glaze pore.

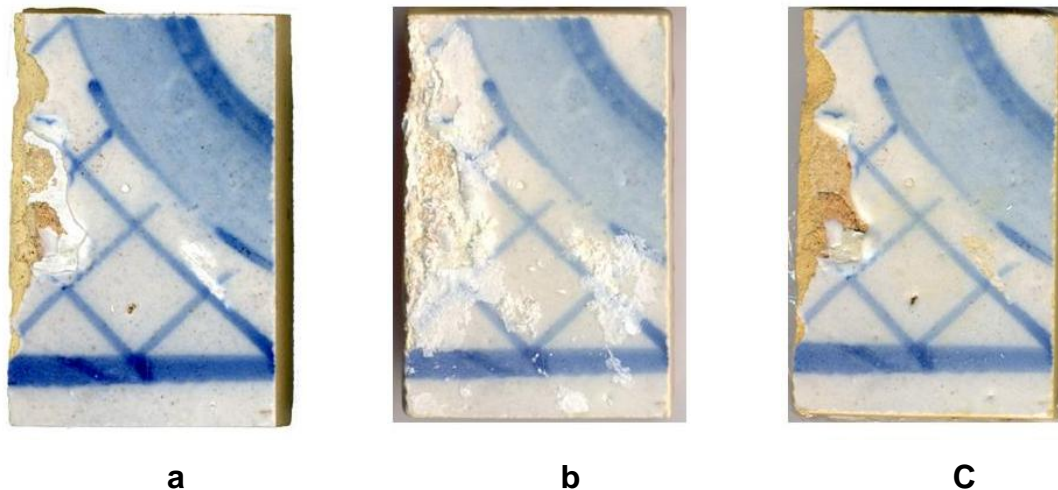
Figure 14. Sample A4 after cycles: a) Ci0; b) Ci1 and c) Ci4

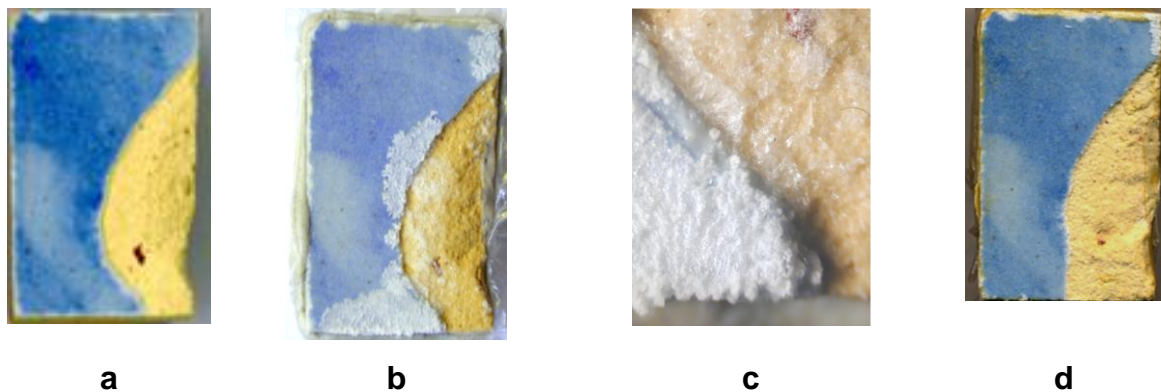
Extensive efflorescence were observed and after cycle Ci5 a piece of the glaze detached. This sample was therefore more susceptible to degradation when compared to sample A6a.

Figure 15. Sample A6b after cycles: a) Ci0; b) Ci1, c) detail Ci1, and c) Ci8

A6b has a high capillarity coefficient such as A6a, but due to its large unglazed area it exhibits high permeability and fast drying rate, the worst conditions when durability is considered. The reason this sample (A6b) from tile A6 dried faster than sample A6a is likely its large unglazed area but could also result from its smaller size.

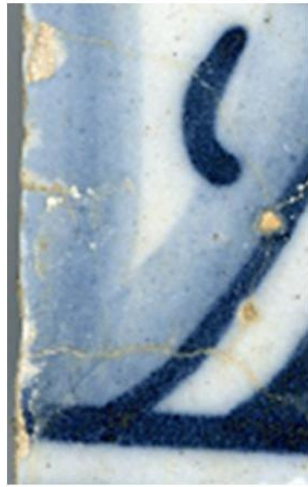
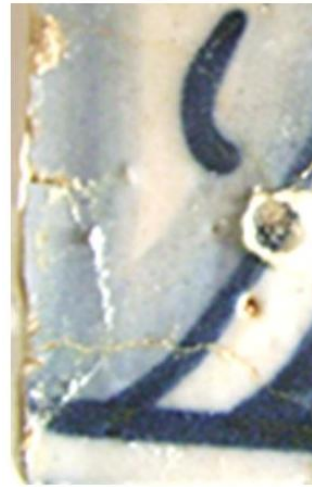
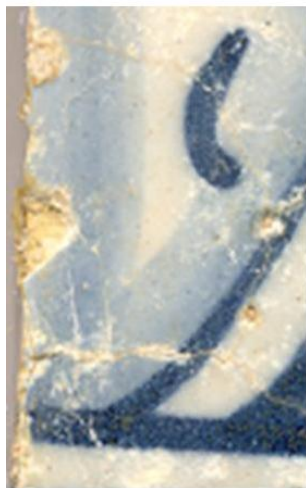
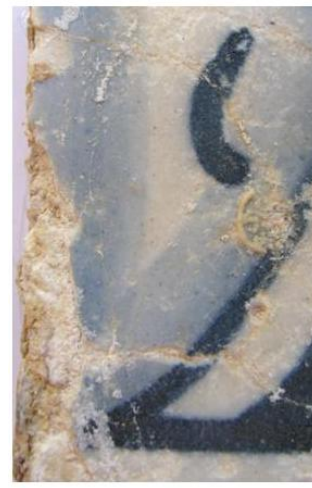
Figure 16. Detail of sample A1 glaze degradation after cycle: a) Ci0; b) Ci1; c) Ci3 and d) Ci4.

Sample A1 presents a moderate capillarity coefficient and drying rate but high permeability. The cracked structure of the glaze is probably responsible for its increased permeability. The fact that the sample presented Type II glaze fissures (interfacial propagation of crazing cracks – Mimoso 2011) proved highly sensitive to glaze damage under salt crystallization conditions. This resulted in consecutive detachments of the glaze layer on a so called “detachment front” (Figure 16 a-e). On the initial cycle it was observed that the efflorescence pattern spread relatively evenly through the surface and defects of the glaze (Figure 10). After some glaze pieces detached it was observed that the efflorescence concentrated on or closer to the unglazed area, an indication that the locus of salt crystallization is highly

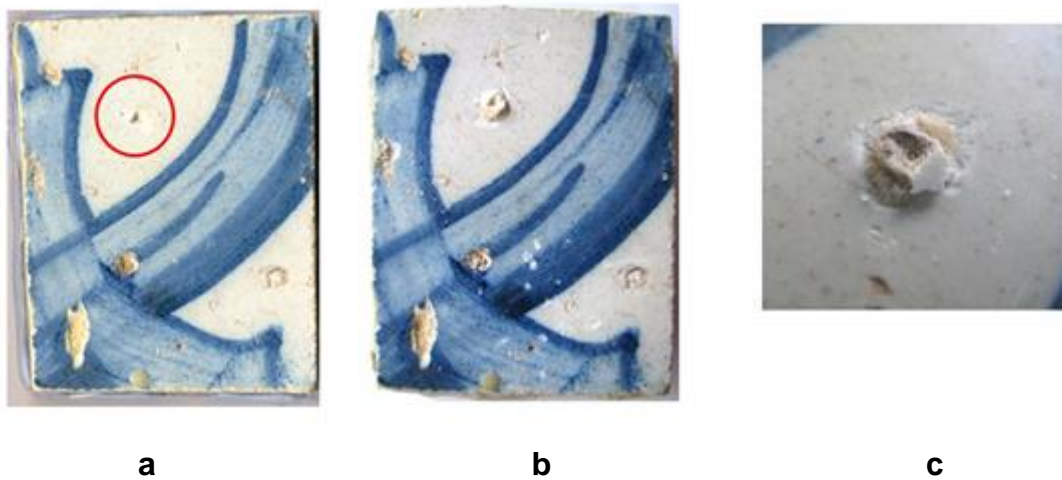
Sample A7 presented very low capillary coefficient, low porosity with small pore size distribution, high specific surface area, and low drying rate. This sample would indicate to be less susceptible to decay except for the presence of small pore sizes and large specific surface area. However, even if not presenting massive degradation signals, after cycle Ci3 it started presenting some efflorescence and decay marks around a pore in its glaze layer (Figure 17). This sample had not shown any marks of degradation or efflorescence before this cycle. An influencing parameter could also have been the increase of salt content in its body through a second imbibition in saturated NaCl solution on this cycle. The slower drying rate of this sample was the reason for a lower number of cycles achieved (5 in the whole). After cycle Ci3, however, no new major deterioration has been observed.

Figure 17. Sample A7 after cycles: a) Ci0; b) Ci3 and c) Detail of pore degradation.

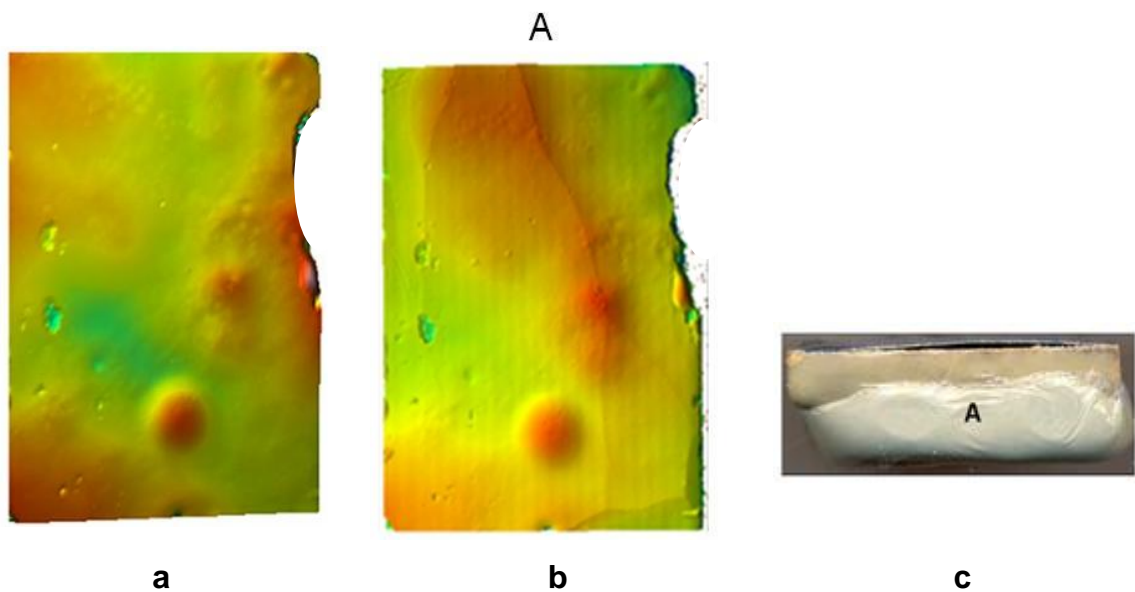
Figure 18. Surface analysis of sample A3 via a 3D profilometer with 20 μm resolution. a) Ci1, b) Ci2, c) lateral image of bulging glaze layer of sample at Ci2.

Sample A3 presented a small capillarity coefficient, slow drying rate and we have no information about its permeability coefficient. Both these characteristics could indicate that it would be less prone to decay, however it turned out to be the sample with the most serious glaze degradation. In fact the delaminated area of the tile began to blister and crack (Figure 18) up to the point when, after few cycles, it broke off entirely, leaving a large unglazed area with remains of salt crystallization in the interface (Figure 19).

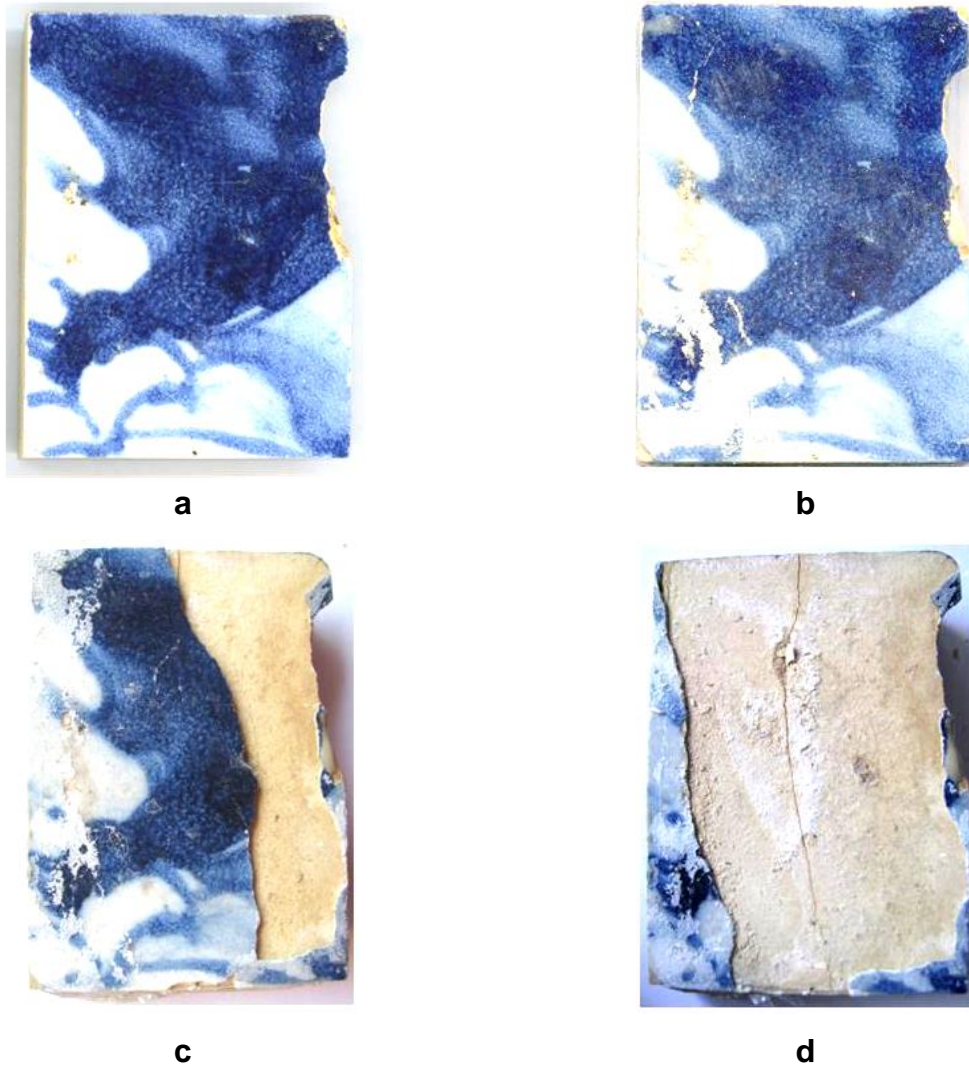
Figure 19. Sample A3 after cycles: a) Ci0; b) Ci2; c) Ci3 and d) Manual detachment of glaze after Ci3.

It could also be observed that the ceramic body was also fissured after the ageing cycles. This might be explained by the relatively high water expansion-contraction coefficient (Table 7) and the resulting stresses imposed to the biscuit (not homogeneous, showing coloured streaks and small round and elongated pores where stresses may concentrate) during the imbibitions/drying cycles.

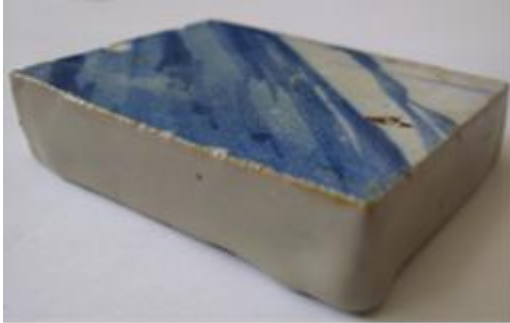
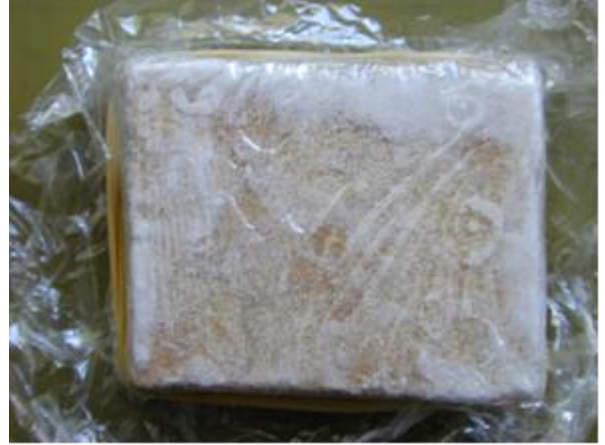
Isolation method A1

Figure 13. Vapor insulation method A1 of sample A2 using plastic sheet and an elastic. (a) with epoxy resin on the sides; b) With mastic and a plastic sheet after the drying cycle, with massive efflorescence's on the back. .

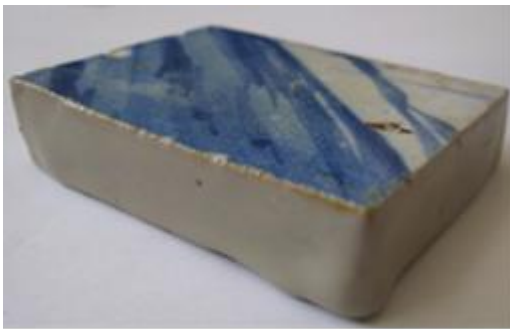
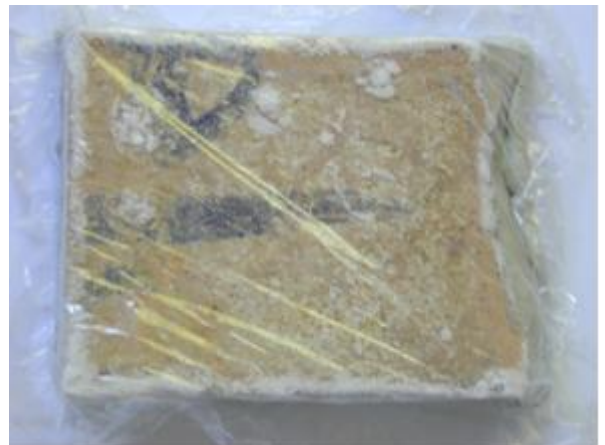
Isolation method A2

Figure 14. Vapor insulation method A2 of sample A2 using plastic sheet and mastic. (a) with epoxy resin on the sides; b) With mastic and a plastic sheet after the drying cycle, with efflorescences on the back. .

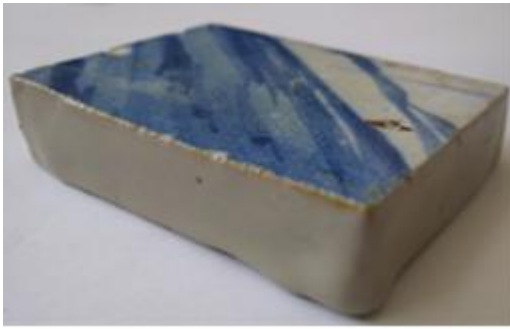
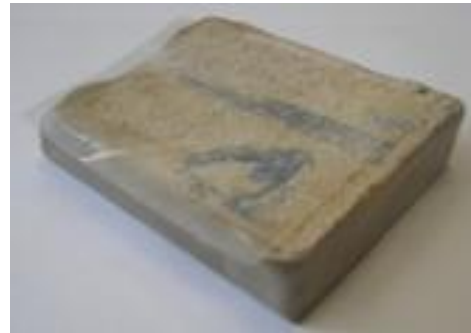
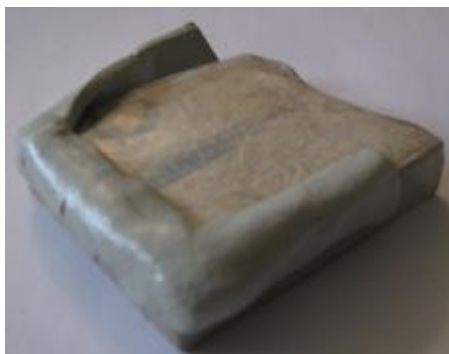
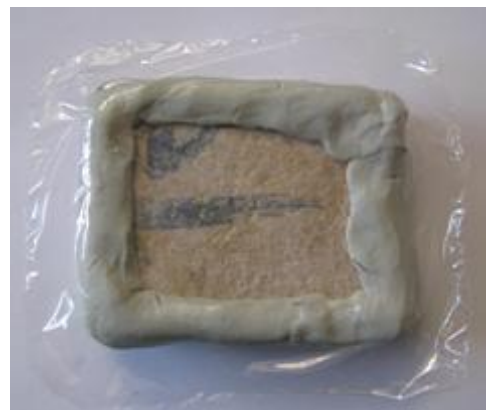
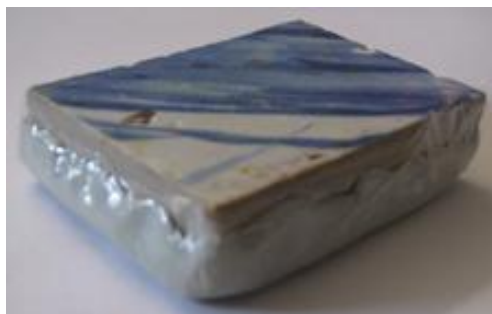
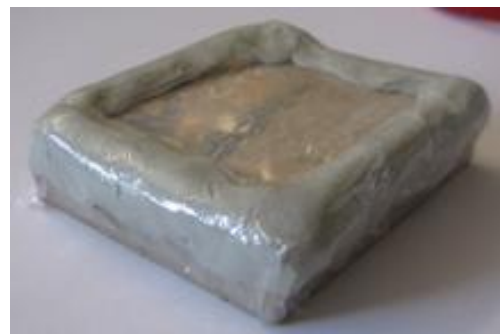
Isolation method A3

Figure 15. Vapor insulation of sample A2 using Mastic. (a) with epoxy resin on the sides; b) adding a rigid plastic sheet on the back; c) sealing with Mastic; d) Adding a plastic sheet in the end; e) final isolation view from the front; and, f) final isolation view with no efflorescences on the back.

During the drying cycles several methods have been tested in order to prevent the evaporation through the back and enhance it via the front, around the glazed area. The several vapor proofing methods tried are illustrated in Appendix A. Method A1 comprised covering the back part of the tiles with a plastic film held by a rubber band (Appendix A, Figure 13). Method A2 used mastic to try to hold the plastic film on to the sample perimeter (Appendix A, Figure 14). Method A3 made use of an acetate layer in the shape of the back of the tile (Appendix A, Figure 15), attached with mastic on to the edges and covered with a final layer of thin plastic sheet. Method A4 was as A3 but using the high temperature resistant Sticky tape AT199 or AT200 from 3M instead of mastic (Appendix A, Figure 16).

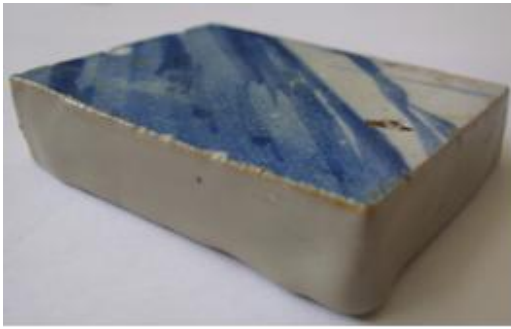
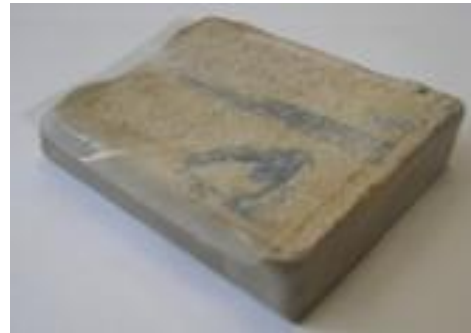
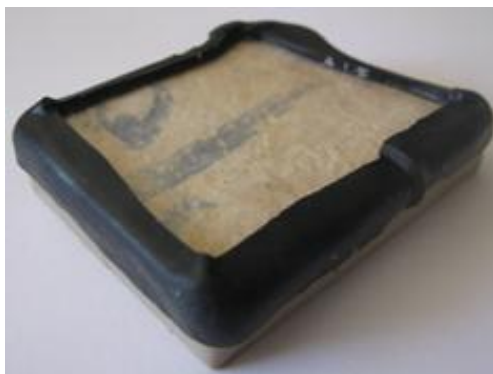
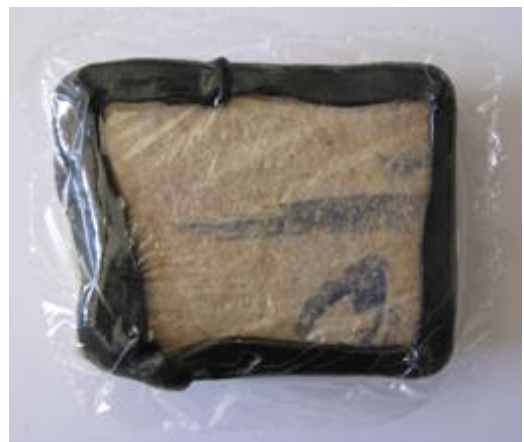
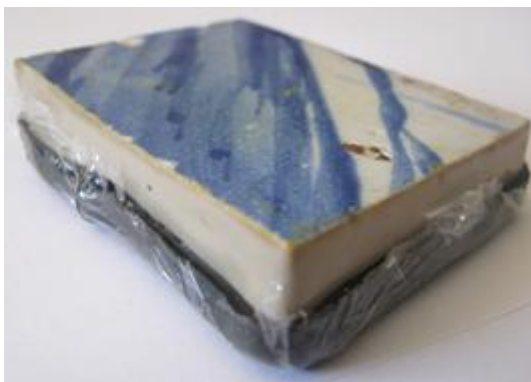
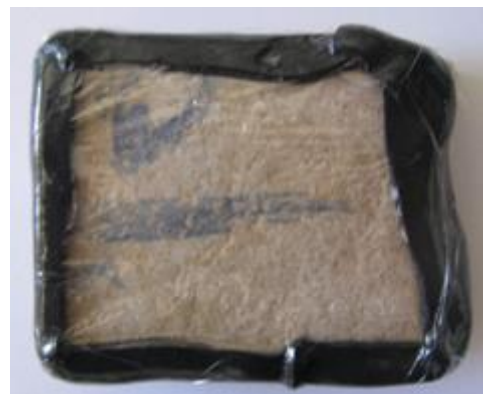
Isolation method A4

Figure 16. Vapor insulation of sample A2 using Sticky tape AT199 from 3M. (a) with epoxy resin on the sides; b) adding a rigid plastic sheet on the back; c) sealing with Sticky tape AT199; d) Adding a plastic sheet in the end; e) final isolation view from the front; and, f) final isolation view with no efflorescences on the back.
