## DAMAGE PROGRESSION IN RUBBLE-MOUND BREAKWATERS SCALE MODEL TESTS UNDER DIFFERENT STORM SEQUENCES

This paper describes the 2D physical model tests performed for a rock armour breakwater at LNEC's facilities, under the framework of the HYDRALAB+ project. The aim of the present work was to evaluate damage evolution under different approaches of storm sequences, corresponding to different climate change scenarios. The tested wave conditions intended to simulate different sequences of water levels (low water and high water), significant wave heights and peak periods. Damage evaluation was based on the traditional visual method and on stereo-photogrammetric techniques. Results in terms of the non-dimensional damage parameter, the non-dimensional damage depth and the percentage of displaced armour units are compared for the different storm sequences.

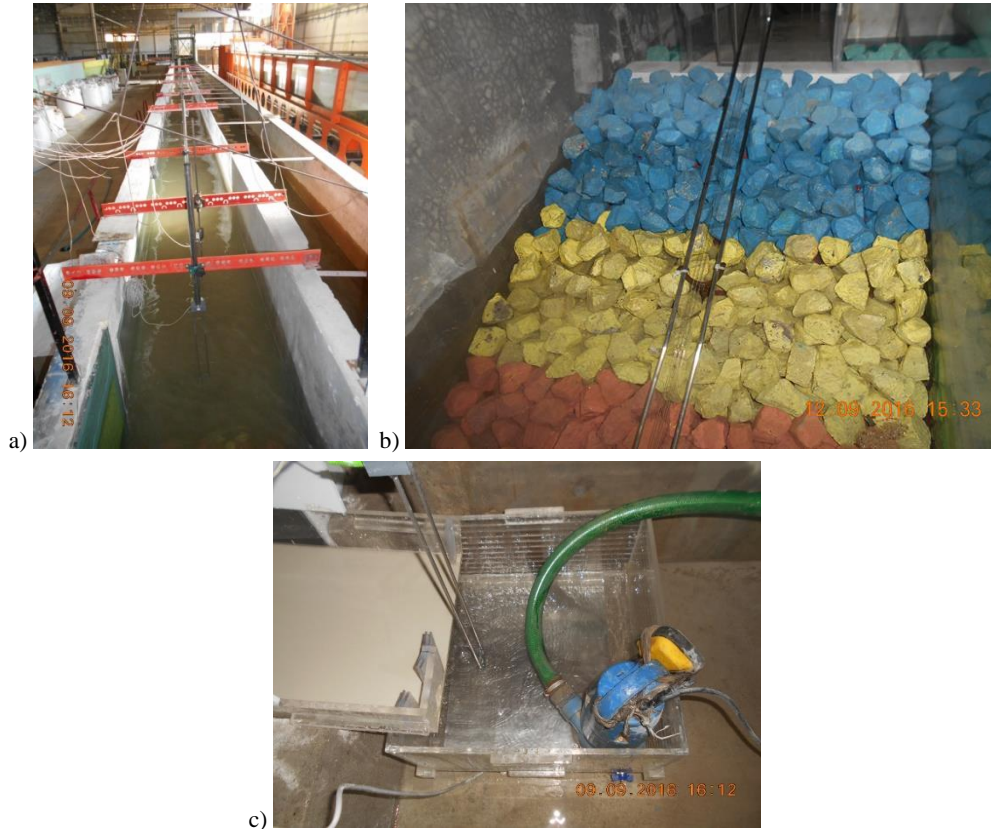
**Figure 3. Measuring equipment: a) wave gauges to measure free-surface elevation; b) run-up wave gauge; c) chute, overtopping tank, load cell and water-level gauge for measuring overtopping variation.**

The flume was equipped with twelve resistive-type wave gauges deployed along its length, to measure the free-surface elevation at different locations, Figure 2b and Figure 3a. In order to measure run-up levels, an additional gauge was placed on the model armour layer slope, Figure 3b.

The equipment used to collect the volume of water that overtopped the structure consisted on a tank, located at the back of the structure. The water was directed to the tank by means of a chute, 40 cm wide, Figure 3c. The overtopping tank was placed over a weighing scale (KERN KXS-TM), which also allowed the measurement of the overtopping volumes, Figure 3c. The measured data were collected as time series and stored, in digital format, at a frequency of 1 Hz.

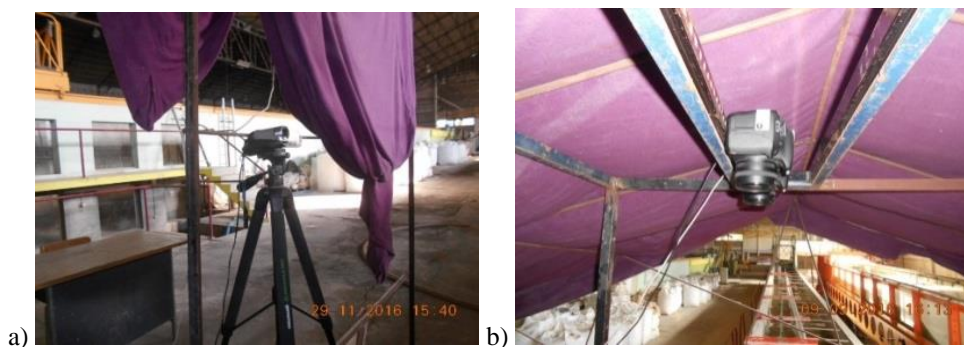
**Figure 4. Photographic equipment: a) video cameras; b) photographic cameras**

For damage assessment, two methods were used. The counting of falls and movements of the armour units was performed by visual observation and photo captures of the breakwater cross-section with a standard camera. The stereo-photogrammetry technique used two DSLR cameras (Canon EOS 600D), fitted with fixed focal length lenses (Canon EF 35mm  $f/2$ ), mounted side by side in a frame. This setup enabled both cameras to simultaneously photograph the same scene (Figure 4). All tests were also video-recorded using 2 video cameras, one above the model and the other on the its side, Figure 4. Those cameras were responsible for the run-up and damage measurements.

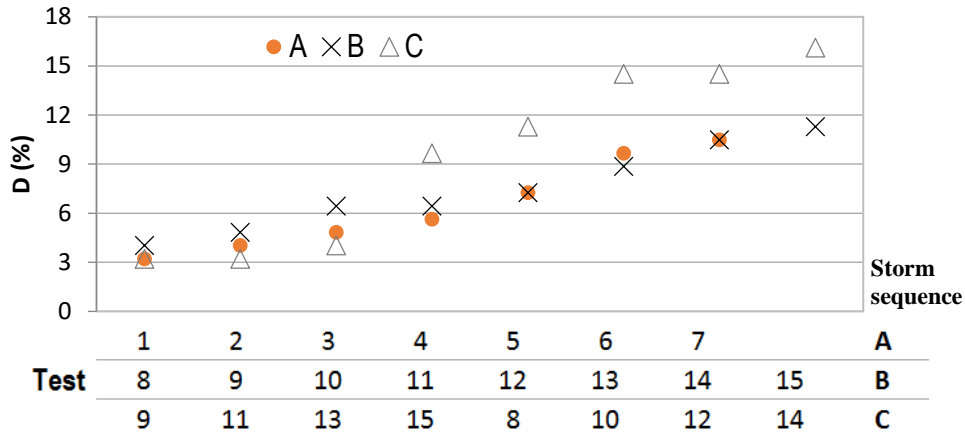
Figure 9. Storm sequences A, B and C. Damage in terms of percentage of displaced armour units ( $D$ ).

According to the damage classification referred to in the Coastal Engineering Manual (U.S. Army Corps of Engineers, 2006), the cumulative damage at the end of the last test of each sequence corresponds to an intermediate damage (units are displaced but without causing exposure of the under or filter layers to direct wave attack). However, some differences between sequences were found in the damage.

The highest percentage of displaced armour units in the first three tests occurred for storm sequence B and the difference increases from test to test. For these tests, storm sequences A and C were run with low water levels, whereas for storm sequence B, the water level changed from test to test, showing the influence of the water level in the armour damage.

After the fourth test, the trend changed, with storm sequence C presenting the highest damage. For the fourth test, the main difference between storm sequences is the value of the significant wave height, with storm sequence C having a value of  $H_s$  1.5 m and 1.0 m higher than the values tested for storm sequences A and B, respectively. After that test, the cumulative damage continues growing in the three sequences, with similar values of parameter  $D$  for sequences A and B, despite the differences in the wave conditions.

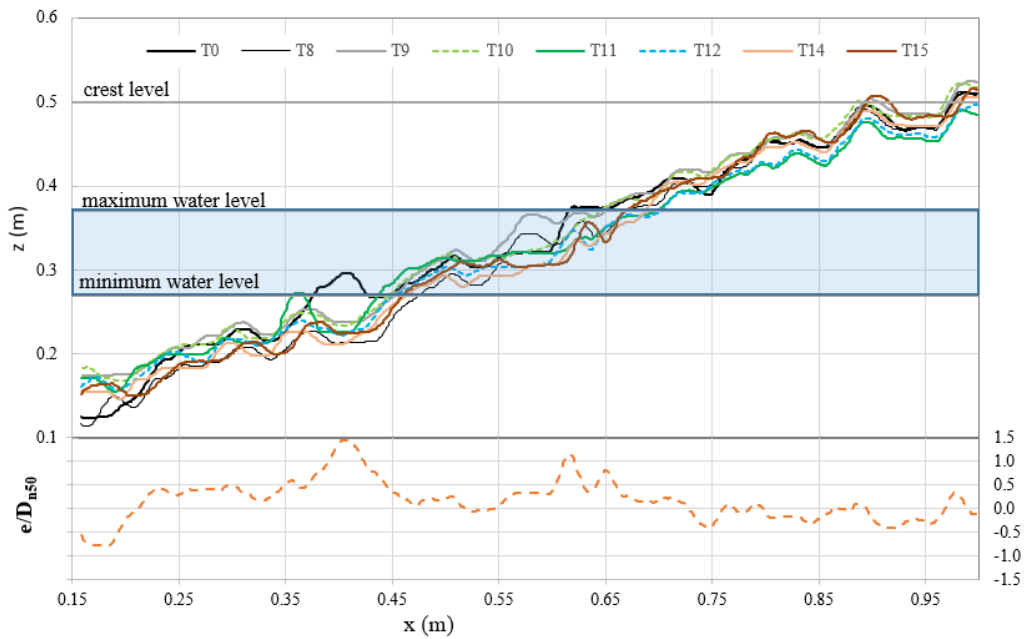
Figure 12. Profile P4 for each test of storm sequence B and  $e/D_{n50}$  between T0 and T15

Figure 12 shows the surveys for profile P4 during storm sequence B, together with the variation of  $e/D_{n50}$  with the cross-shore coordinate ( $x$ ) along the slope cross-section, with  $x$  origin at the toe of the structure. Figure 13 presents the variation of  $e/D_{n50}$  calculated for the last test of each sequence A, B and C. As referred before, results for Test 13 for storm sequence B are not presented.

For profile P4, and for storm sequence B, it can be observed that the damage is higher for  $x$  between 0.35 m and 0.65 m, i.e., on the active zone. As expected, within the active zone, for the same water level, the size of the hole increases with the wave height. It can also be observed that the hole size increases with the water level.

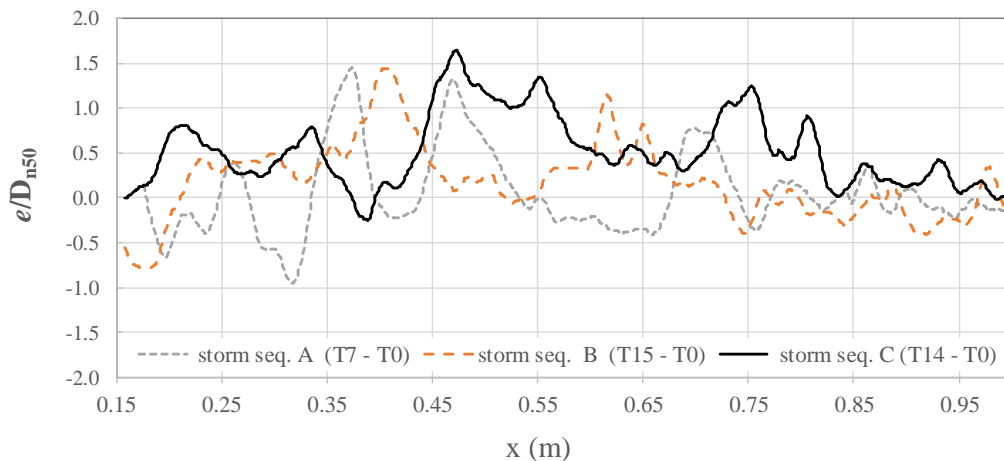
Figure 13. Profile P4.  $e/D_{n50}$  between T0 and the last test of storm sequences A, B and C.

Comparing storm sequences, storm sequence C is the only one that presents cumulative values of  $e/D_{n50}$  higher than 1.5 and with more  $x$  extension, with values higher than 1. For this profile, the position where the hole is larger than one stone diameter,  $e > D_{n50}$ , changes with the storm sequence. Storm sequence A, where water levels tested are lower, presents the lowest values of  $x$  ( $0.35 < x \text{ (m)} < 0.48$ ) for  $e > D_{n50}$ . On the other hand, storm sequence C presents the highest values

of  $x$  for  $e > D_{n50}$  ( $0.45 < x \text{ (m)} < 0.76$ ). For all test series, damage is located in a region with  $x$  ranging between 0.35 m and 0.76 m.
