# MONITORING THE BEHAVIOR OF MEO ARENA ROOF

**Maria João HENRIQUES, Dora ROQUE, Helena CRUZ, Ana FONSECA, Portugal**

Laboratório Nacional de Engenharia Civil, LNEC

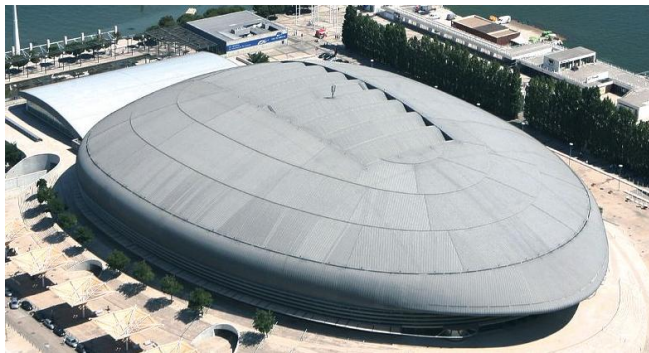
*Fig. 2 MEO Arena roof*

MEO Arena, previously known as Atlantico Pavilion and, before that, during the EXPO' 98 world exhibition, as Pavilion of Utopia, was built as a response to the demand for a large space to hold events like concerts, congresses or sport activities. The roof of the Pavilion is covered with oxidized zinc sheets supported by a timber structure. It is this structure, made of glued laminated timber (glulam) arches, that makes MEO Arena one of the most emblematic buildings of its kind. At the time of its construction, 1995-1997 (Fig. 1), it was claimed to be the largest glulam structure in the world.

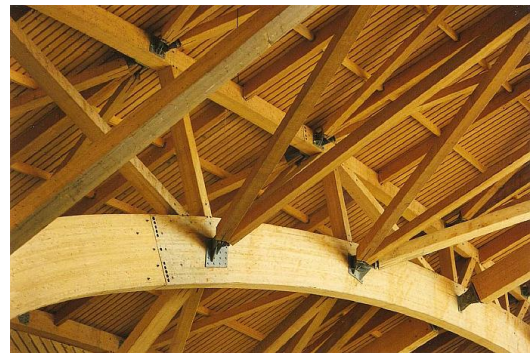
*Fig. 3 Timber structure, including a section of an arch*

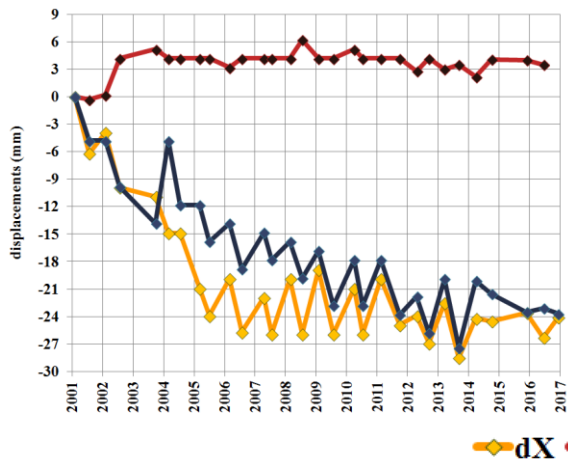
Fig. 5 Components of the displacement (point B14)

The graph from Fig. 5 points out that, in general, displacements present regular variations added to a time effect that tends to stabilization as the structure ages. A regression model like the one presented in (1) may be used to describe the behaviour of each point.

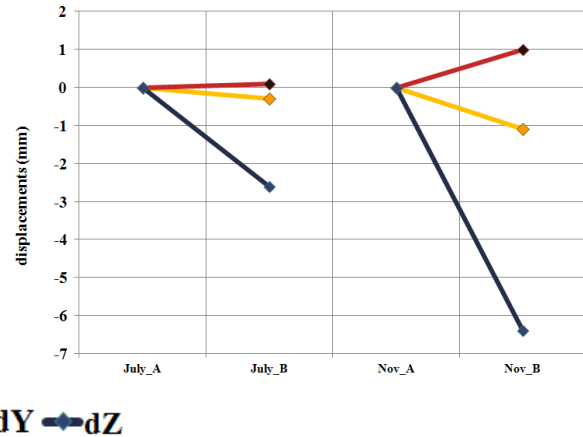
Fig. 6 Components of the displacements due to suspended loads (point B12)

In the year of 2008 four special campaigns were made with the unique purpose to measure the effects of loads suspended from the structure. The first two campaigns were made in July, one without the grid, the other with the grid suspended. The third and the fourth campaigns, made in November, were carried out just before and after setting an especially heavy décor composed by a second metallic grid, three big screens, many spotlights and loudspeakers and heavy curtains in the back of the scenery, all suspended from the metallic grid that was up in its position on both campaigns. Figure 6 presents the corresponding displacements of point B12. In both cases, the reference of the displacements is the campaign made when there was less weight. Figure 7 presents a photo of the room during the preparation of a show where one can notice the metallic grid and suspended curtains.

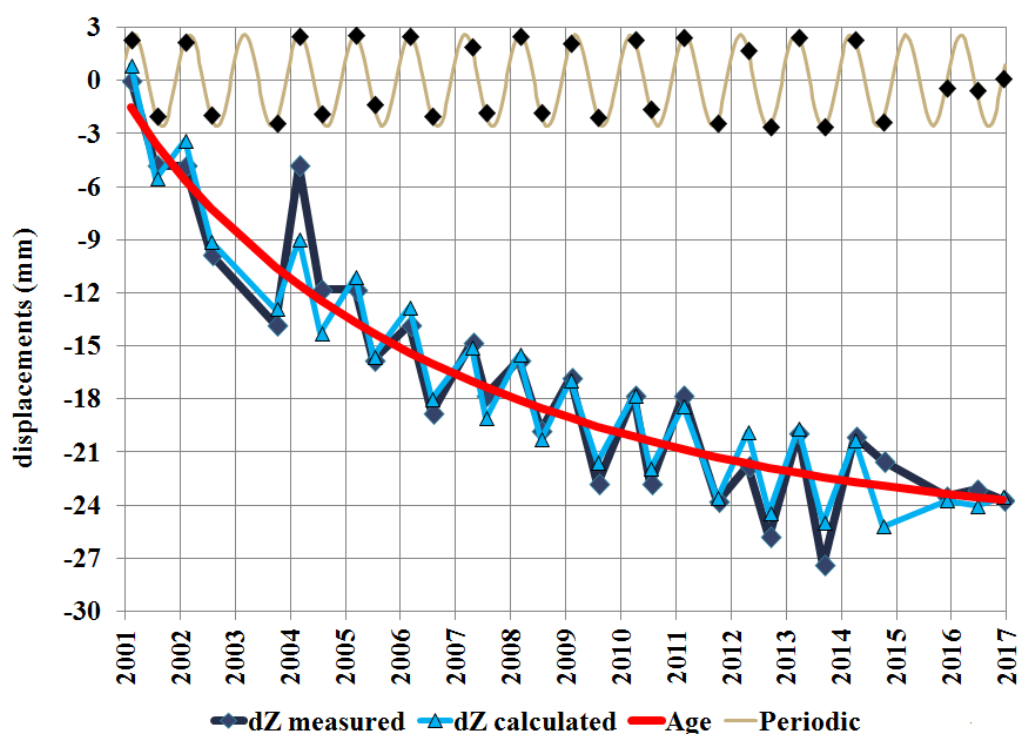
Fig. 8 – Vertical ( $dZ$ ) displacements measured and calculated

After solving the three systems of equations, three sets of parameters  $a_1, \dots, a_5$  are calculated which allows to estimate the displacement for any specific date. The chart in Fig. 8 presents: i) the displacements  $dZ$ , presented before in Fig. 5; ii) the displacements calculated using the regression model (1); iii) the effects of age (sum of the last three terms of (1)); iv) the cyclic effects ((2)).

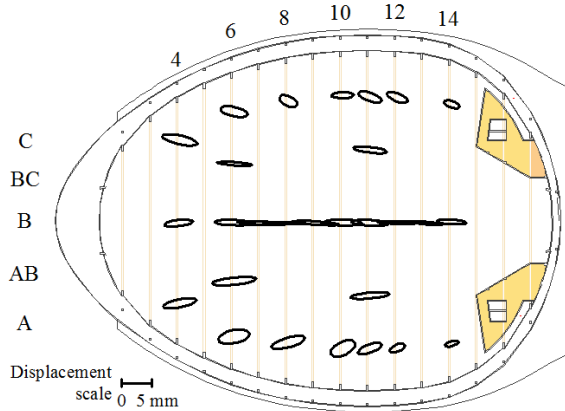
Fig. 9 Expected cyclic horizontal displacements

From equation (2) it is possible to estimate, for each point, the displacement due to cyclic effects (see Fig. 9 and 10). One can notice that: i) displacements have Y symmetry (compare points in row A with those in row C; or AB with BC); ii) points in row B have almost no displacements in Y direction; ii) points in row AB have larger cyclic horizontal displacements when compared with points in row BC (average 20% larger); iii) points in row A have larger cyclic horizontal displacements when compared with points in row C but the difference is not significant (average 5% larger).

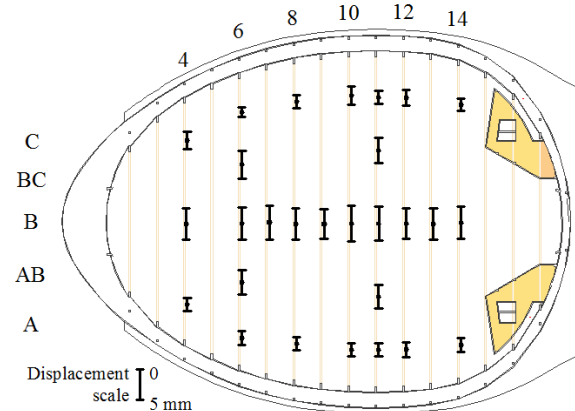
Fig. 10 Expected cyclic vertical displacements

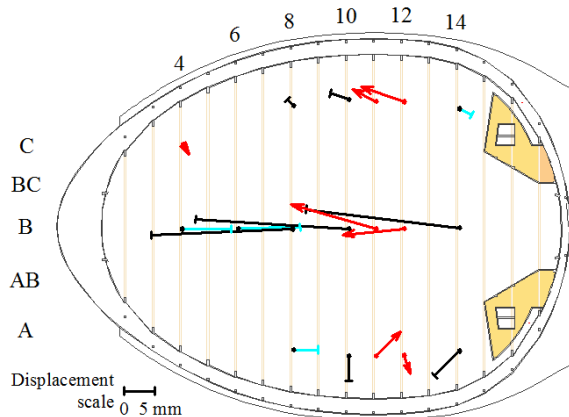
Fig. 11 Aging effect since 2001. Horizontal component

Concerning the effects of aging (including settling of structural joints and creep), Fig. 11 and 12 present the results of 18 of the 21 points that were placed in 2001. In the first campaigns, there was no visibility to points A4, A6 and C6. The analysis of the data showed that, for most points, the aging effect became negligible around the year 2009. However, points in arches 11 and 12 are still presenting significant displacements (red arrows). Concerning the horizontal components, one can notice that most points have moved in the same direction. When the lines have cyan colour they indicate that the displacements have already stopped but they were in the direction opposite to the ones represented with black color.

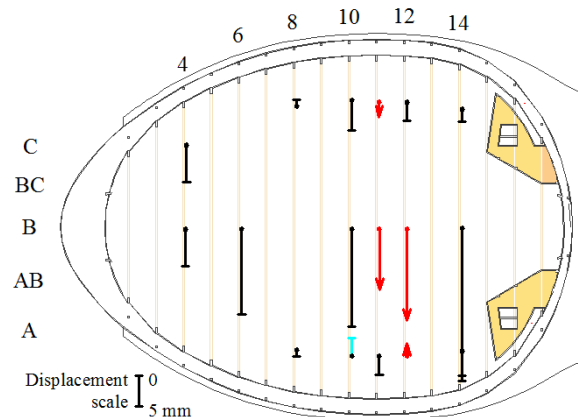
Fig. 12 Aging effect since 2001. Vertical component

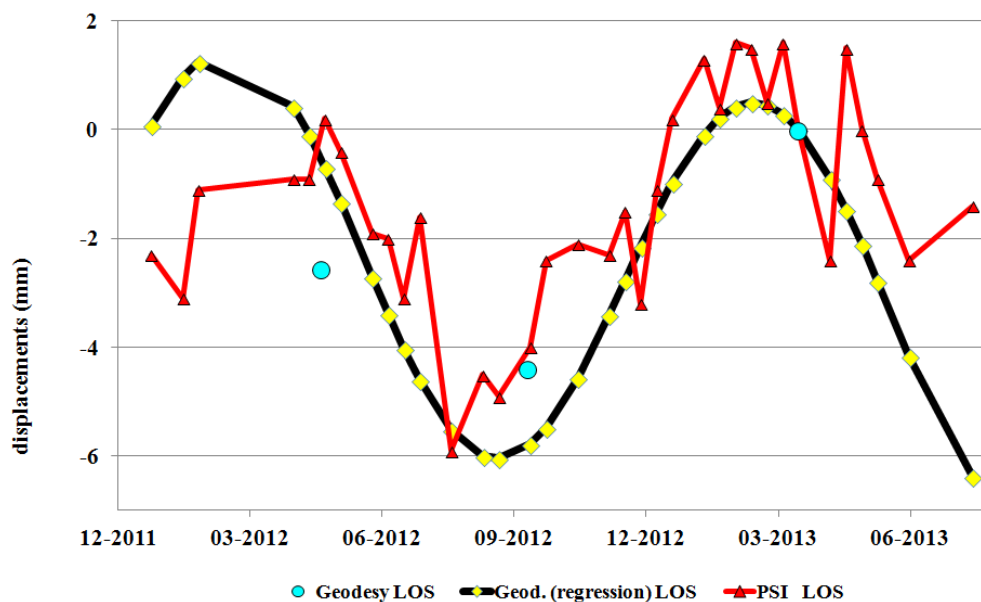
Fig. 14 Geodetic displacements of point B13 and InSAR displacements of the closest point on the metallic roof

Fig. 14 presents the displacements of a point of the glulam structure monitored by geodetic methods (B13) and the closest PS to its vertical. The results presented (Roque *et al.* 2016) are: i) the geodetic displacements of point B13 in the LOS direction; ii) the displacements of this point for each SAR image acquisition date calculated by applying (1), the regression model, also in the LOS direction; iii) the InSAR displacements of the closest PS. The three sets of displacements have as reference the date of 2013/03/18, chosen because this geodetic campaign is the closest to a SAR image acquisition (only one day apart). To transform the geodetic displacements into the LOS referential, two transformations were applied: the rotation from the referential X0Y (see Fig. 4) to WGS84 UTM 29N and the projection to the LOS direction, through the heading and the radiation incidence angles.
