Characterization of Renders and Plasters from a 16th Century Portuguese Military Structure: Chronology and Durability

M. R. Veiga^{*}, A. Santos Silva, M. Tavares, A. R. Santos and N. Lampreia
Laboratório Nacional de Engenharia Civil (LNEC), Lisbon, Portugal

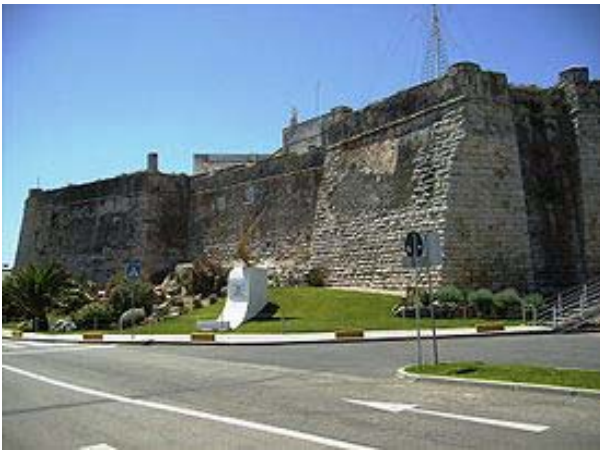
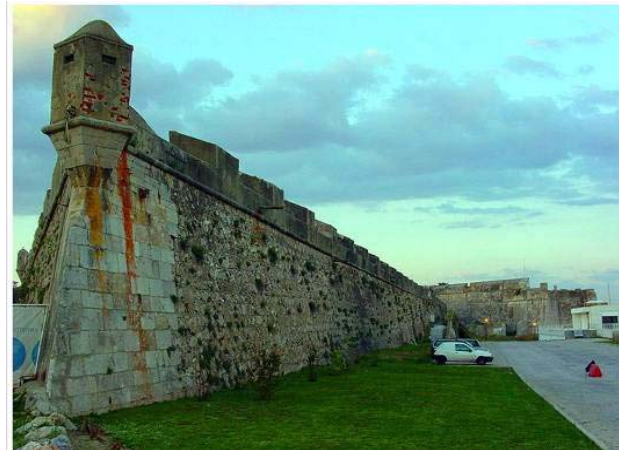
Figure 1: External views of *N. Sra. da Luz* fortress.

the old *Tower of St. António* can be found, also known as the *Joanina Tower* because it was built by order of D. João II, in 1488. In 1580, the tower was transformed into a fortress with three Bastions (Fig. 1) [7, 8].

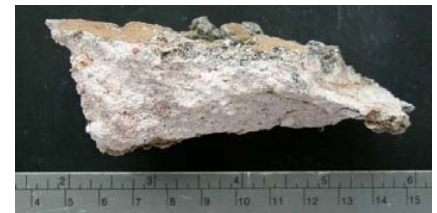
NSL MS8 render sample

Figure 4: Photographs of the render and plaster samples studied.

| Samples | Localization and approximate dating | Description | |
|---|---|---|---|
| NSL MS8 | South Wall XVI-XVIII century | External walls | Render composed of a single mortar layer of white colour covered by an ochre colour paint |

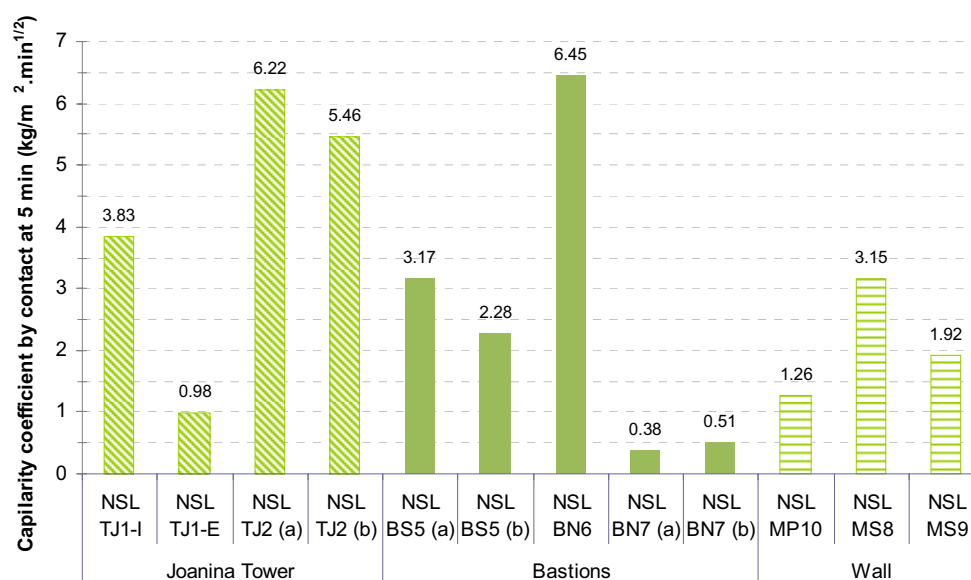
Figure 9: Results of water absorption coefficients (kg/m²·min^{1/2}).

- NSL TJ2 and NSL BN6 samples have the highest capillary absorption coefficients ($> 5.46 \text{ kg/m}^2 \cdot \text{min}^{1/2}$) indicating larger capillary pore diameters of these samples, while NSL TJ1-E, NSL BN7 and NSL MP10 have the lowest values ($< 1.26 \text{ kg/m}^2 \cdot \text{min}^{1/2}$), corresponding to smaller capillary pore diameters (Fig. 9).
- The compressive strength of NSL TJ2, NSL BS5 (a) and NSL BN6 samples is low ($< 1.7 \text{ N/mm}^2$) and their dynamic modulus of elasticity indicate high deformability ($E \approx 1500 \text{ N/mm}^2$) (Figs. 10 and 11). These data evidence a lower mechanical strength of

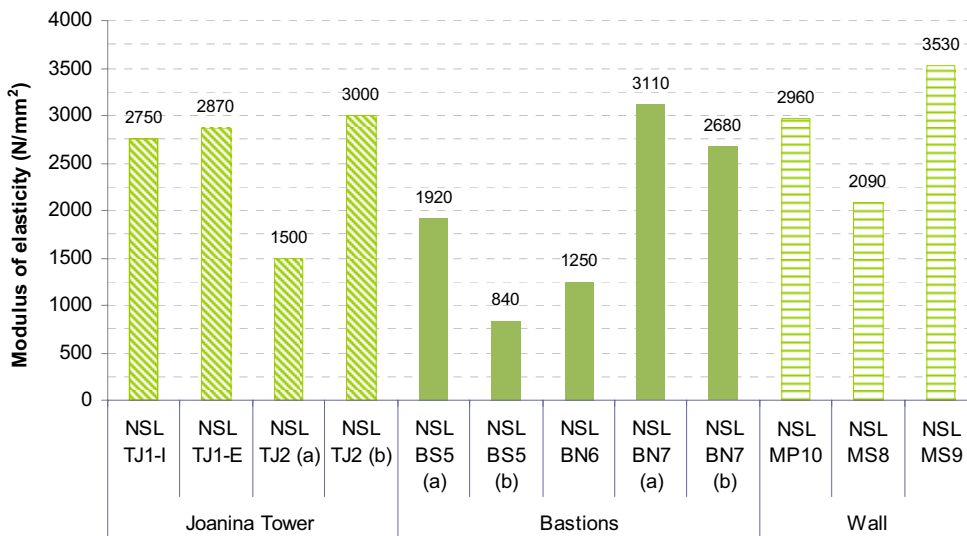
Figure 11: Dynamic modulus of elasticity results (N/mm²).

Ultrasonic testing was used to evaluate the compactness and stiffness of the renders. This test is based on the Brazilian standard NBR 8802/94 [15], the propagation velocity of ultrasonic waves through the material under study is measured. An Ultrasonic Tester *Steinkamp BP-7* model was used, which emits waves, between two transducers positioned in different points of the sample (in this case, on the same face - indirect transmission) and registers the transmission times, in microseconds, between the two transducers. Samples with at least one dimension larger than 10 cm and a surface regular enough were used for these measurements.
