# HDPE geomembrane's behaviour after 20 years in service at Areias de Vilar Water Reservoir

**ABSTRACT:** A high-density polyethylene geomembrane installed 20 years ago at Areias de Vilar Water Reservoir has experienced degradation and damages, such as tears, punctures and stress cracking. In order to study its behaviour, samples were taken from the west cell, from the four slopes, in two locations (above and below the water level). Tensile tests, static puncture tests and standard (Std) oxidative induction time tests (OIT) were carried out. The results show that the tensile strength at yield, the strain at break and the puncture resistance of the geomembrane remain close to the its initial values, while the tensile strength at break and the strain at yield showed a decrease. Also Std-OITs measured were low and approaching a residual value.

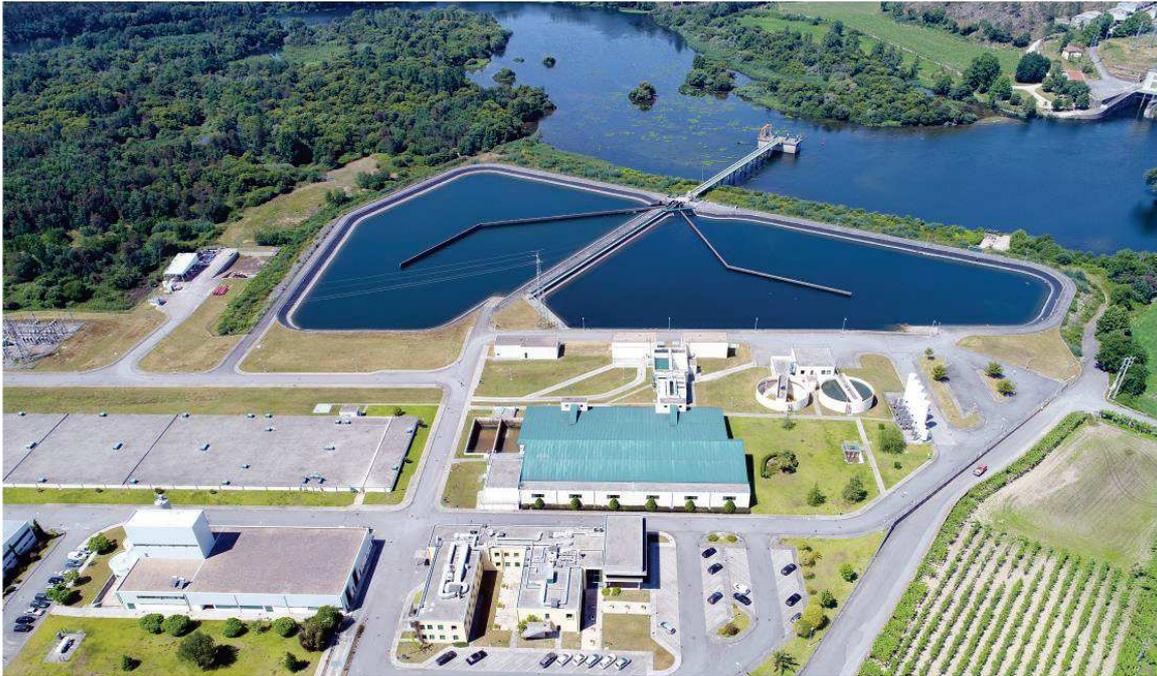
Figure 1. View of the Areias de Vilar Water Reservoir

The Water Reservoir is located in the north of Portugal, at the municipality of Barcelos, close to the Cávado River. It includes two cells, with a global capacity of 175 000 m<sup>3</sup> (Figure 1). This volume of water corresponds to a water reserve of more or less 24 hours. The cells are limited by embankment dikes, 6.5 m high, with slopes of 2.25H:1V (where H is horizontal and V is vertical). The reservoir lining system comprises a HDPE geomembrane, 1.5 mm thick, at the slopes, and, a bituminous concrete mat, at the base. The lined area is, approximately, 20 000 m<sup>2</sup>. The geomembrane rests on a needled punched non-woven geotextile, made of polypropylene.

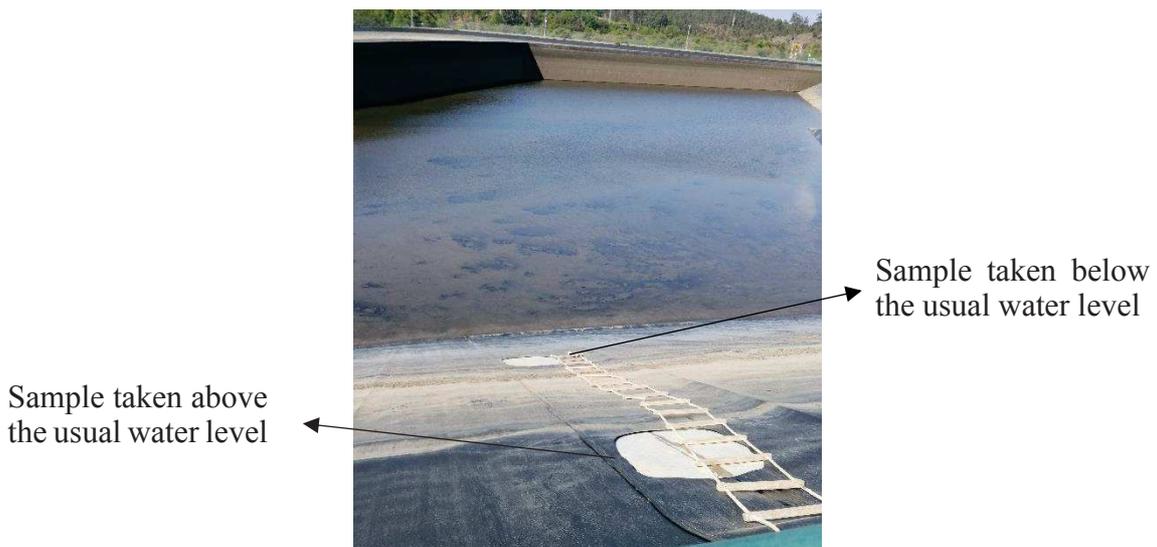
Figure 2. Sampling at south-facing slope

Seven geomembrane samples were exhumed from the four slopes of the west cell. This cell presents less damage compared to the east cell, which will be replaced soon. Six samples were taken from the north, east and south facing slopes, in two locations (Figure 2): above the water level (emerged) and below the water level (submerged). The remaining sample was taken from the west-facing slope above the water level, on an area where the geomembrane had a pronounced crease (Figure 3).
