International Symposium Stone Consolidation in Cultural Heritage

Short stories and personal perspectives
on the history of stone conservation

Editor: José Delgado Rodrigues

LNEC, Lisbon, 23-25 March, 2022

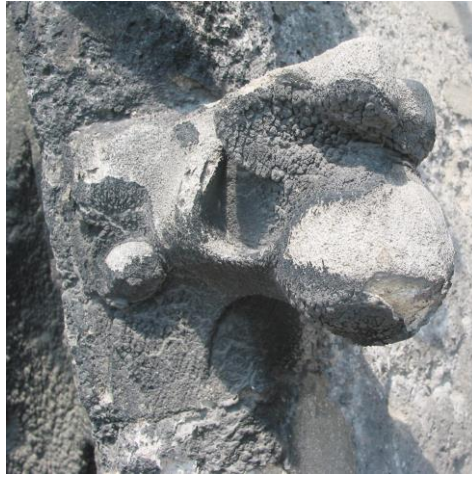
Figure 2a (top): crab at Vienna Cathedral, biocalcarene; characteristic features of weathering with gypsum crust in sheltered areas and surface erosion at exposed surfaces.

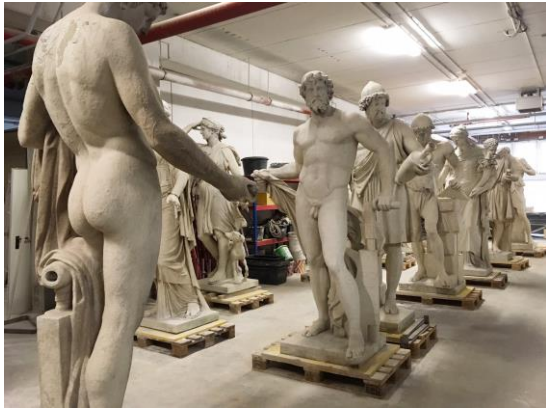
Figure 3: 19th century Carrara and Laas marble sculptures from the attic of the Austrian Parliament building, removed during its refurbishment; the photo was taken after cleaning and conservation; due to their advanced state of microstructural decay even after consolidation, extensive survey by ultrasound transmission had to provide criteria for their re-assembly at the attic of the building.

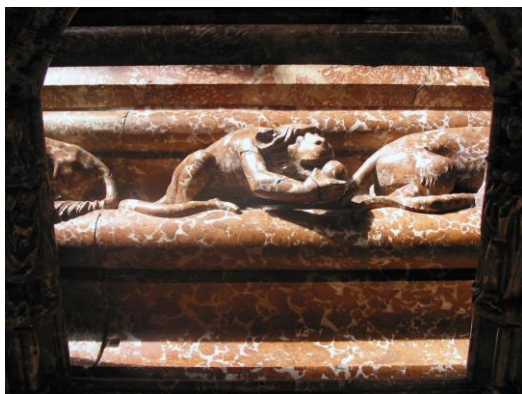
Figure 4: detail of the monumental tombstone of Emperor Friedrich III (finished in 1510) in the interior of Vienna Cathedral; the so-called Rotscheck is amongst the most precious varieties of the Mesozoic Adnet limestone quarried near Salzburg since the Roman times.

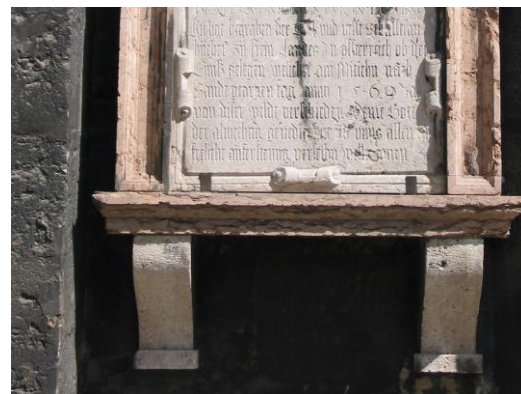
Figure 5: detail of an epitaph on the exterior façade of Vienna Cathedral; the photo, taken before conservation, shows four lithotypes of limestone with differing susceptibility to atmospheric impact. The red framing (Adnet limestone, regular variety with clayey veins) reveals the worst state of weathering.

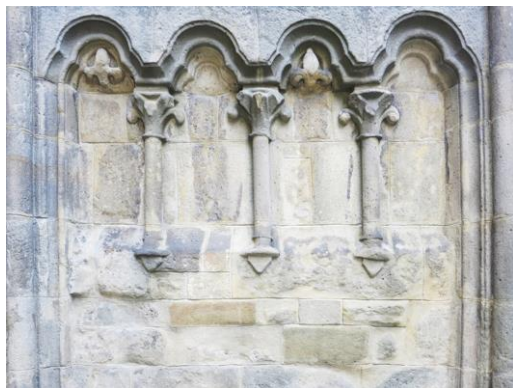
*Pink - scale formation; Violet - sanding
Grey - salt efflorescence*

Austria is a relatively small country, and therefore generally tended to watch the international developments in stone conservation and make use of the primary products marketed abroad. This fact, however, did not preclude certain system modifications sometimes developed and tested in the laboratories of the BDA or in other research institutions. In times of competing concepts advocating either synthetic resins, or silicate consolidants to strengthen decayed stone in cultural heritage, Austria kept a somewhat pragmatic approach, well aware of the fact that a great deal of our sculptural and architectural stones – porous detrital limestones - differ from the majority of lithotypes in the heritage of our neighbors, especially German, Bohemia and Italy. Thus, the use of methyl and ethyl silicates, in Central Europe widely applied in the consolidation of silicate sandstones, was not adopted without reservations for the carbonate lithotypes in Austria until it proved useful as consolidant, especially when equipped with specific bonding agents for carbonate substrates. The first use of silicic esters in Austria was nevertheless performed on a silicate sandstone, namely a Flysch sandstone from a Romanesque stone ossuary in Tulln near Vienna, in the year 1971 or 1974. To date TEOS is by far the most widespread group of products used for the microstructural consolidation of weathered stones in Austria. In the above-mentioned case, just like in many other projects following this intervention, water repellent treatments were applied, either as a silicone component of the consolidant, or separately as the a final step of intervention. A survey performed at the Tulln Ossuary after 40 years (Ban et al 2022), revealed the formation of a hard and compact shale above a weakened layer of stone, with a still hydrophobic surface (Figures 6a, b).

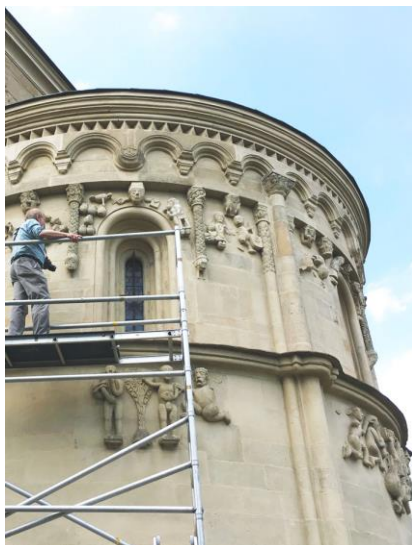
Figure 8: translucent sacrificial lime-sand layer, applied on the sandstone façade of the apse of the Romanesque church of Schöngrabern, Lower Austria, after completion of its conservation. The photograph was taken approx. 20 years later.

The revival of the concept of heritage preservation of the 20th century was based on two fundamental criteria, one being the reconstruction of the original aesthetic appearance, the other one the idea to provide a protective, or rather sacrificial layer to the chemically sensitive and highly porous limestones and calcarenites to protect them against the acidic pollutants. The original approach using linseed oil with white lead was no longer considered appropriate, so the coatings were now performed with lime. To avoid the formation of a dense surface film which would completely cover the stone, altering its appearance and its physical properties, the wash is usually applied as a water-rich slurry of fine aggregates and lime aimed at a translucent aspect. Figure 8 shows a recent example.

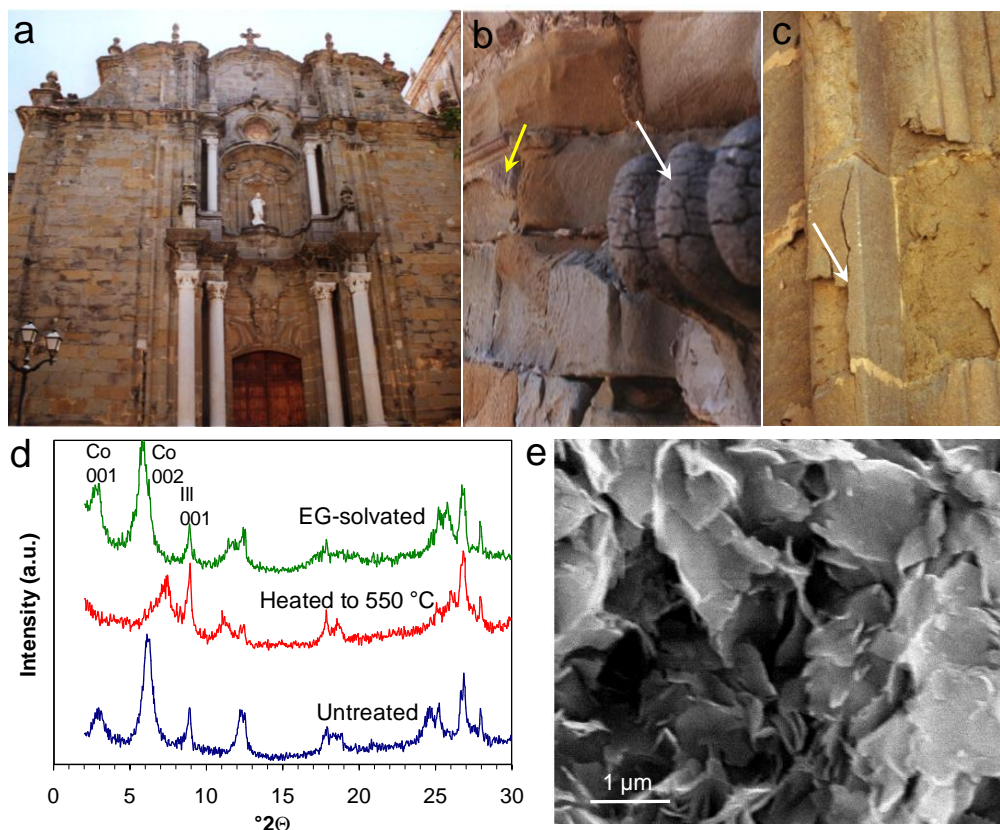
Figure 3. Clay swelling damage at the Church of San Mateo in Tarifa (Spain). a) Overview of the main façade of the church, showing extensive damage (scaling, delamination, contour scaling and drying cracks); b) detail of drying cracks, also known as "mud cracks" (white arrow) and scaling (yellow arrow) of the stone blocks and surface reliefs; c) detail of contour scaling (arrow); d) XRD patterns (Cu K α radiation) of oriented aggregates of the clay fraction (~5 wt%) of Tarifa sandstone showing Bragg peaks of Corrensite (Co), a regular mixed layer smectite-chlorite (i.e., a swelling clay), and non-swelling Illite (III). The d_{001} -spacing of Corrensite expands upon EG solvation from 28 up to 32 Å and collapses to 12 Å upon heat treatment, confirming the presence of such a regular mixed layer clay (Moore and Reynolds, 1989); e) SEM image of the swelling clays within Tarifa sandstone. Modified from Sebastian et al. (2008).

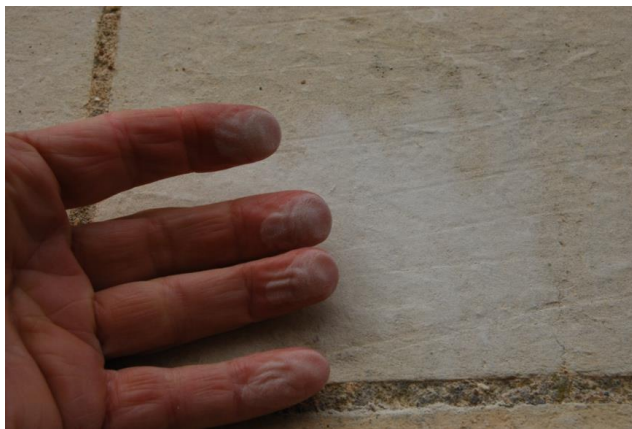
Fig. 1 Chalking of lime stone surface, photo from MDCS

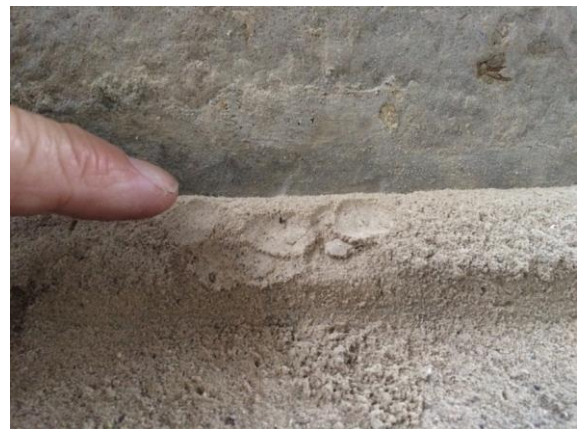
Fig. 2 Powdering of lime stone, photo from MDCS

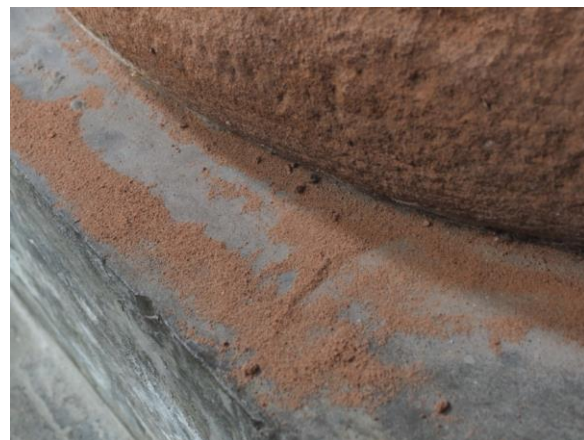
Fig. 3 Sanding of stone (sandstone), photo from MDCS

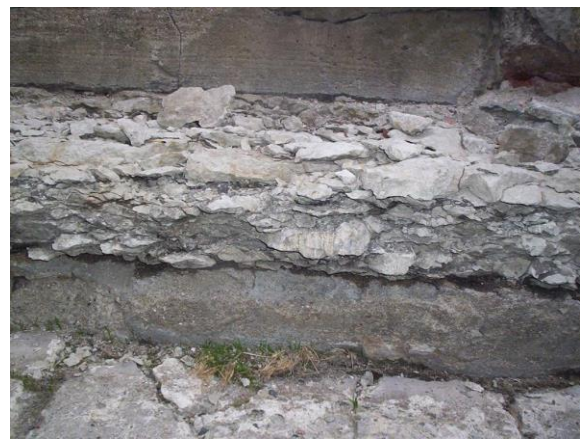
Fig.4 Crumbling of stone, photo from MDCS

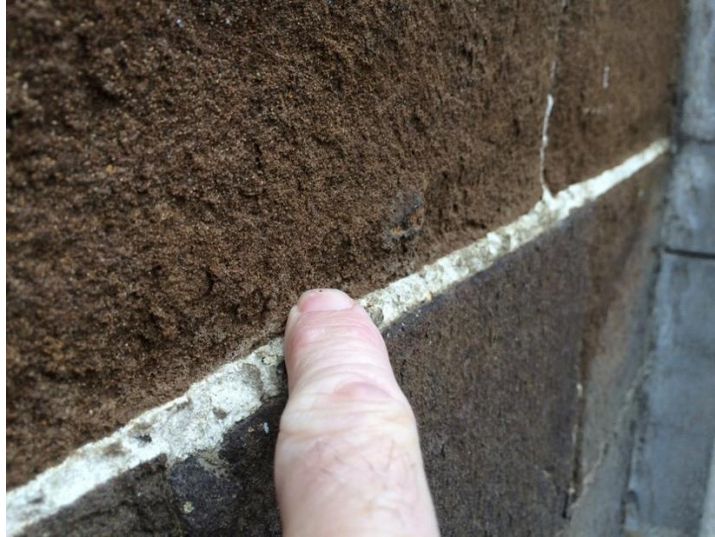
Fig. 5 In between stage of sanding and crumbling (ferruginous sandstone); photo from MDCS

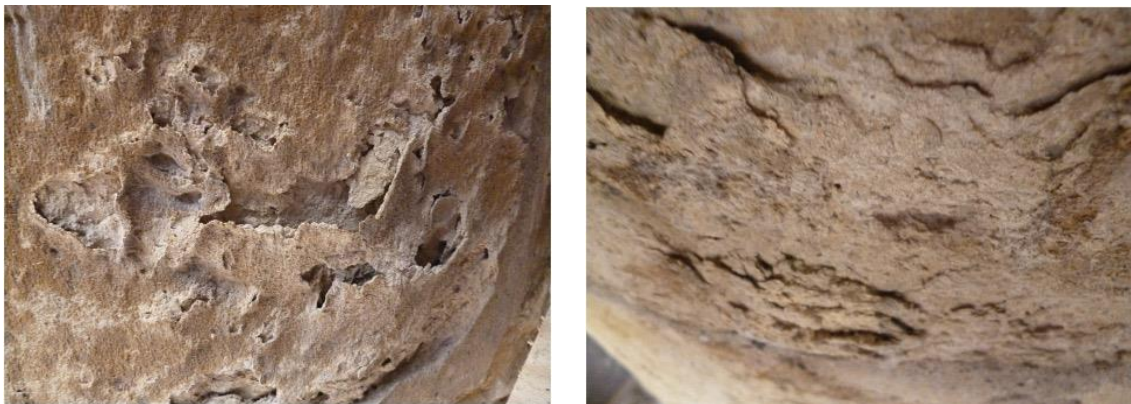
Fig. 6 Two types of degradation that are not to be treated with a consolidant; left, bulging / blistering, right, exfoliation

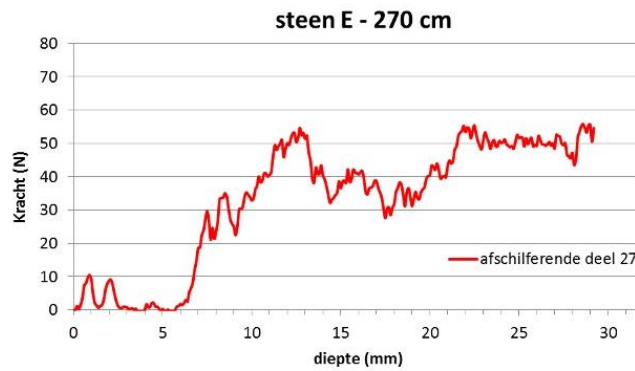
Fig. 7 DRMS profile of Lede sandy limestone, depth of degradation ca. 6 mm

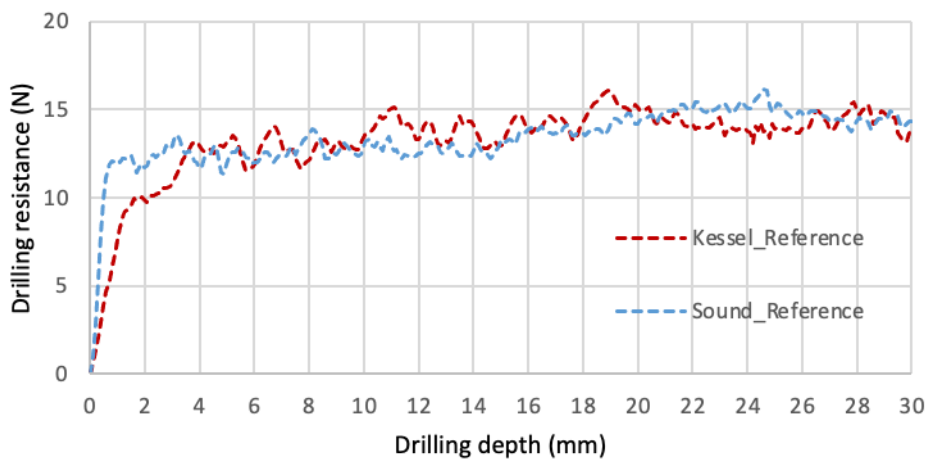
Fig. 9 Maastricht limestone. 'Sound_reference', refers to fresh stone, 'Kessel_reference' to weathered stone found in practice: a moderate degradation can be seen in the first 3 mm from the surface (Borsoi et al. 2017)

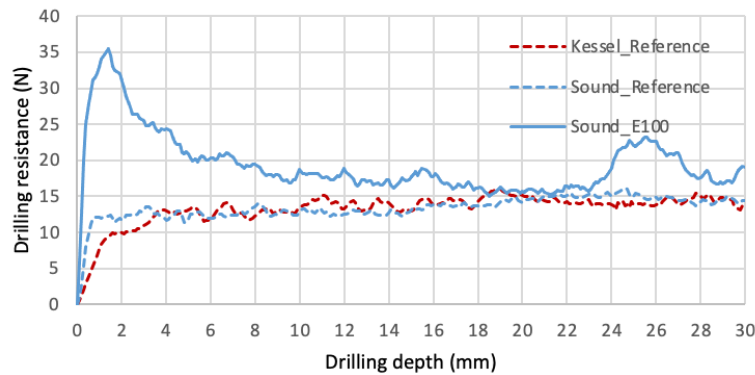
Fig. 10 Laboratory try out with repeated application (7x) of a nanolime consolidant on a sound stone (Borsoi et al. 2017). The surface layer has become too strong, but the question remains how to ‘translate’ this result to a degraded stone...

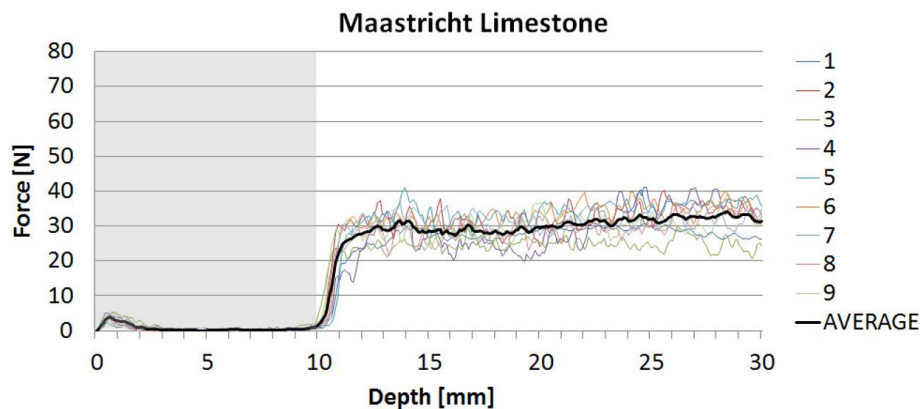
Fig. 11 Maastricht limestone, with ‘weathered’ surface layer of 10 mm, obtained by applying a re-aggregated layer consisting of particles of Maastricht, bound with a lime mortar. The coherence obtained in this way for the ‘degraded’ surface layer is comparable with examples found in practice cf. figs. 6 and 7, (Lubelli et al. 2015)

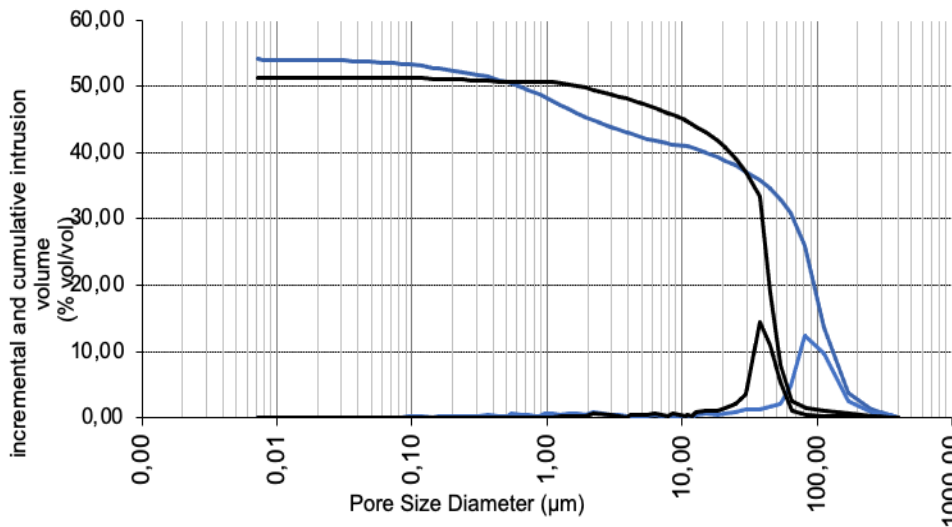
Fig. 12 MIP on Maastricht limestone. Fresh Maastricht (black curve), re-aggregated 1:6 (blue). The total porosity of the re-aggregated layer is slightly higher; most remarkable is the shift in average pore size towards coarser pores (Lubelli et al 2015)

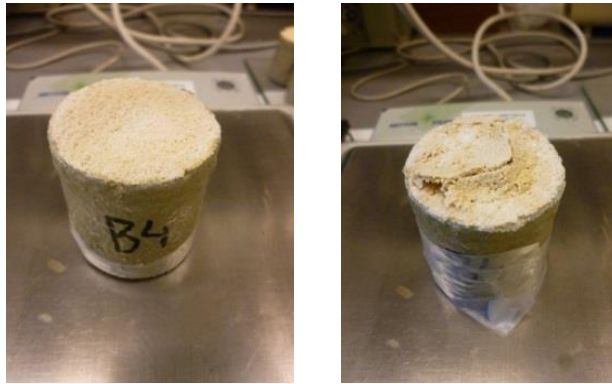
Fig. 14 Spalling of the reaggregated layer in a salt crystallisation test, after consolidation treatment (Bolhuis 2014)

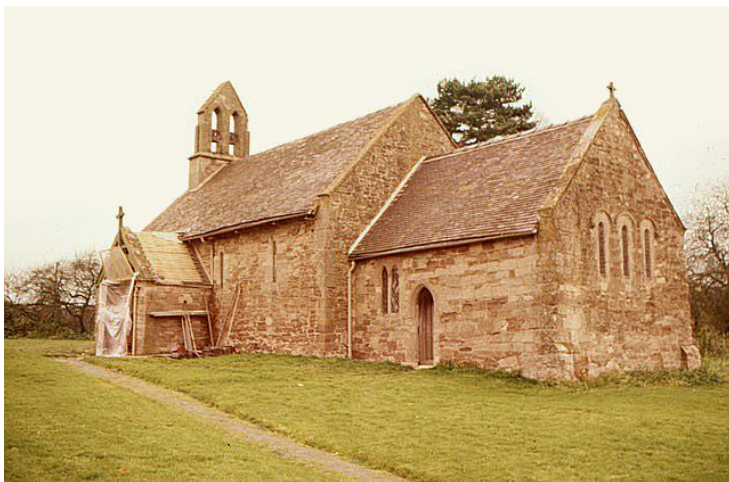
Figure 1. Aston Eyre Church showing the entrance porch containing the tympanum sheeted with protective polythene during consolidation in 1974 (photo: Deborah Carthy).

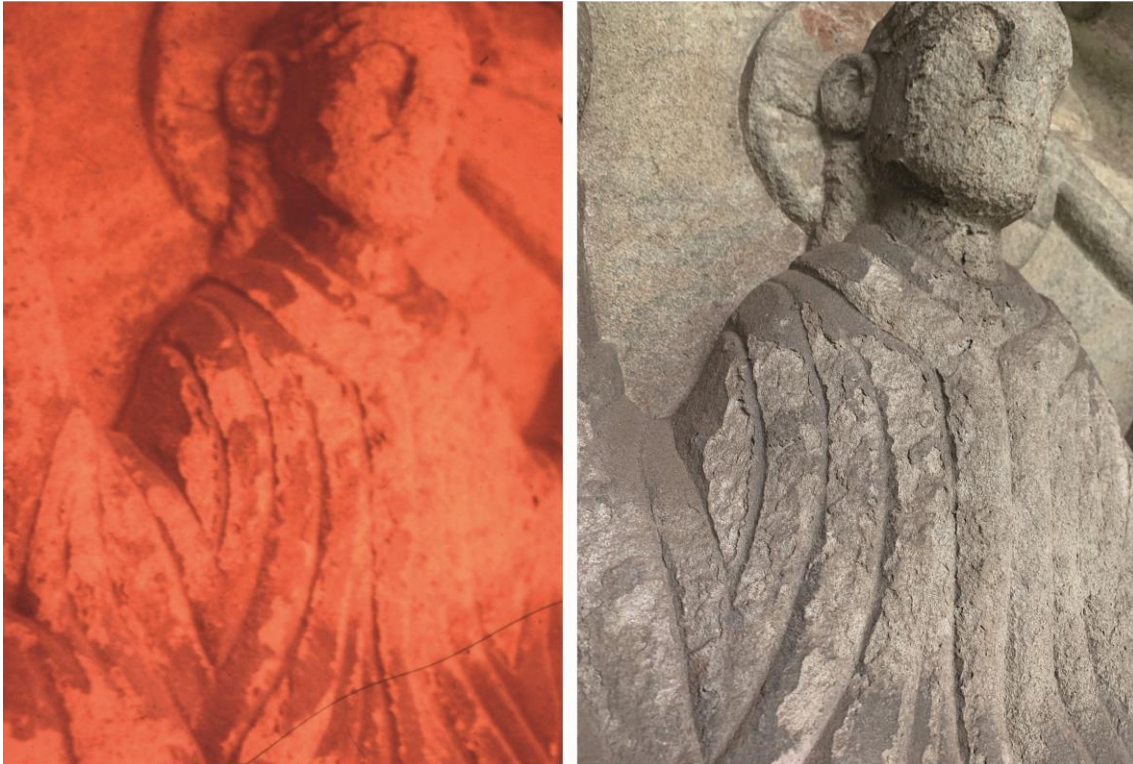
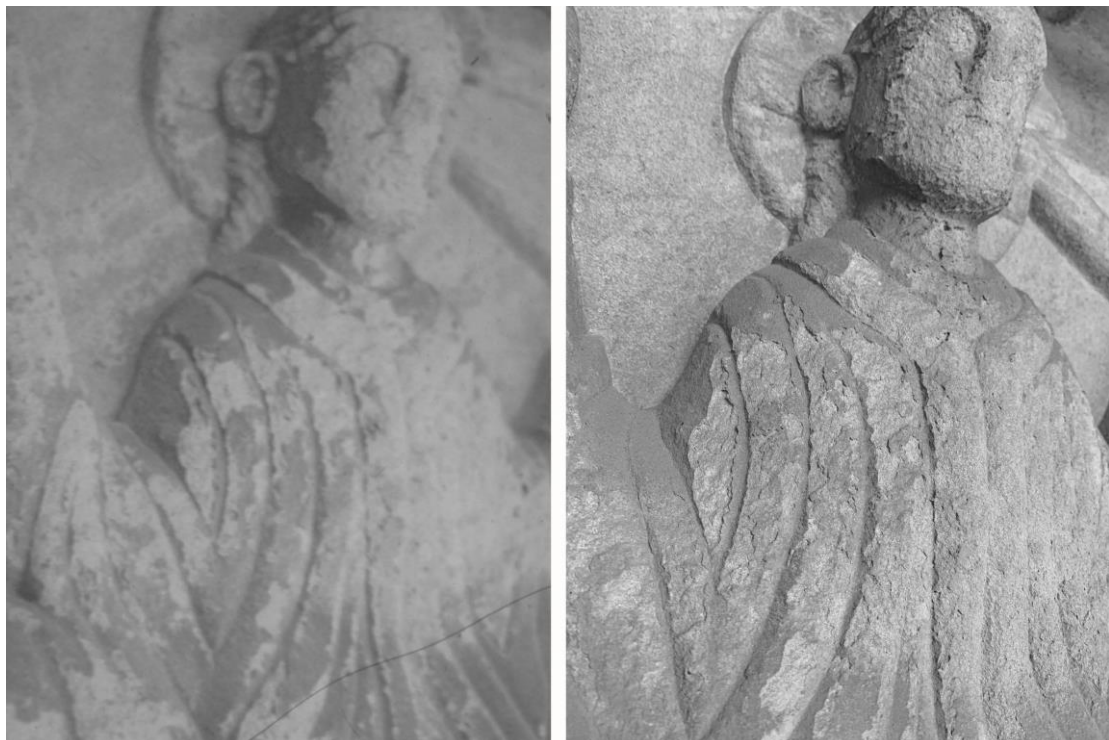
Figure 3. Aston Eyre church tympanum. Left; detail of figure of Christ in discoloured transparency from 1974. Right, photographed in 2020 (photo: Deborah Carthy).

Figure 4. As in Figure 3 but black and white version.

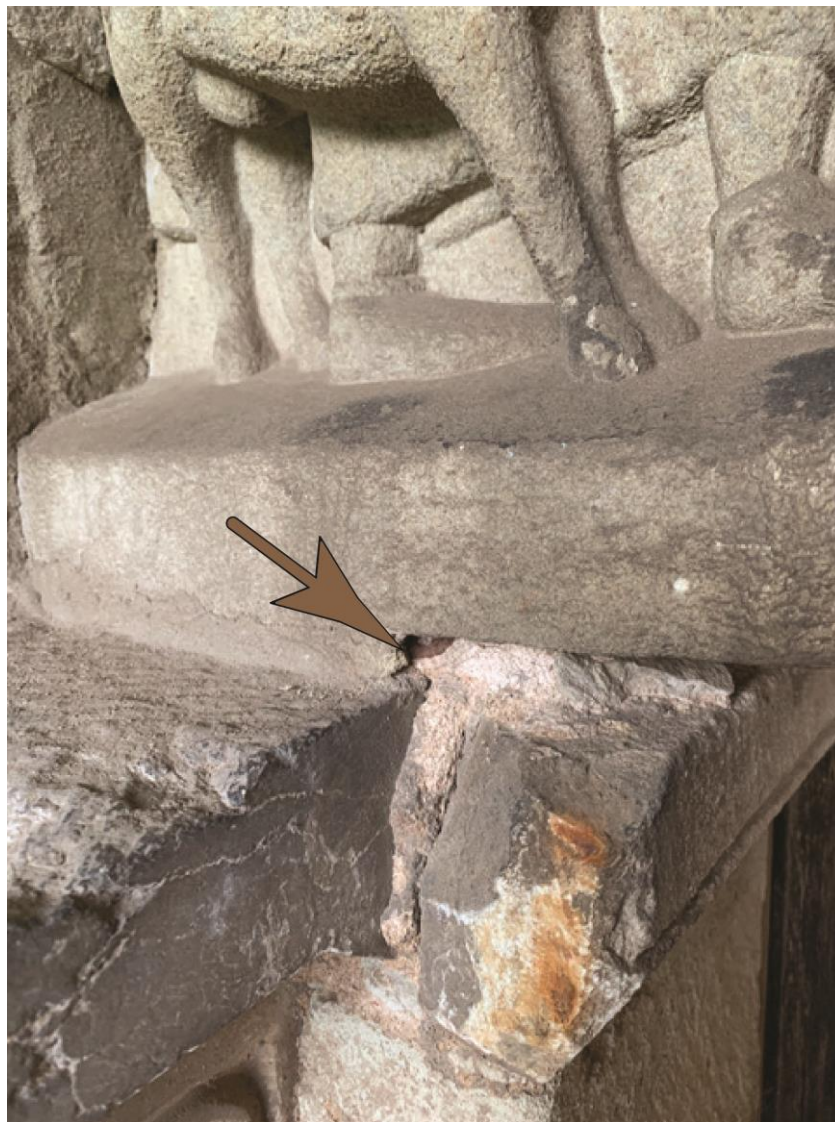
Figure 5. Aston Eyre Church tympanum. Detail of the sand/silane mortar mix at the base of the sculpture. The arrow shows the cavity where the mortar powdered away when gently probed in 2020 (photo: Deborah Carthy).

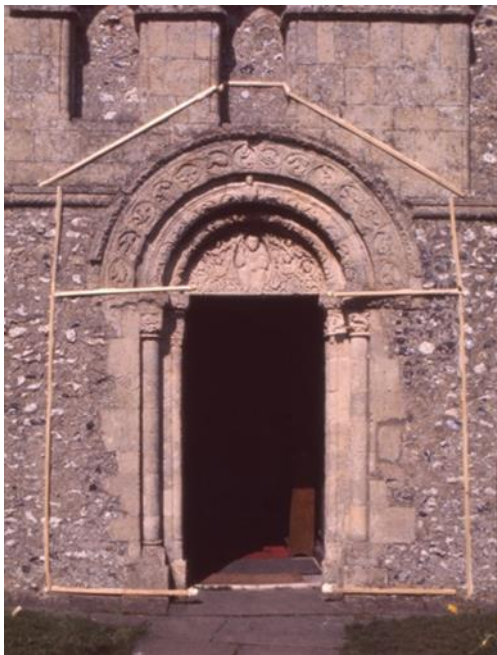
Figure 6. St Nicholas church, Barfrestone. Main doorway with carved decorative stonework framed for polythene sheeting prior to consolidation treatment in 1977 (photo: Deborah Carthy).

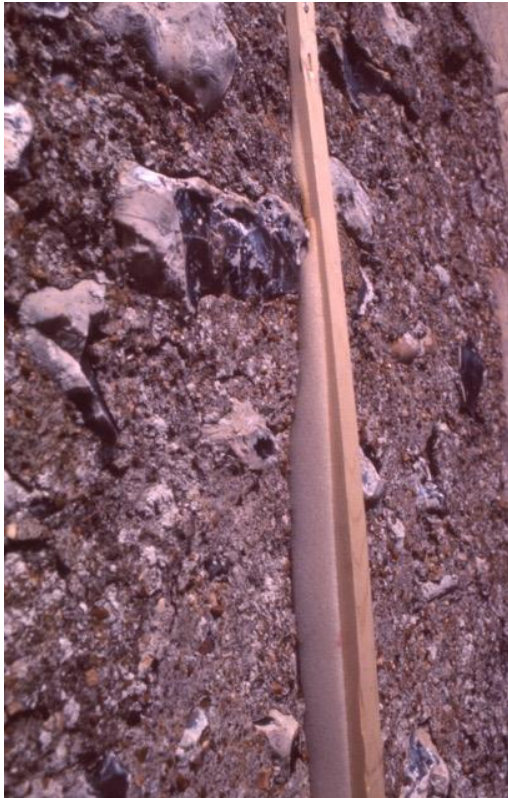
Figure 7. Detail of framework in Figure 6 showing the intimate junction to the stone surface (photo: Deborah Carthy).

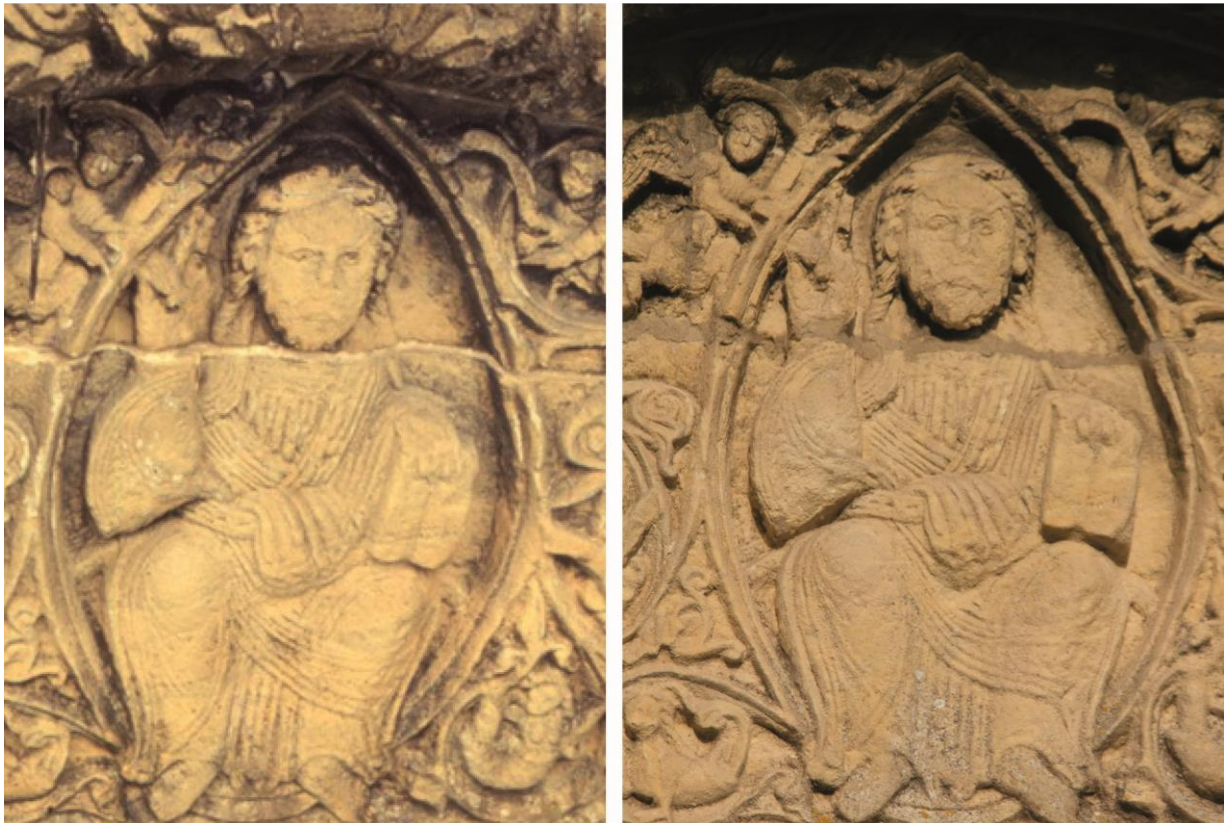
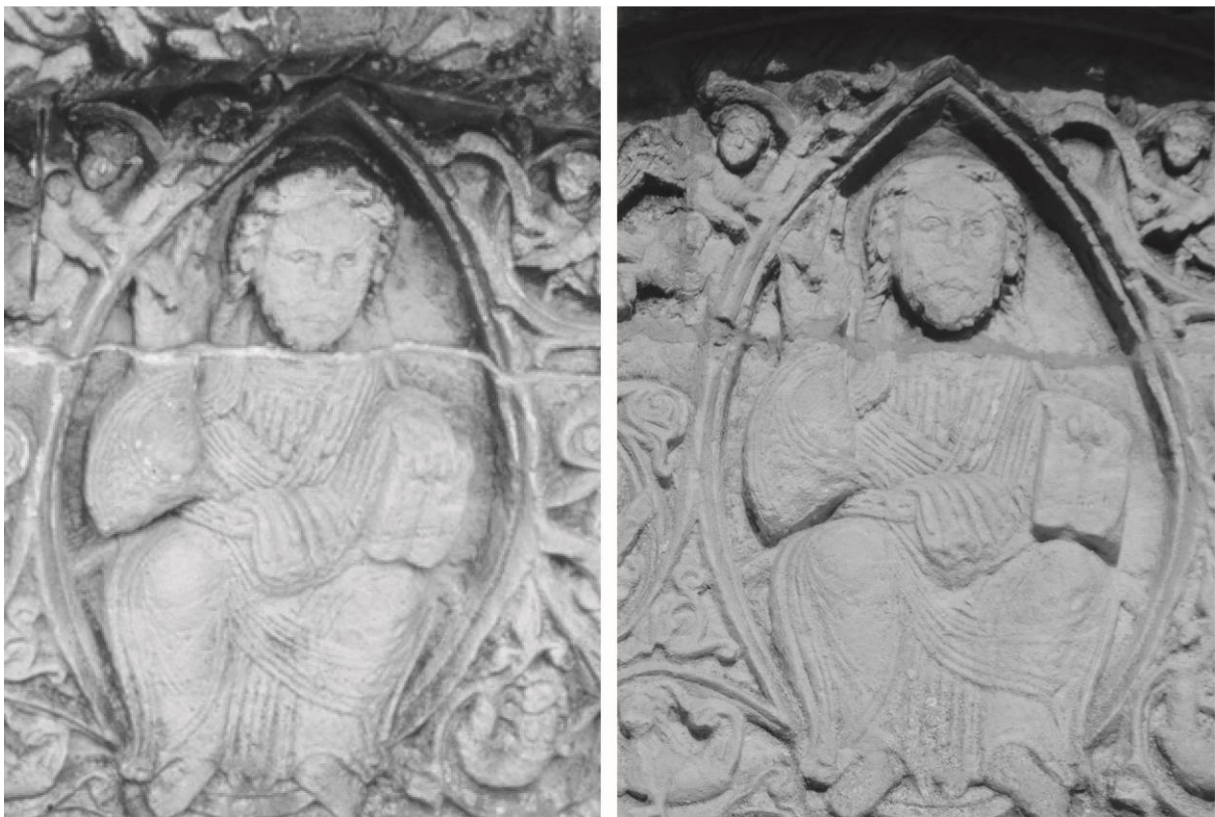
Figure 8. St Nicholas Church, Barfrestone. Detail of depiction of Christ in Glory at the doorway apex. Left; in 1977 after raking out the mortar but before consolidation, Right; in 2019 (photo: Left, Deborah Carthy; Right, Richard Cook).

Figure 9. Black and white version of Figure 8.

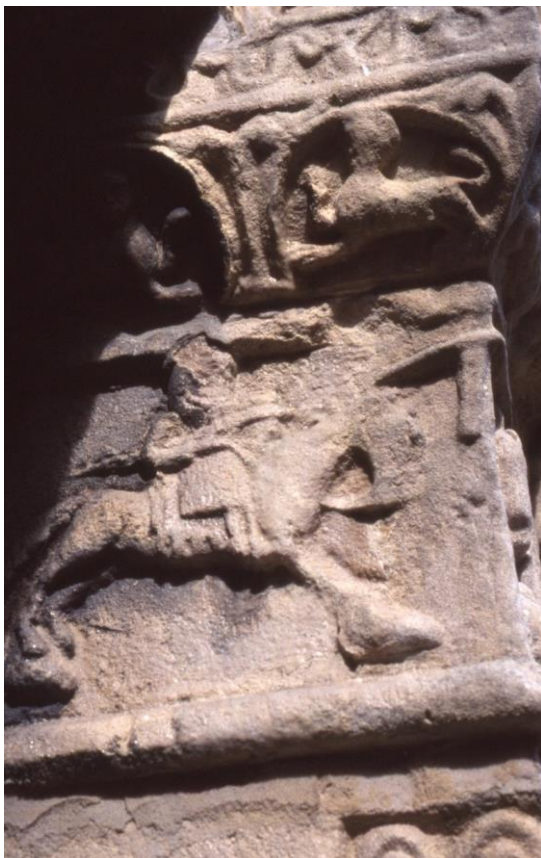
Figure 10. St Nicholas Church, Barfreestone. Detail of one of the many small carvings flanking Christ showing highlights in the photograph of 2004 where only very few small residues of silane were still visible on the surface (photo: Deborah Carthy).

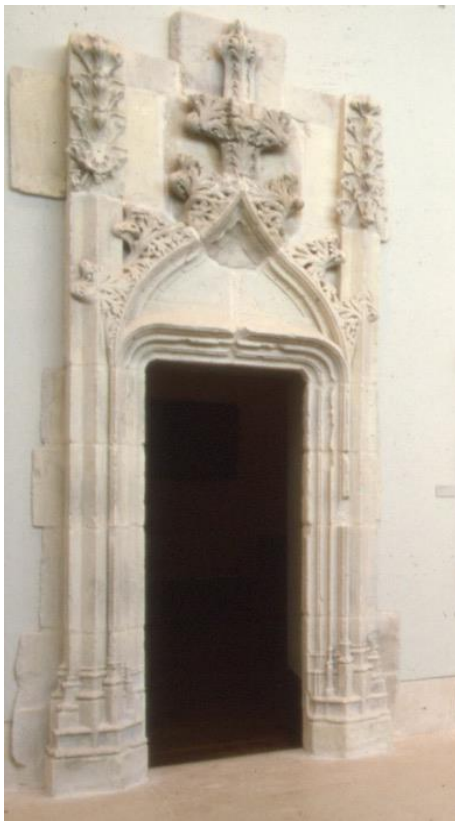
Figure 11. Burrell Collection French doorway (Reg. No. 44/89). Darkening of the stone in the upper central fragile area after consolidation (photo: Glasgow Museums).

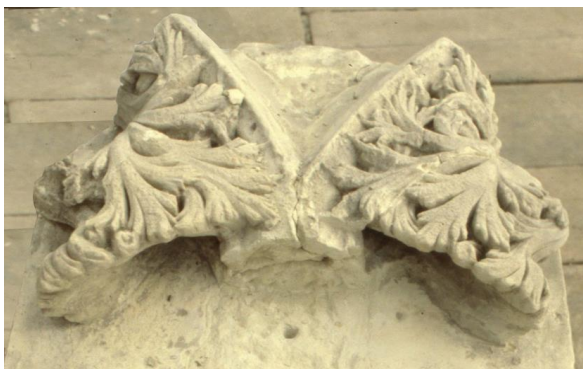
Figure 12. Burrell Collection French doorway (Reg. No. 44/89). Fragile stonework block photographed in 1981, prior to consolidation (photo: Deborah Carthy).

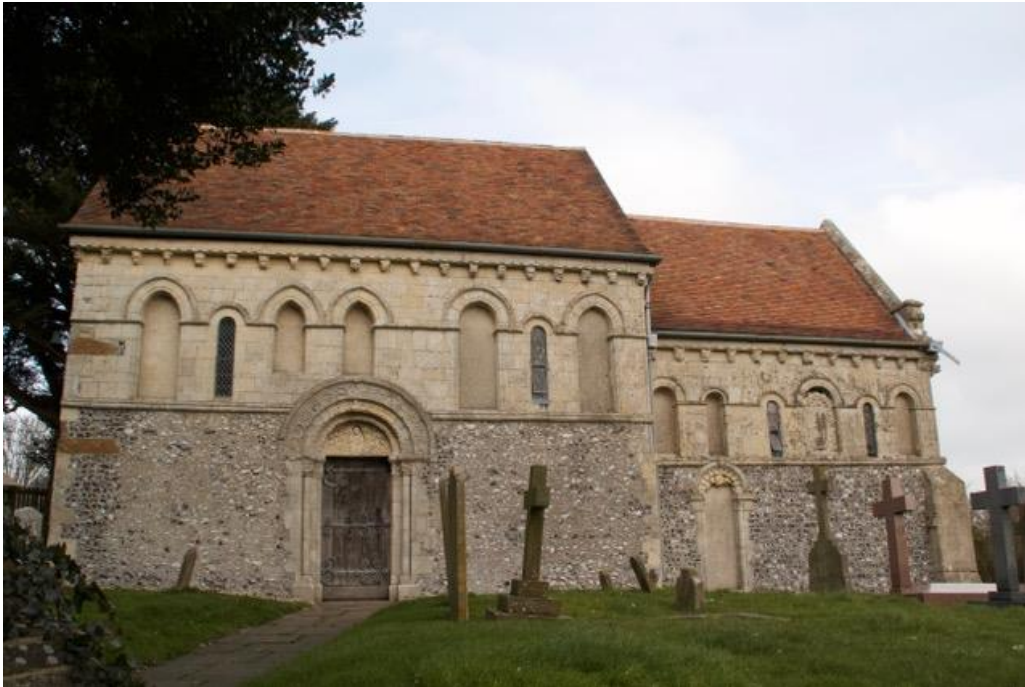
Figure 13. St Nicholas Church, Barfrestone. The south-facing aspect showing the consolidated doorway and the adjacent, unconsolidated minor doorway in 2019 (photo: Deborah Carthy).

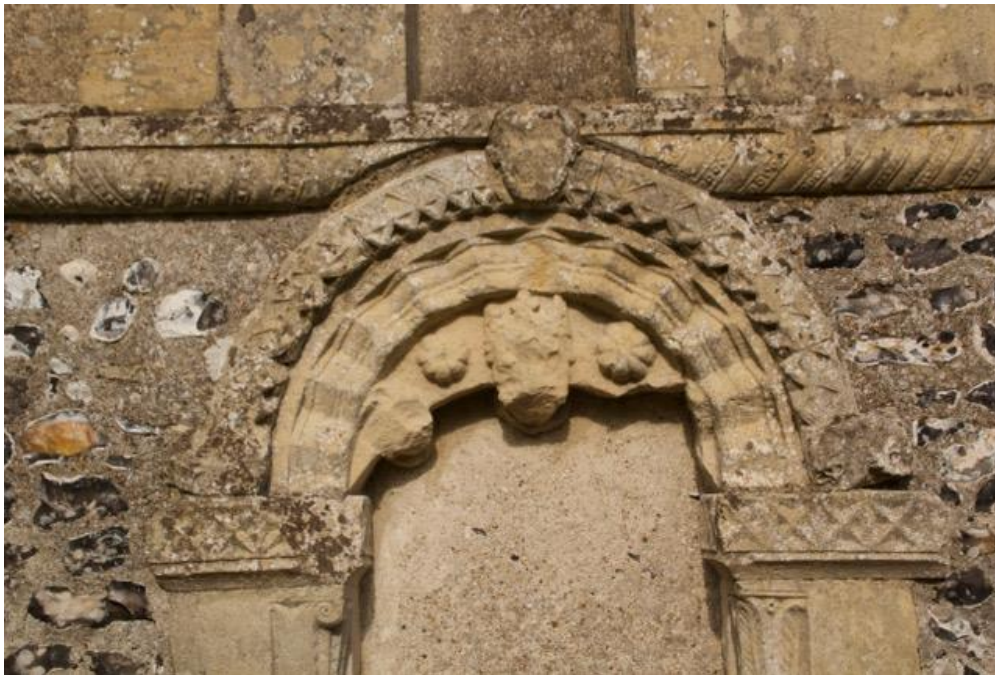
Figure 14. St Nicholas Church, Barfrestone. Extensive stone erosion and significant lichen growth on the stonework of the unconsolidated south-facing doorway in 2019 (photo: Deborah Carthy).

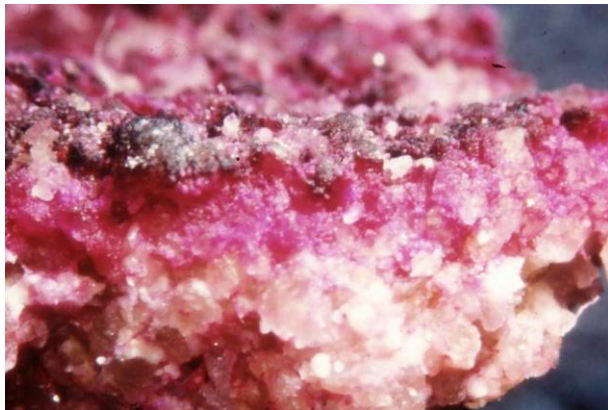
Fig. 1: Microbial biofilm penetrating into the pore system of a natural stone (e.g. Burgsandstein at Pommersfelden, Bavaria, Germany) as visualized by red PAS-staining.

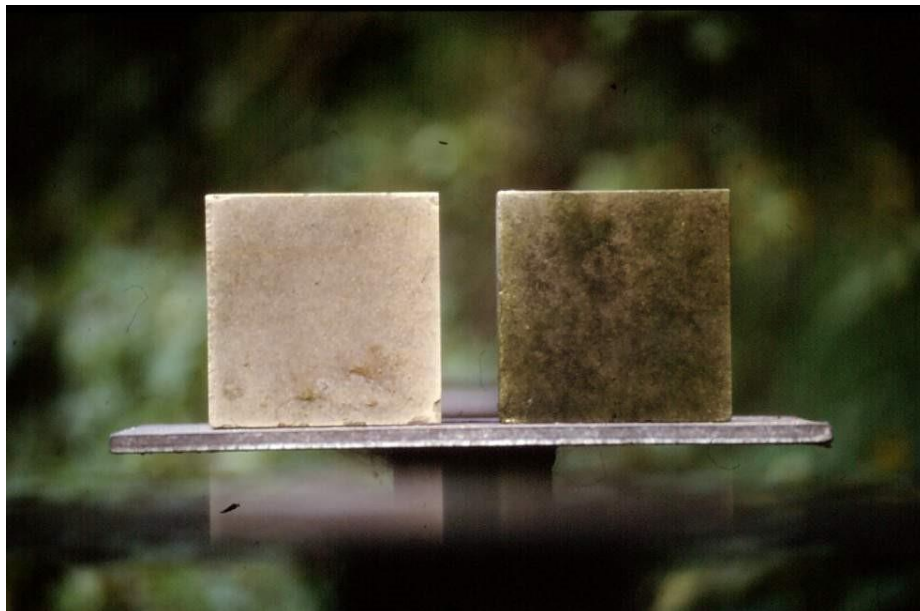
Figure 3: Biofilms force the accumulation of dust and aerosols.

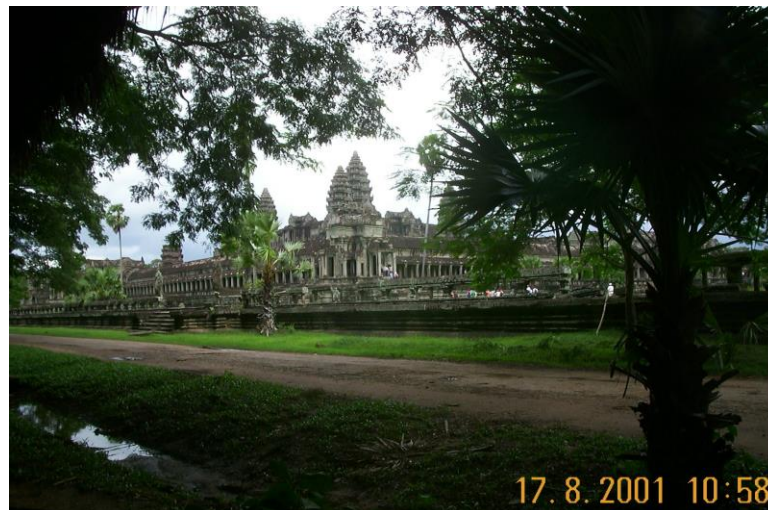
Figure 6: Natural stone affected by biocorrosive and biofouling microorganisms at the temple of Angkor Vat (Cambodia).

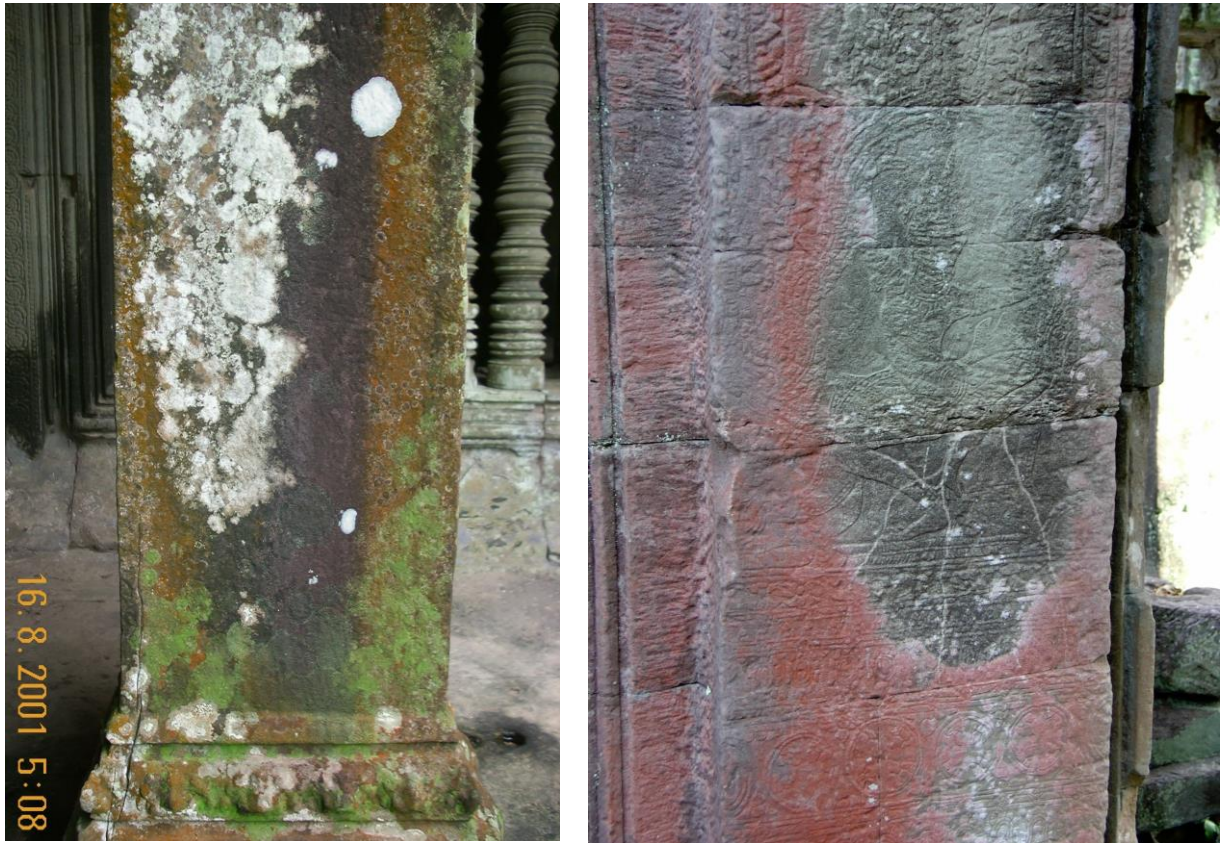
Figure 7 a + b: Natural multicolored biofilms of different photosynthetic microorganisms (e.g. lichens, algae and cyanobacteria) on Angkor monuments distinctly separated due to expositional factors and interspecific competition.

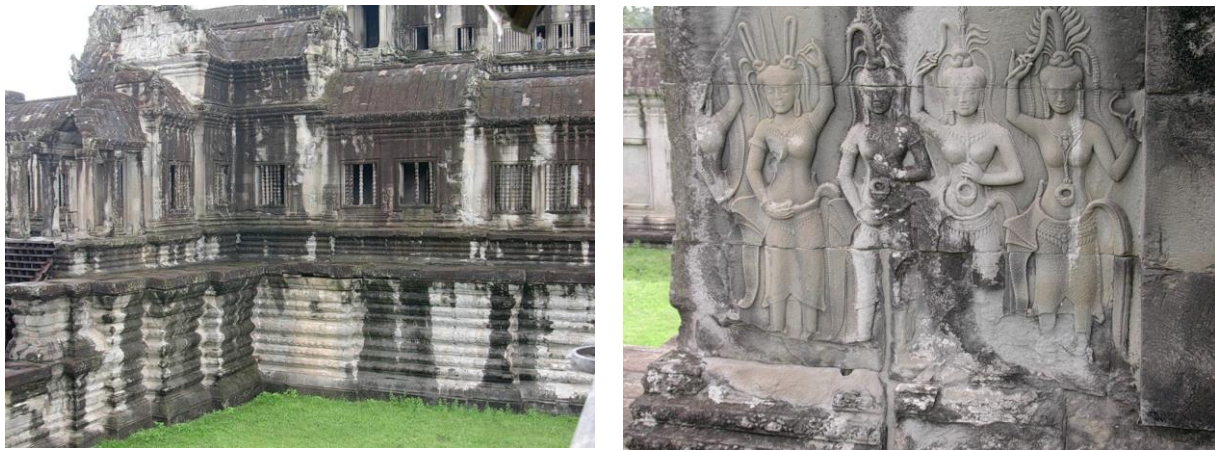
Figure 8 a + b: The removal of the natural biofilms led to an intensive regrowth of blackening cyanobacteria at Angkor Vat with additional thermal-hygic stresses to the sensible clay-containing sandstone resulting in a severe detachment of rock shales from Apsara carvings

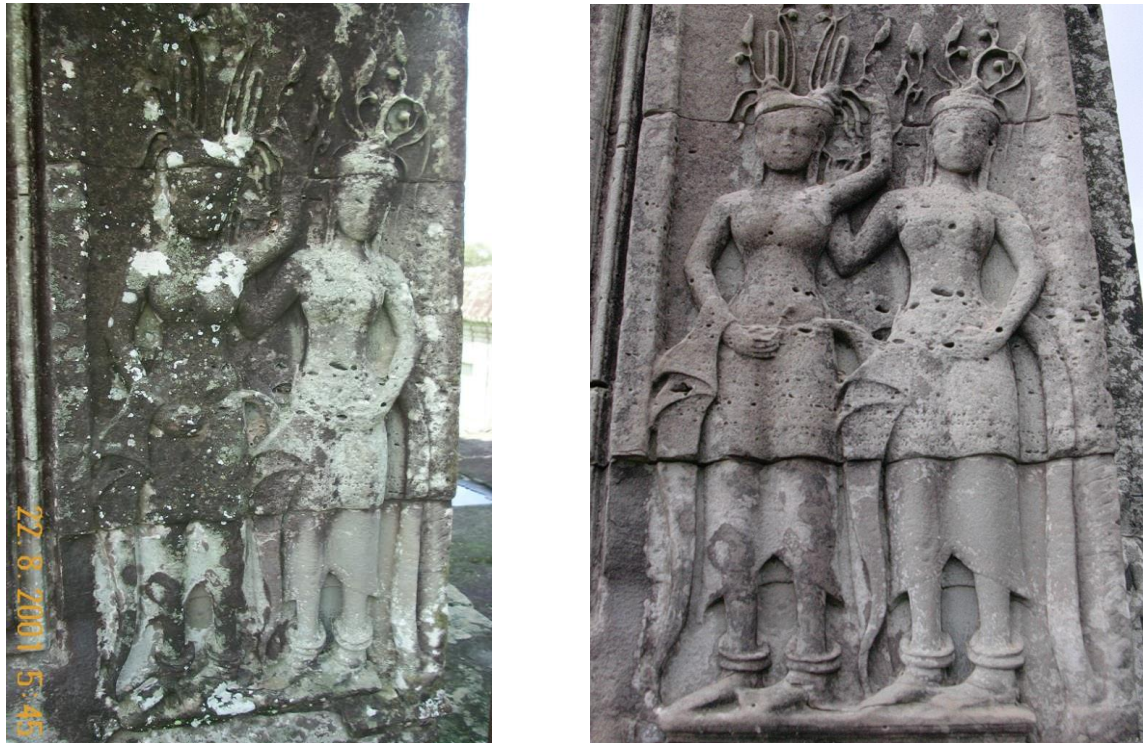
Figure 9 a + b: Successful application and long-term efficient protection of a specific designed biocidal formulation at the northern bibliotheca at the Angkor Vat within the 3rd enclosure four years after treatment.

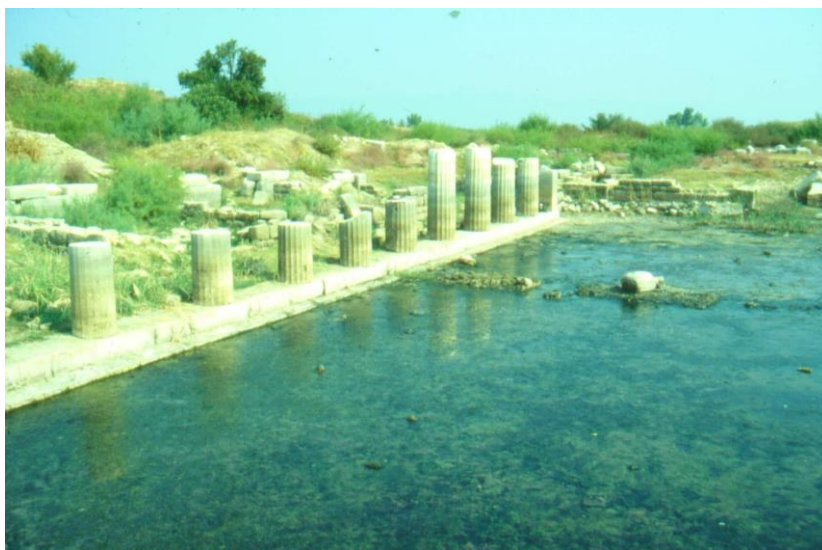
Figure 10: Spring flooding of the harbor monument within the archaeological site of Milet (Turkey)
