International Symposium
**Stone Consolidation
in Cultural Heritage**

Extended Abstracts

LNEC, Lisbon, 23-25 March, 2022

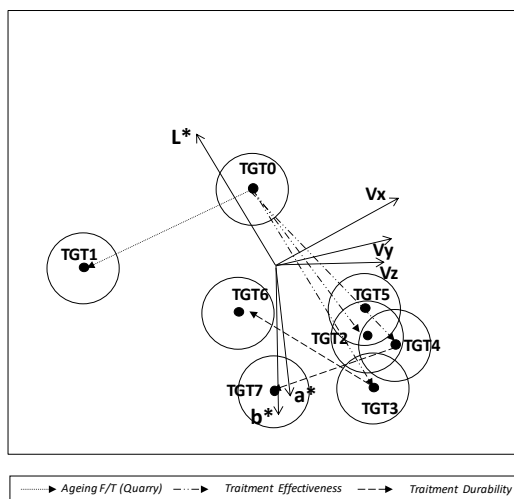
Fig. 1: Canonical Biplot for the stone variety TG (axes 1 and 2).

In most of the cases studied, the ultrasonic propagation speed decreased in both the untreated samples and those treated with the conservation products after carrying out the aging process. Moreover, it was found that the ultrasonic propagation speeds were lower in untreated samples than in treated ones. Ultrasonic propagation tests indicate that the treated samples are more durable than the untreated fresh samples. Also, the chromatic coordinates of the treated samples, in general, were darker ($\downarrow L^*$), redder ($\uparrow a^*$) and more yellow ($\uparrow b^*$) with respect to the untreated samples. As an example, the figure corresponding to the TG sample of silicified sandstone is given (Fig. 1).

indicating that the greater the grain size of the minerals (TG and Z1), the greater the decrease in the ultrasound propagation speed, Fig.1. Additionally, no variations were observed in samples TB, TO, and TR, Fig. 2, as these are the most porous stones (Iñigo et al., 2020) with a large number of pores greater than 5 μm . The process of freezing/thawing did not cause a disruptive effect, because drainage occurred, as well as the expulsion of fluids within the advance line of the freezing front (Winkler, 1973).

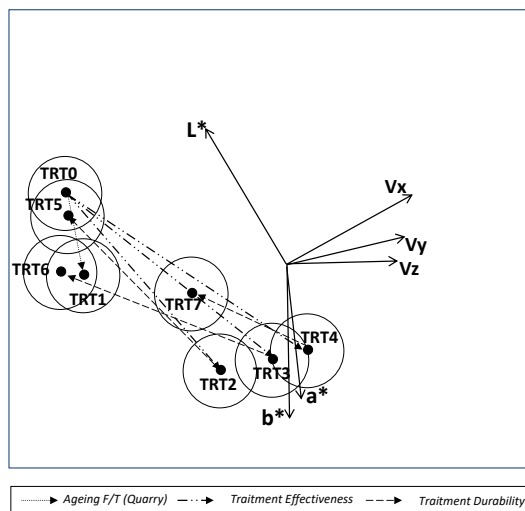
Fig. 2: Canonical Biplot for the stone variety TR (axes 1 and 2)

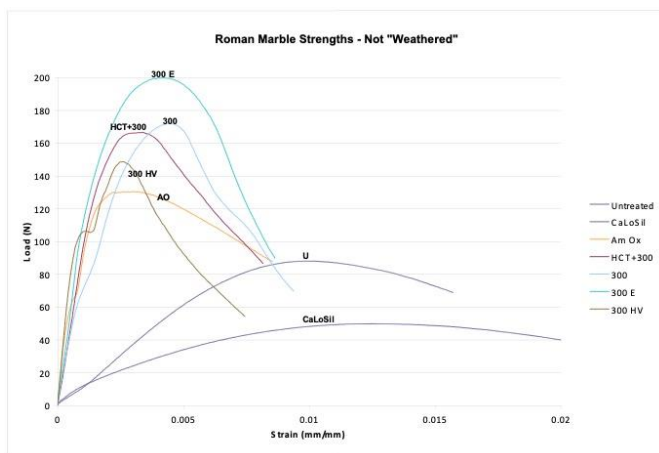
Figure 1. All consolidants with the exception of *CaLoSil* provided significant strength increases to the degraded marble.

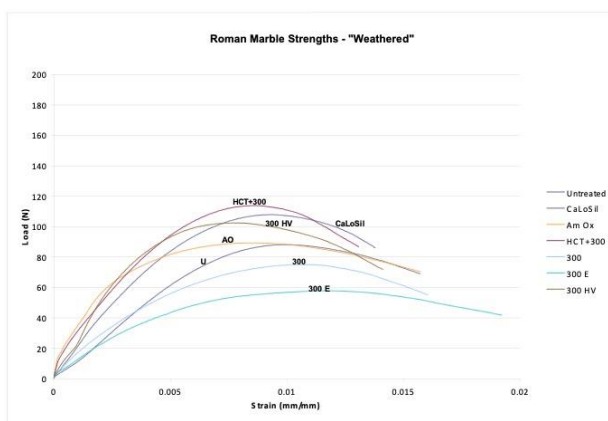
Figure 2. All consolidants with the exception of *CaLoSil* have lost much of the strength provided before weathering. The *CaLoSil* treated samples have increased in strength above the untreated and weathered samples.

Figure 2 shows that after exposure in the environmental chamber, all of the consolidants that had previously provided strength increases have now lost almost all of their strengthening effect with some – *FUNCOSIL 300* and *300E* – lower than untreated and weathered samples. On the other hand, the *CaLoSil E-15* treated samples have *increased* in strength, possibly due to increased carbonation of the calcium hydroxide in the formulation.

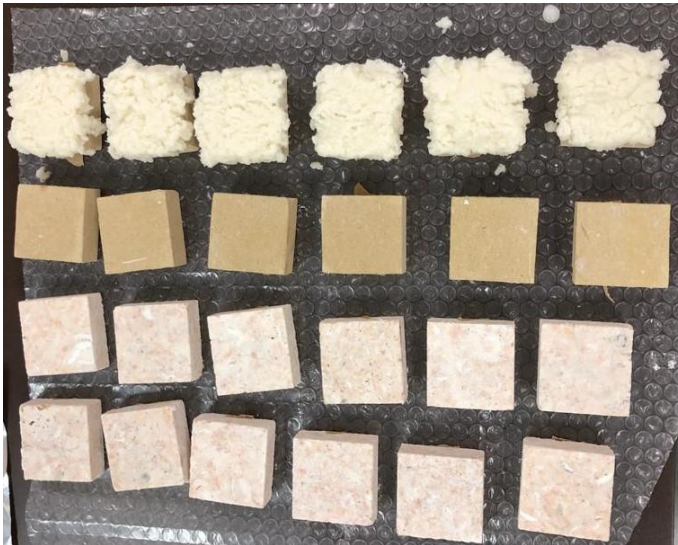
Fig. 1. Treated samples. The image shows the stone samples during the application of DAP. In particular, the upper row shows the Finale stone samples with the poultice.

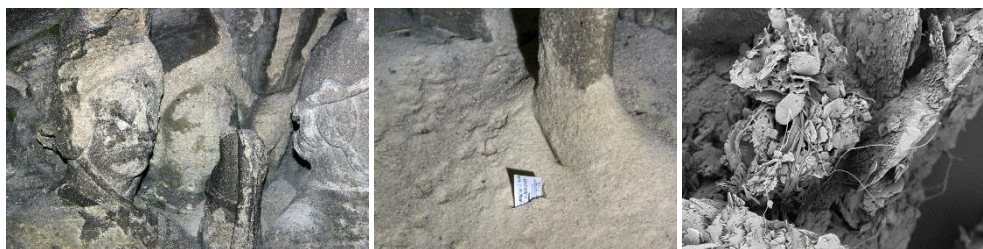
Fig.1: Details from previous state: Crusts and loss of material, decomposition and SEM image of a fragment with biogenic cover mixed with salt crystals.

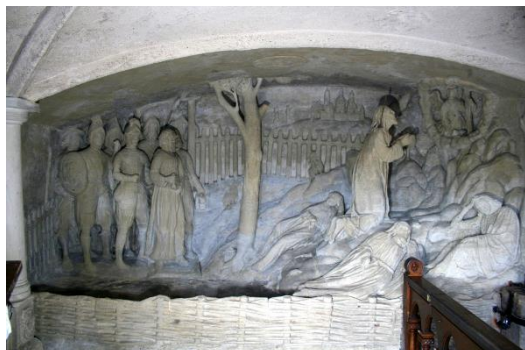
Fig. 2: Conserved Mount of Olives representiaon.

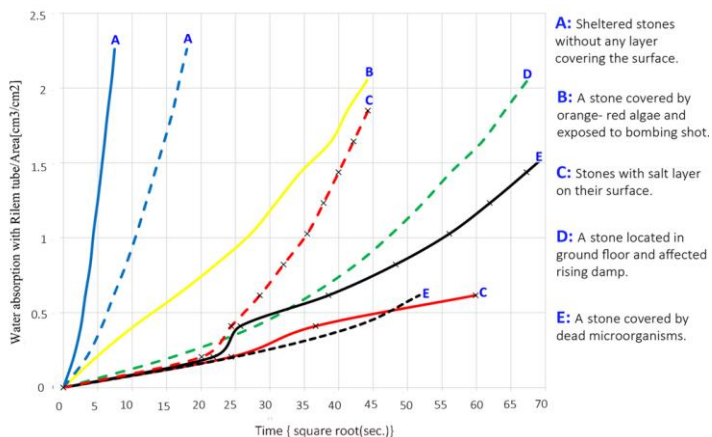
Figure 1 The absorption diagram of the tested stones by Rilem Tube

The results presented different kinds of absorption behaviour of stone blocks. The investigation showed that it depends on both the condition of the stone, i.e., stone deterioration type, its spread, how the intensity of it on the surface, and the orientation of the stone (Figure 1).

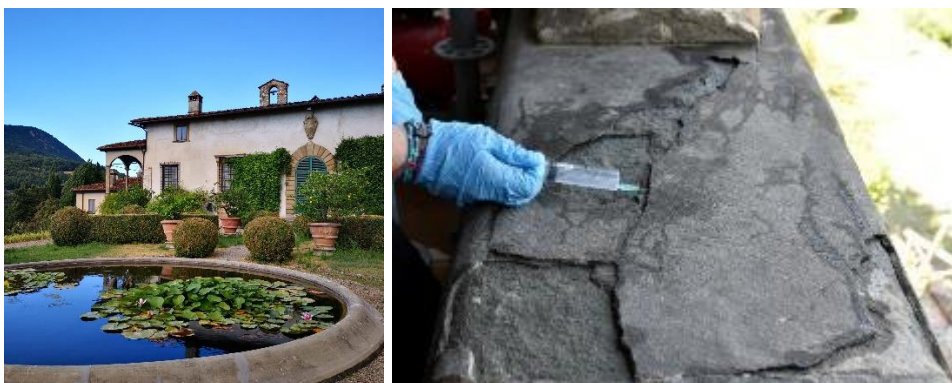
Villa Rucellai, south facade of the house, on the left is the loggia.

Pre-consolidation with ethyl silicate (Wacker_OH) applied by syringe.

The intervention was developed based on testing, visual and analytical investigation of the stone using technical photography, FT-IR spectrometry and thin section observations. A structural evaluation of the bearing capacity of the deteriorated columns, carried out by a structural engineer, confirmed that replacement was not necessary and that the conservation could 'simply' focus on the surface of the column.

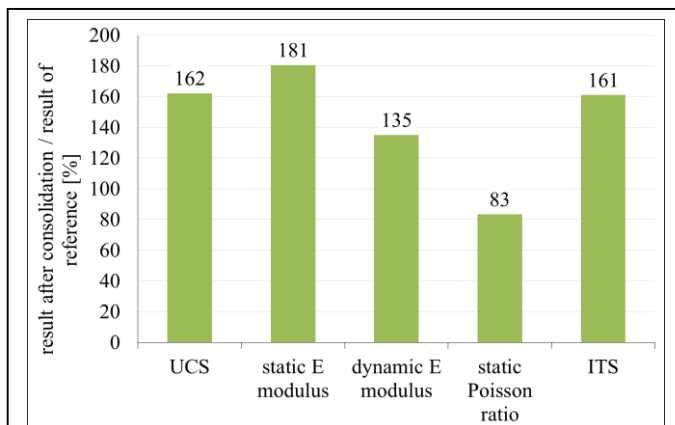
Figure 1 Change in UCS, static modulus of elasticity, dynamic modulus of elasticity, static Poisson ratio and ITS after consolidation

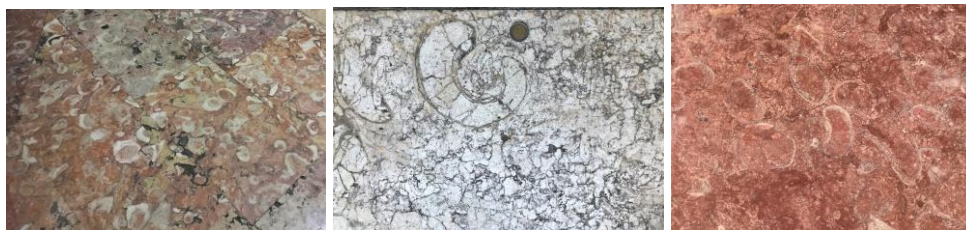
Figure 01: Photographs of different types of *Lioz* limestones, presenting somatofossil contents of rudist bivalve shells in different cuts (Photo: Antônio Gilberto Costa).

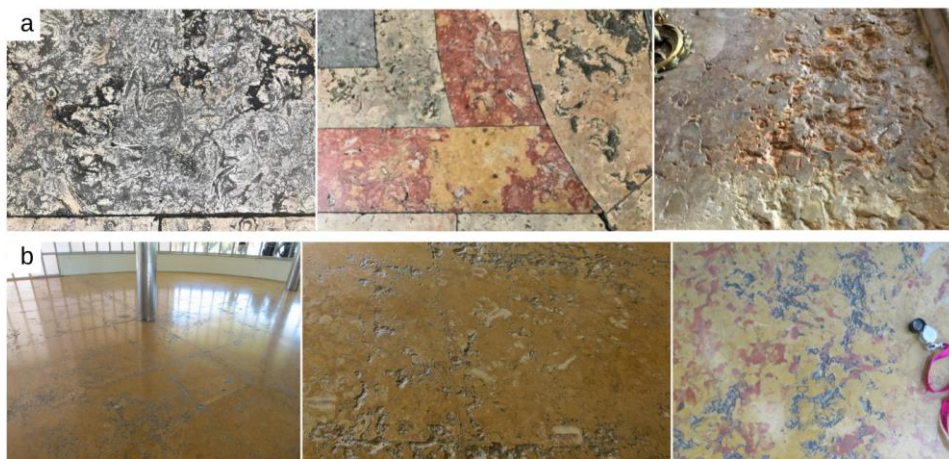
Figure 04: Photographs of internal floor and wall covering (right) applications of the *Lioz* inside the *Basilica da Estrela*, in Lisbon, Portugal (a), and of the internal floor of the Museum of Modern Art, in Belo Horizonte, Brazil (b). The rocks present chromatic variations, presence of fossils, differential erosion and loss of matrix (Photo: Antônio Gilberto Costa).

the Museum of Modern Art, in Belo Horizonte (Fig. 04b), the rock is also partly reddish or red, associated with yellow, and presents differential erosion and loss of matrix.

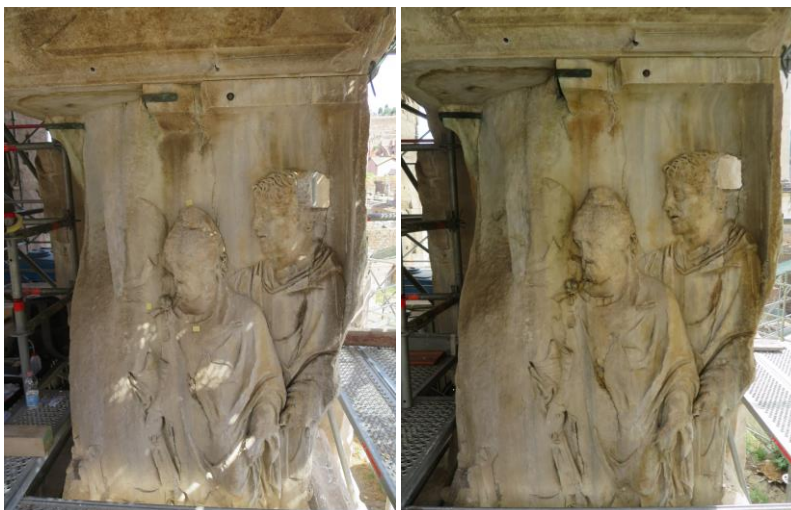
Fig. 1: West plane of the plinth before (left) and after (right) the biomineralisation treatment.

figurative reliefs carved in marble, still legible – significant lacunae notwithstanding –, some with grooves from the original carving tools (Fig.1).

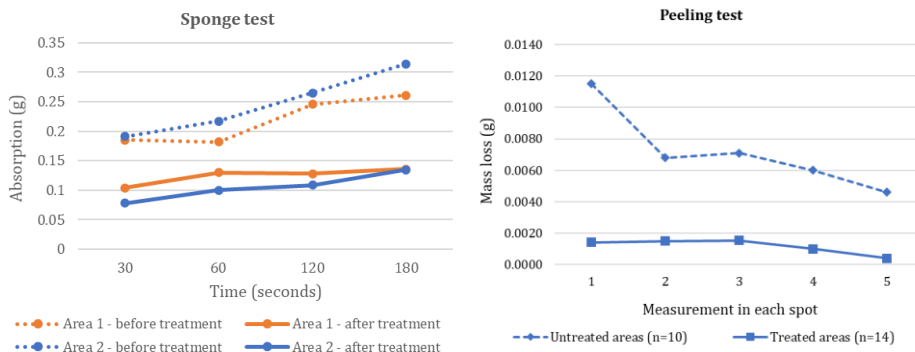
Fig. 2: Sponge test (left) and peeling test (right) results before and after treatment.

Results of the peeling tests are also shown in Fig. 2. Since before and after tests must be performed in distinct zones, the graph presents average values obtained in each condition (untreated/treated). Averages were computed point by point following the sequence of measurements made in a same test spot; in total, 10 and 14 areas were tested, respectively, before and after treatment, to ensure result robustness. The peeling tests showed a significant cohesion increase after treatment, with mass losses 5-10 times lower than those before treatment.

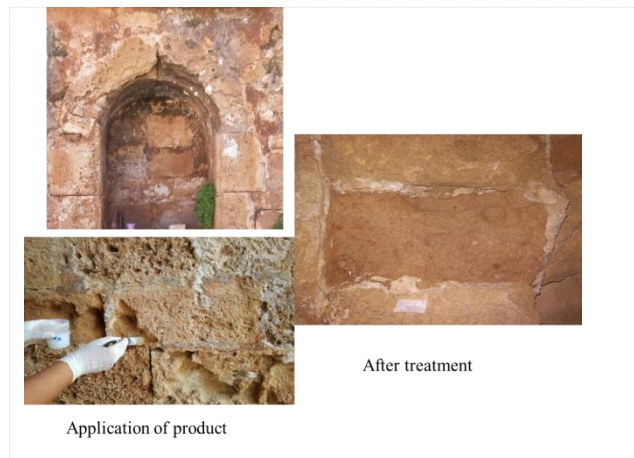
Fig.1_ Consolidation treatment with TEOS-CaOx.

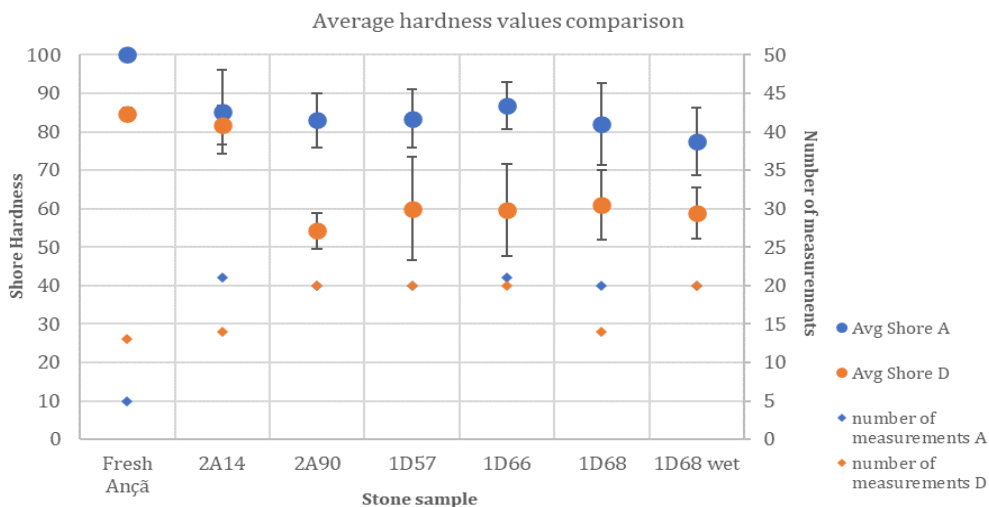
Figure 1: Comparison between average hardness values obtained with the two Shore durometers: Shore D seems to be less sensitive to small changes in surface hardness and more sensitive to rugged surface morphologies.

The diagram in Figure 1 displays the average results, and respective standard deviations (error bars), obtained for the samples measured with both durometers.

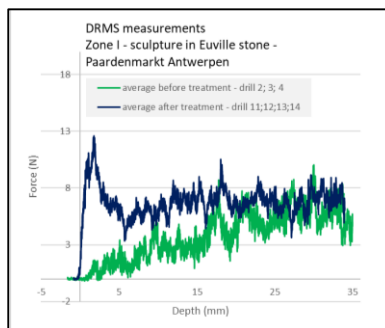
Figure 4: Mean values of DRMS measurements, before treatment (green curve) and after treatment (blue curve).

(hole on the left). Figure 4 represents the mean values of the DRMS profiles obtained in the same area as in Figure 3 and indicates a granular disintegration before treatment (green curve) and an (over)consolidating effect after treatment (blue curve).

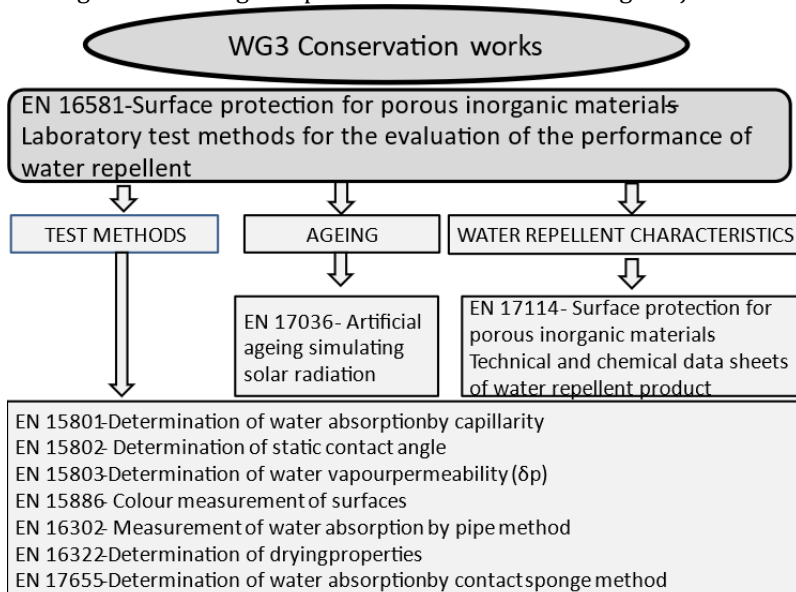
Fig. 1 Complete set of standards to evaluate the performance of water repellent.

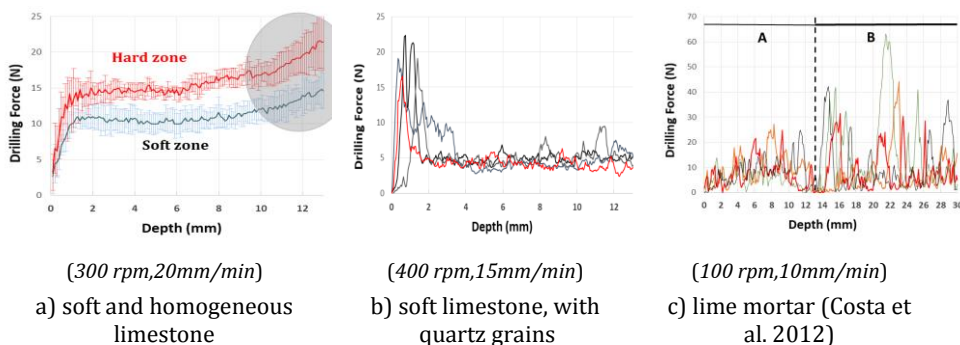
Figure 1. Profiles on surfaces made on soft stone and similar materials using DRMS

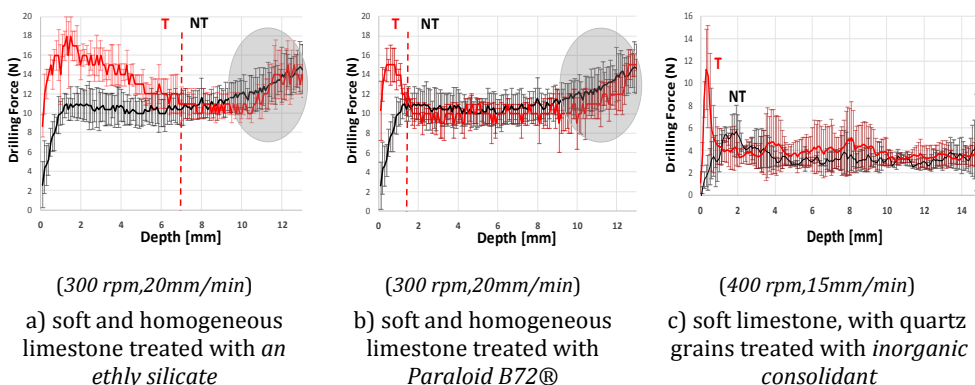
Figure 2. Examples of profiles of stone consolidation treatments applied on pilot zones

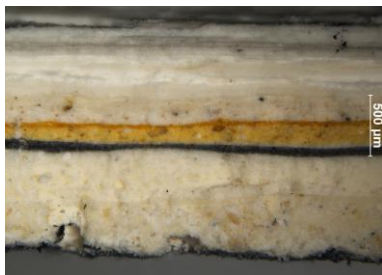
Figure 1. Unpolished cross section from the wall painting covering layer, Magleby Church Denmark. From the bottom, the contact surface with the original wall painting and towards the top of the picture still newer added layers.
