International Symposium Stone Consolidation in Cultural Heritage

Full Papers

Editors: : José Delgado Rodrigues and Marlucci Menezes

LNEC, Lisbon, 23-25 March, 2022

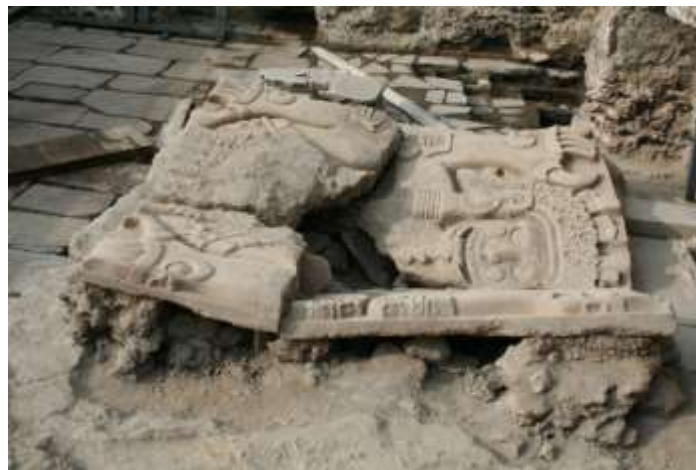
Figure 2. Tlaltecuhltli monolith *in-situ* (PTM-INAH)

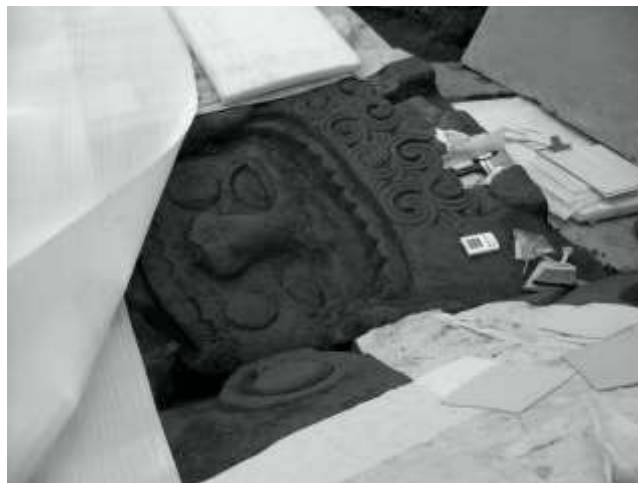
The monolith was protected with different insulating materials to prevent rapid drying; there were also installed some tarps and wooden sheets to control the direct sunlight, as well as absorptive materials which were previously damped with water and carefully added over the stone fragments.

Figure 3. The controlled drying procedure with insulating materials (PTM-INAH)

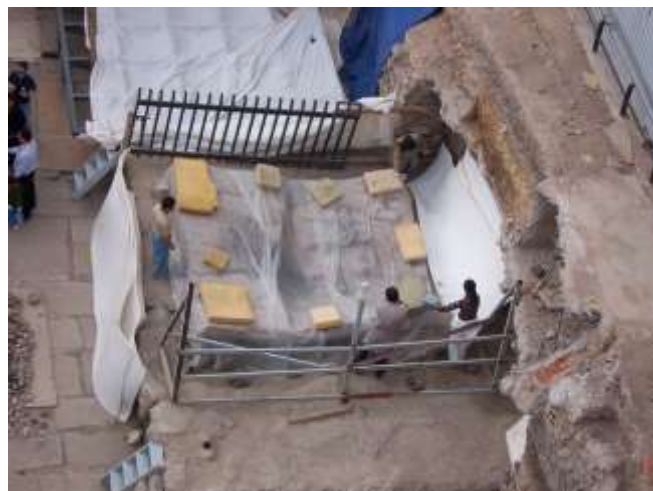
Figure 4. Protection of the sculpture and its surroundings (PTM-INAH)

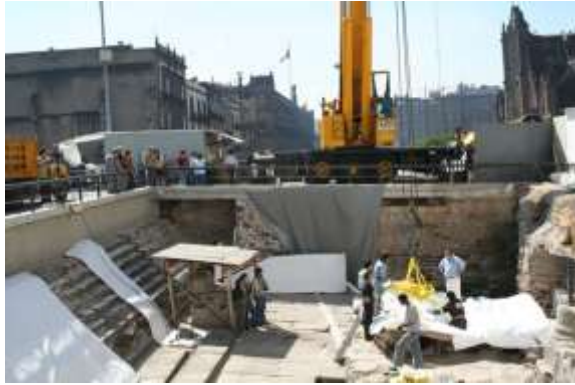
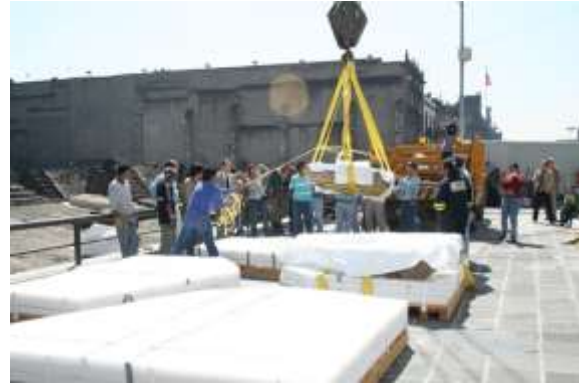
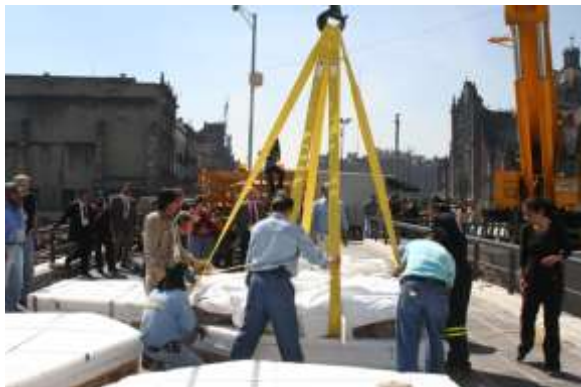
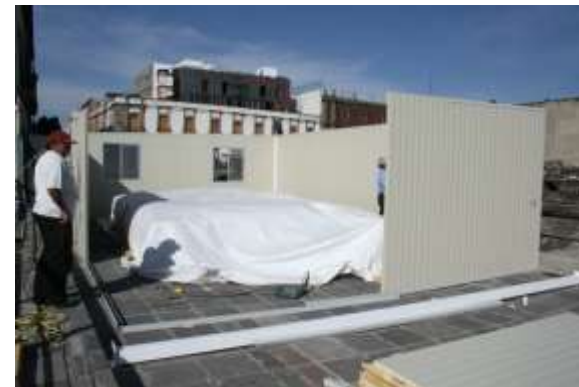
Figures 5, 6, 7 and 8. The lifting procedure for the four fragments from the site to the street level (PTM-INAH)

In November 2007 the stone was sufficiently dry to be lifted from its original place to the site street level in order to start working in the diagnosis and preliminary analyses of the monolith. The four fragments were removed from the ground by the contractor Luz Especializado, a specialized company that has more than 30 years of experience working in movements and transports of heavy and delicate objects. For this procedure, Luz Especializado used a long-armed massive crane, and as each one of the fragments was lifted, the crane placed them over temporary wooden support bases padded with foam, that were ready and waiting in the street. Once the fragments were stable over their temporary supports, a gatehouse and barrier for security were constructed around them, and since that day, this gatehouse was transformed in the new conservation laboratory for the Tlaltecuhтли monolith.

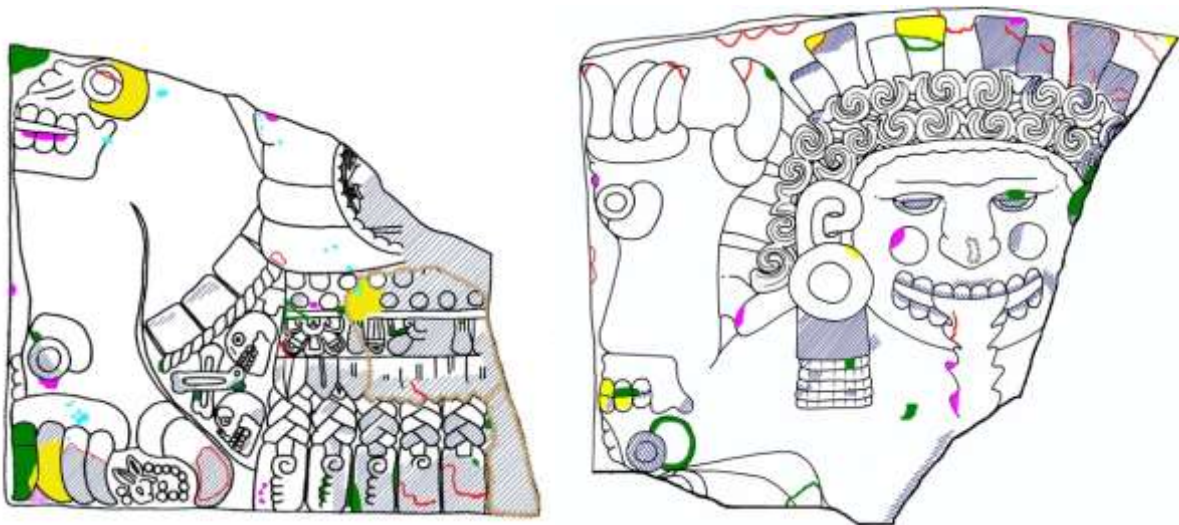
As a result of this detailed diagnosis, we were able to detect some local alterations over the fragments. These alterations were caused either by the rituals that were taken place in the Aztec period, and also by the monolith's interaction with the context after its burial (López Luján, 2010:111). The main alterations that could be detected were abrasion, cracklings, mineral and salt deposits, flakings, and also some missing parts. All the results derived from these observations were marked over graphics for each one of the fragments' diagnosis.

Figures 20 and 11. Graphics obtained in the conservation diagnosis of each fragment (PTM-INAH)

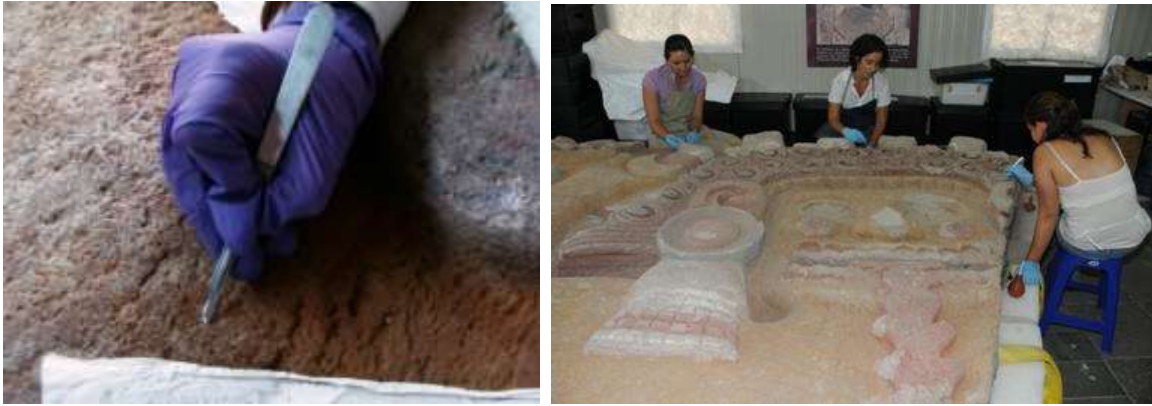
Figures 12 and 13. The cleaning procedure (PTM-INAH)

As we were able to advance in this diagnosis, we parallelly worked in a cautious cleaning process that was focused in the removal of the dried soil that covered the original colours. We knew, since the moment of the discovery, that this massive sculpture conserved almost completely its decoration over its surface but at the same time it was really delicate because of the loss of the original binder. The mechanical cleaning process was carefully done with different tools such as soft brushes, needles and scalpels. This process took us around ten months to be concluded, and as a result of our detailed work, we could see for the first time, each one of the fragments showing a vivid original polychromy just as the Aztec people should have seen it (Barajas *et al*, 2016:19).

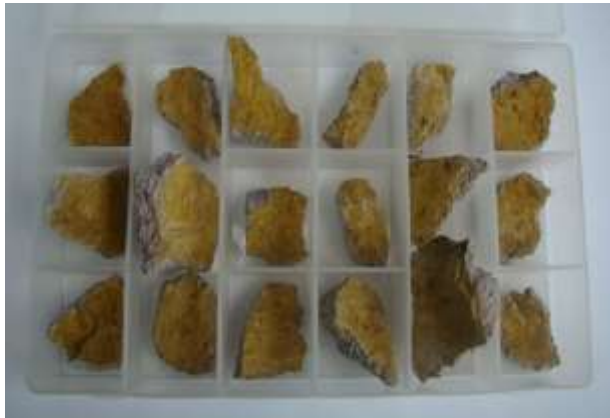
Figure 45. Samples ready for the analyses

Original fragments of the stone were found right beneath the center of the sculpture. Assuming that these fragments possibly belong to the monolith, we selected small samples of this andesite stone. All of the samples were painted in ochre pigment using a brush, and this pigment was fixed to the stone surfaces with each one of the selected different substances. We also worked with a painted sample without consolidant for comparison purposes.

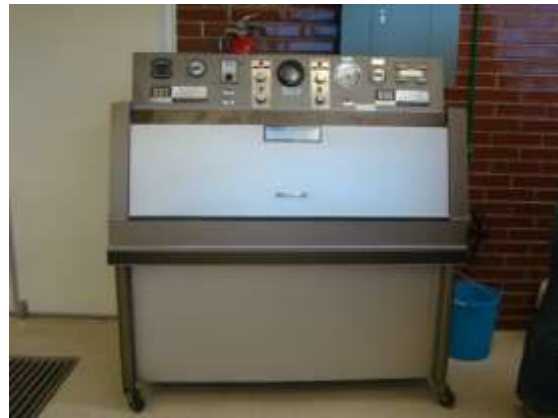
Figure 56. Accelerated ageing chamber

We worked with two groups of samples treated with each one of the selected substances as well as a painted sample without treatment. One of this group of samples was treated to simulate ageing. For this procedure, the samples were placed in an accelerated ageing chamber to simulate the deterioration after time under specific conditions of humidity and solar irradiation. Temperature was maintained at 45-50°C for 16 hours under UV exposition and a relative humidity of 20-30%, and then 8 hours at 45-50°C under 80-100% of relative humidity without UV exposure. This cycle was repeated for 75 days which were equivalent to 3 years in real time. The purpose of this treatment was to determine how much the fixation agents could modify the pigments and/or resist the action of time. At the same time and because of this purpose, we decided to also analyse a group of “fresh samples” that wasn’t treated in the accelerated ageing chamber. This method gave us the possibility to compare the different analyses results between the aged and the fresh samples (Barajas *et al*, 2010: 2882).

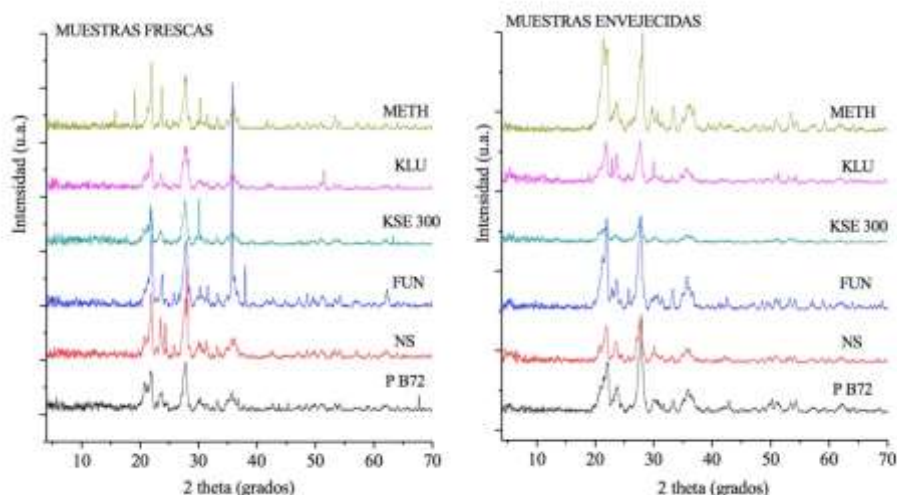
The aged as well as the fresh samples, were studied by powder X-ray Diffraction (XRD) to identify the different compounds. The morphology of the different surfaces on each one of the samples was also studied with Scanning Electron Microscopy (SEM), as well as some elemental analyses in selected zones of the samples with an EDX (Energy Dispersive X-ray) spectroscopy. We also managed to do some leaching tests over the samples, by softly rubbing humidified cotton against the surface of the different samples in order to measure the effectiveness of the fixation process. Finally, an analysis by Nitrogen Adsorption (BET) contributed to calculate the surface area and pore diameter values for each one of the samples. Surface areas were calculated with the BET equation and the pore diameter values with the BJH method (Barajas *et al*, 2009: 2883).

Figure 67. XRD patterns for the six different options

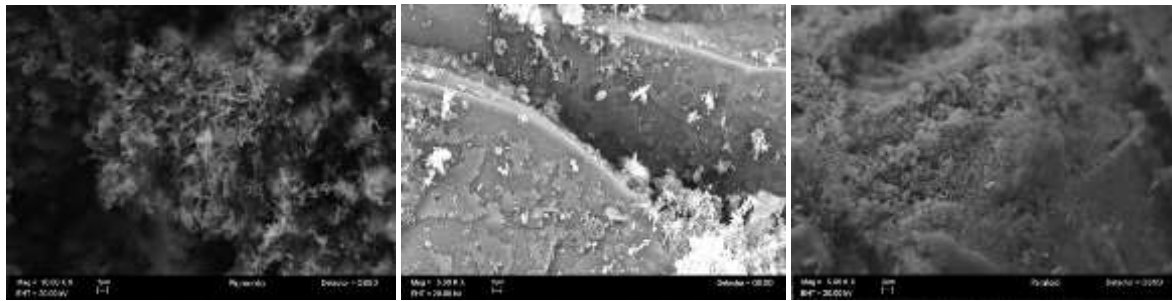
Figure 78. Non treated sample

Figure 89. Paraloid B72®

Figure 20. Paraloid B72® after ageing

The SEM images obtained for the samples treated with KSE 300® and with Paraloid B72® showed that, for the fresh samples these two consolidants appear to be covering the painted stone surface in a different way: comparing the images with the one obtained for the sample without any treatment (just the pigment over the stone surface) we found that in the sample treated with Paraloid B72®, the andesite was completely covered by a polymer which formed a smooth surface in combination with the pigment's particles. KSE 300® also covered the andesite surface, but globular particles were formed, and the surface did not turn out to be fully sealed.

Evaluating and comparing the results obtained in the XRD and the SEM analyses for these two consolidants, we could conclude that Paraloid B72® does not induce changes regarding crystalline composition, however, it was clear in the SEM images that Paraloid B72® sealed completely the porosity in the stone's sample. As for the KSE 300®, we noted in the XRD that it modifies the composition because of the formation of quartz crystals from the silicic acid, but the SEM images showed that the surface of the aged sample treated with this consolidant was not completely sealed; therefore, we knew that KSE 300® induced a more permeable surface than Paraloid B72®.

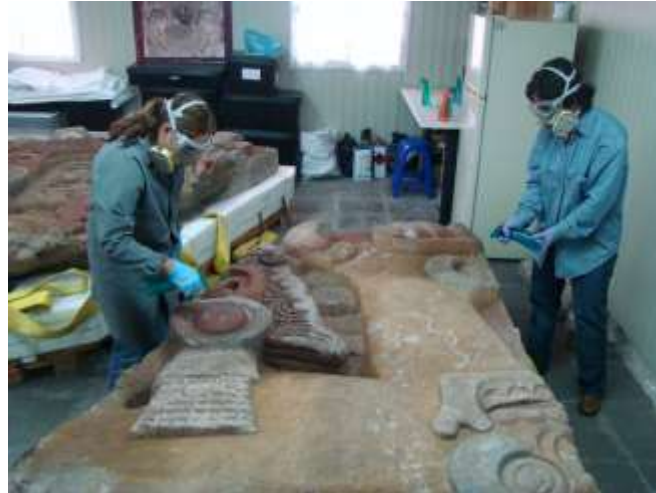
In the process, important security procedures such as the use of gloves, masks and protection glasses had to be considered. This helped us to control possible damages that could be caused by the consolidation agent. The KSE 300® was prepared 1:1 in ethanol, and was applied to the stone by atomization. This method contributed to stabilize the superficial decoration with the stone, avoiding at the same time a deeper penetration, and therefore gaining a controlled fixation action.

Figure 24. Application of KSE 300® over each one the fragments (PTM-INAH)

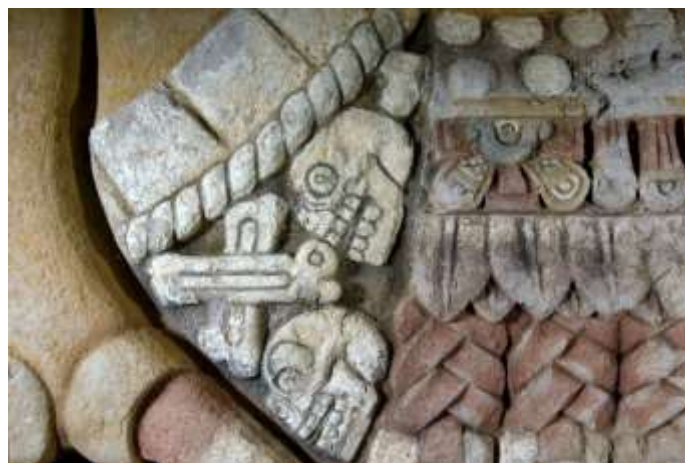
Figure 25. Detail of the monolith's decoration (Jesus Eduardo López, PTM-INAH)

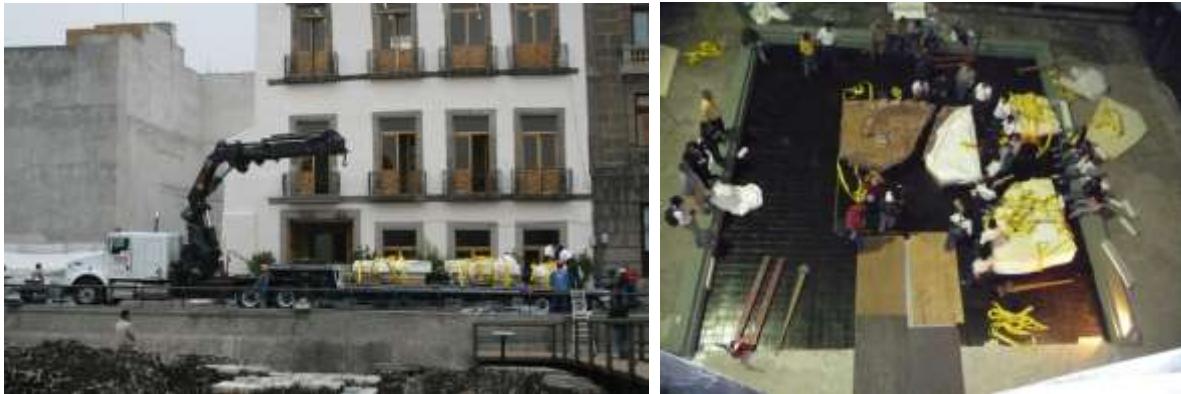
Figure 26 and 27. Transportation and mounting jobs for Tlaltecuhltli's exhibition (PTM-INAH)

for its transportation from the site to the museum, which is located just a few blocks away. After weeks of planning and discussing between different working teams, the fragments were finally taken from the site to the museum entrance. This procedure, which took us more than 18 continuous hours, was done with the participation of different specialists from INAH as well as with the help of Cordoba Plaza Company, which specializes in the packing and transportation of all kinds of museum objects.

The four fragments, already packed and prepared, were taken over a special truck with a crane, directly to the Templo Mayor Museum. This exhibition project provided the opportunity of showing Tlaltecuhltli's monumental sculpture for the first time in one of the main areas, located in the museum's vestibule. In this exhibition place, the four fragments were cautiously placed and joined one to each other. After hours of delicate working, we were able to see the unique and impressive image of the earth goddess showing its vivid polychromy in her new exhibition place.

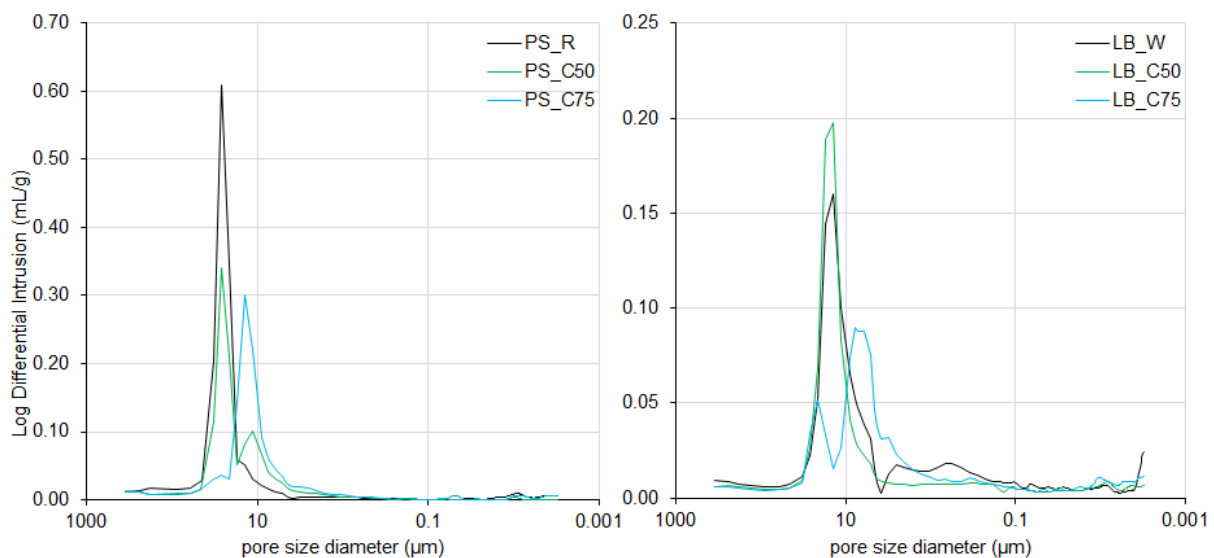
Figure 8 – pore size distribution of PS and LB specimens before (black lines) and after treatment and curing at 50% RH (green lines) and 75% RH (blue lines)

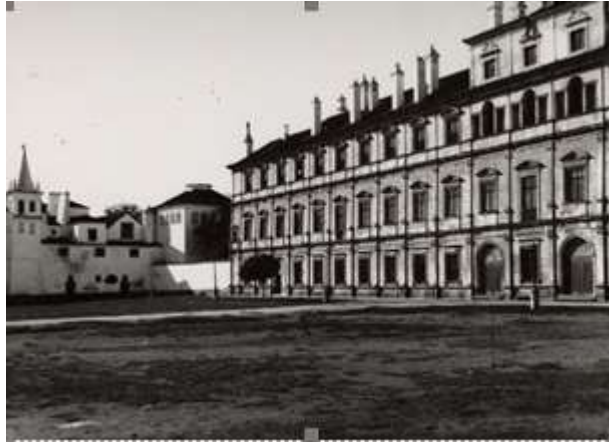
Figure 5. *Vila Viçosa. Palace. Partial view*, [19--]. Secretariado Nacional de Informação, Arquivo Fotográfico, Documental, XII-1, doc. 01058. PT-TT-SNI-ARQF-DO-012-001-01058_m0001. ANTT.

There was also a plan for the construction of a new structure, in one of the outermost sides of the palace, and on preexisting foundations, meant to aggregate several services and storage rooms. As for the façade, the document proposed the “cleaning and repair of the stonework of the main façade, including the replacement of broken marble slabs, in order to display the contrasting colours of the marble which are barely visible today due to the thick patina that, with time, has accumulated there.” [Figs. 5 and 6]

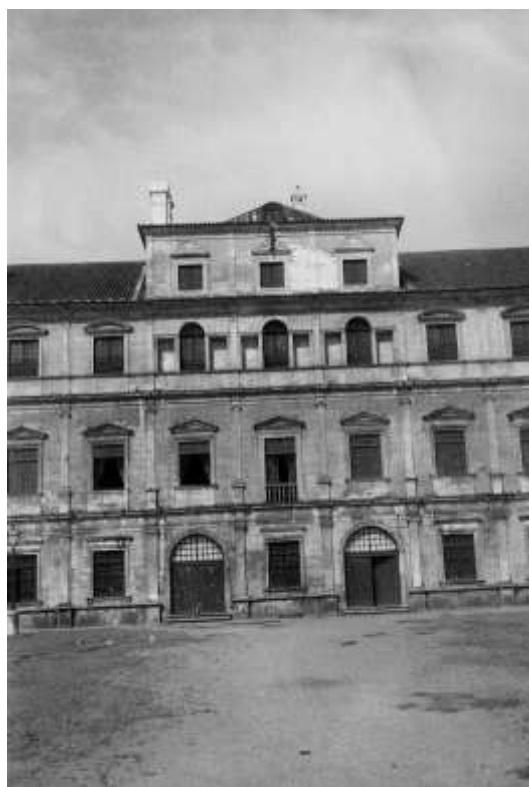
Figure 6. Ducal Palace of Vila Viçosa. Partial view of the main façade, [1943]. DGPC/SIPA. 00163278.

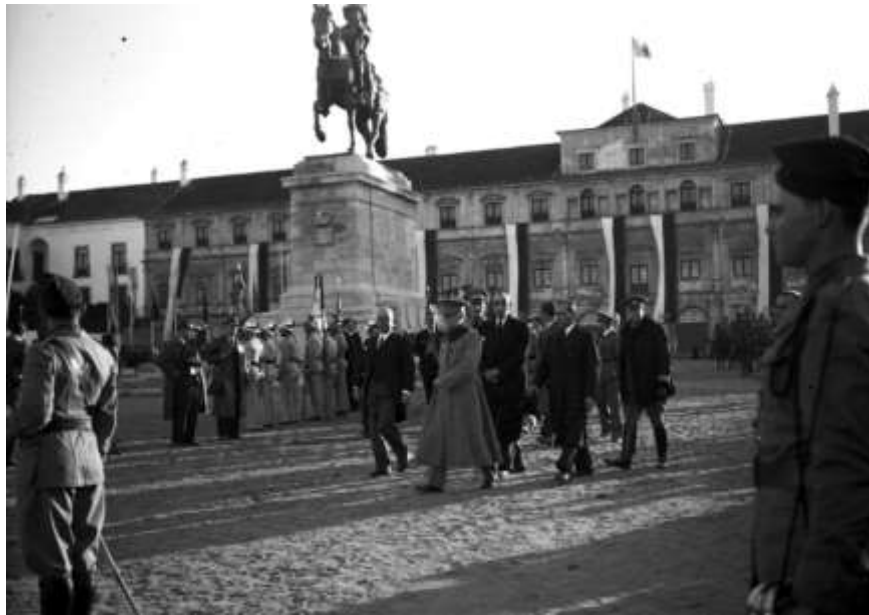
Figure 7. *The Head of State upon his arrival to the Square of the Vila Viçosa Palace* [the façade of the Ducal Palace prior to the intervention], 1943-12-08. Empresa Pública Jornal *O Século*. Álbuns Gerais no. 89, doc. 2304R. PT/TT/EPJS/SF/001-001/0089/2304R. ANTT.

Despite being one of the priorities in the program of the celebrations of the centenaries, and of the speed with which the technical and administrative process regarding the intervention on the Palace was handled, the truth is the actual intervention, led by the architect Raul Lino, only began after the 1940 celebrations, after the Administrative Board of the House of Braganza Foundation took office in January 1945 (Monge 2017, 18, 20). [Fig. 7]

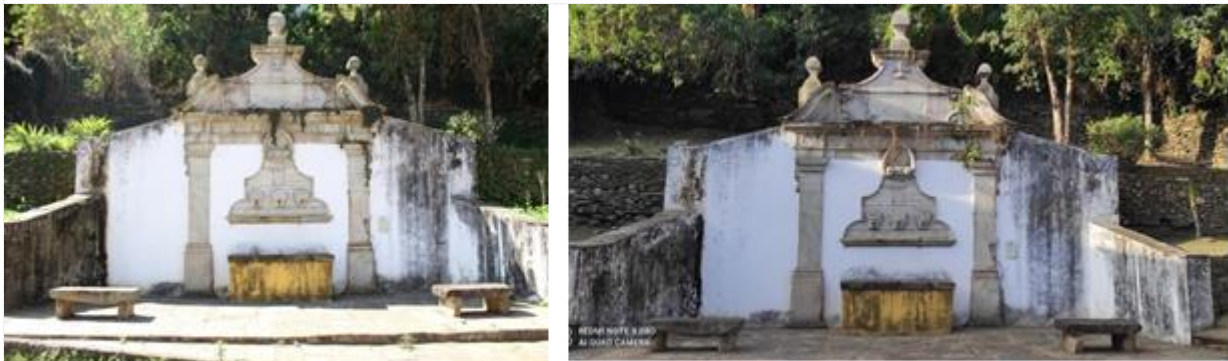
Figure 2: Incidence of solar radiation at Chafariz da Glória at noon in July (left) and in the afternoon at 4 pm (right).
Source: authors' file, 2020

The *Chafariz da Glória* receives insolation throughout the day, in the morning on its east (posterior) facade and in the afternoon on its west (frontal) facade (Figure 2). Regarding afforestation, the back of the fountain has large vegetation of small and large size, which goes up to the slope of *Getúlio Vargas* street. Concerning the relief, it is predominantly mountainous, with many slopes; however, the street where the fountain is located is in the lowest portion of the city.

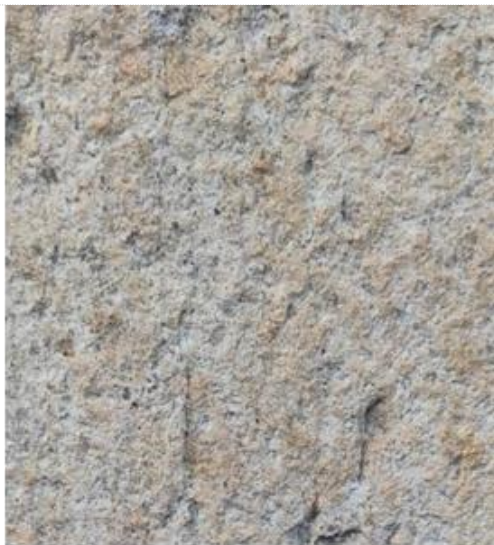
Figure 4: Detail of texture, color and granulometry of Itacolomy quartzite at *Chafariz da Glória*. Source: authors' file, 2020.

Specifically, in relation to the quartzite used in the *Chafariz da Glória*, it can be said that it was extracted in the Itacolomy mountain range. It is characterized by the presence essentially of quartz and low content of white micas (sericite) and opaque minerals, such as oxides and sulfides. From the set of opaque minerals, the presence of hematite to some ilmenite stands out, with also secondary production of limonite. Both in the monument (Figure 4) and in samples collected in the mountains (Figure 5), there is also the presence of tiny and rare fragments of very fine-grained black color material, which may represent fragments of rocks rich in clay. As for the color of these rocks, there is a predominance of whitish tones, and some other variation indicated by the presence of areas with grayish or silver colorations, and the presence of sericite more rarely yellowish and reddish. The latter can be explained in terms of changes in opaque mineral crystals, which are sometimes present, forming lines of opaque minerals. The presence of local areas with colorings ranging from greenish to black (crusts) is related to the presence of biological colonization.

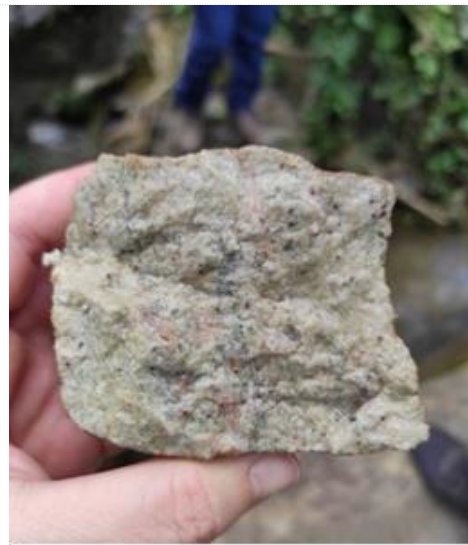
Figure 5: Detail of the texture, color and granulometry of the Itacolomy quartzite from the sample collected in the old extraction area. Source: Source: authors' file, 2020.

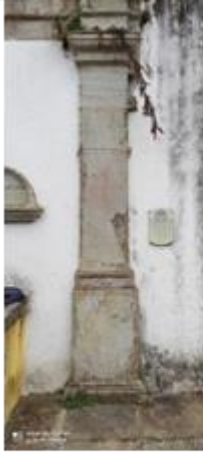
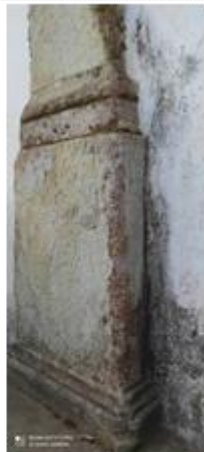
Figure 6: Both pictures from the column on the left side of the fountain, with the highest concentration of degradations. Source: authors' file, 2021.

The *Chafariz da Glória* currently has no damage that could compromise its structural stability. However, it presents superficial degradations that can be considered worrisome, with the presence of swelling, flaking and disintegration, mainly concentrated in the vertices of the niche on the left corner, more precisely in the shaft, and with the presence of microalgae between the flaking plate and the stone integrates (Figure 7).

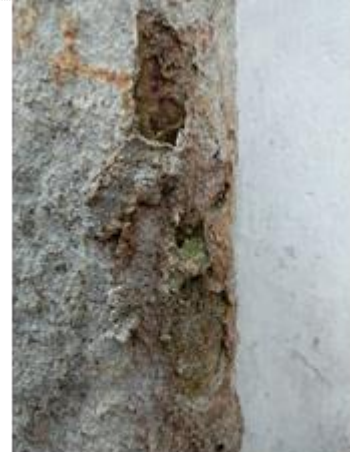
Figure 7: Detail of the greenhouse, where microalgae grow. Source: authors' file, 2021.

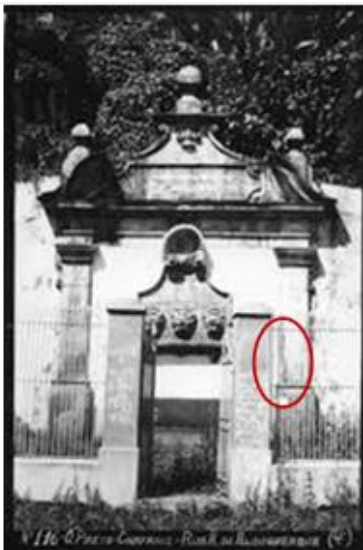
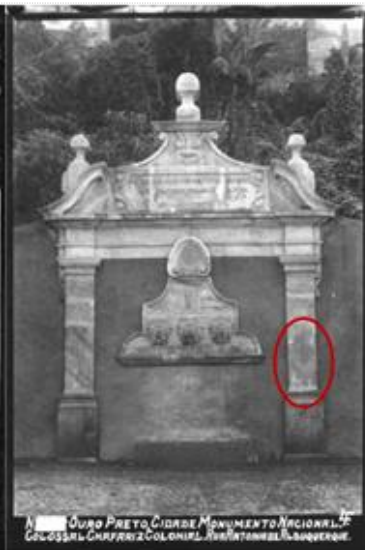
Figure 8: Photographs of the Fountain in 1930 and 1940, respectively. The degradations on the left side of the monument are not yet visible. Source: Luiz Fontana Collection. Accessed July 1, 2020. <https://ouopreto.mg.gov.br/luizfontana>.

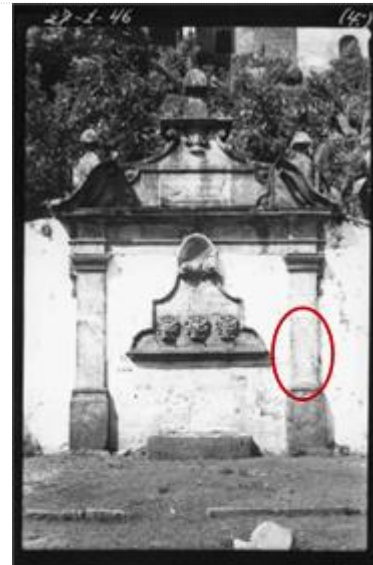
Figure 9: Photograph of the Fountain in 1946. Evidence of degradation appears on the left side. Source: Luiz Fontana Collection. Available at: <https://ouopreto.mg.gov.br/luizfontana>. Accessed on July 1, 2020.

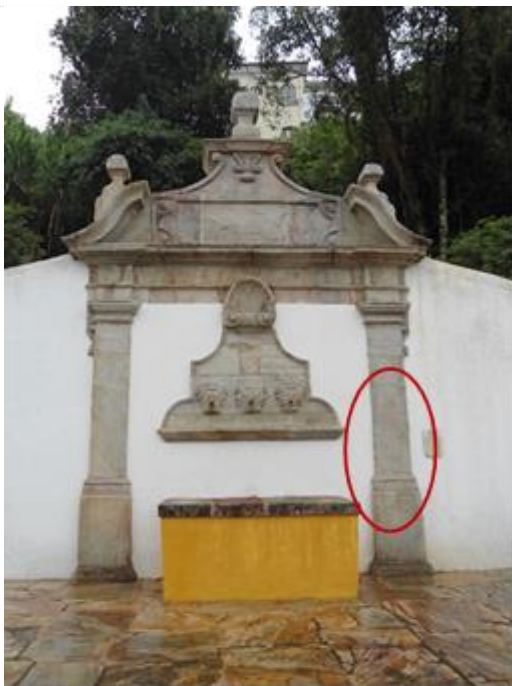
Figure 12: Photograph of the Fountain right after the restoration. Source: National Historical and Artistic Heritage Institute, 2015.

The flaking parts are very powdery and soft. Even if the diagnosis of the conservation status of the Fountain, elaborated in 2011 as a basis for the Restoration Project (PMOP, 2011), does not point to the mentioned degradation, it can be observed in photographic records of the time, which already indicated the presence of changes in the stone at these same points, as well as in older records (Figure 8-11). After the restoration in 2015, the pathologies seem to have been remedied (Figure 11). However, after a period, the degradation process was reactivated, worsening the monument's state of conservation (Figures 12 and 13).

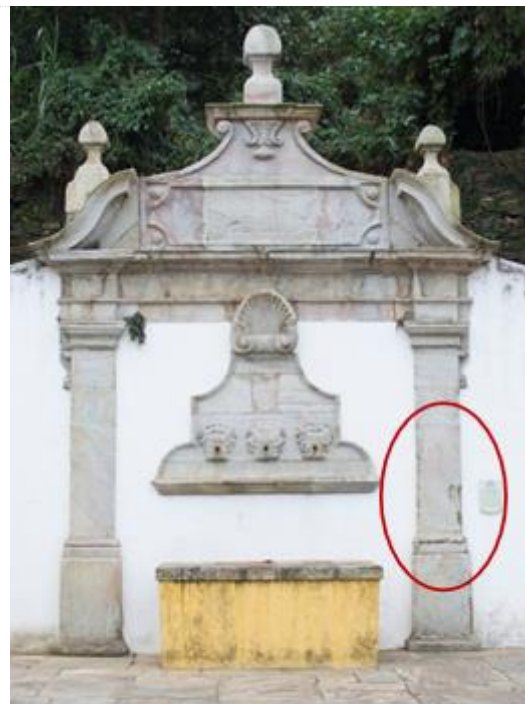
Figure 13: Photograph of the Fountain with the degradations in the left column visible again. Source: Fernando Cardoso, 2018.

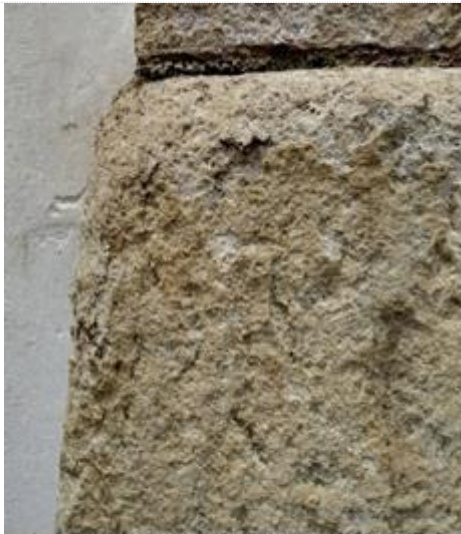
Figure 14: Quartzite swelling and breakdown. Source: authors' file, 2021.

In the stone material used in the construction of *Chafariz da Glória*, there is physical disaggregation of the stone (Figure 14) mainly concentrated in the parts that make up the body of the fountain, such as basement, columns and frowns, and there is a detachment of isolated grains. Associated with this, there is another degradation pattern known as erosion (Figure 15), which promotes a loss of the original surface leading to the smoothing of contours or the modification of roughness (Vergès-Belmin et al., 2008). In the case of the fountain, there is also the performance of another erosive process identified as rounding,

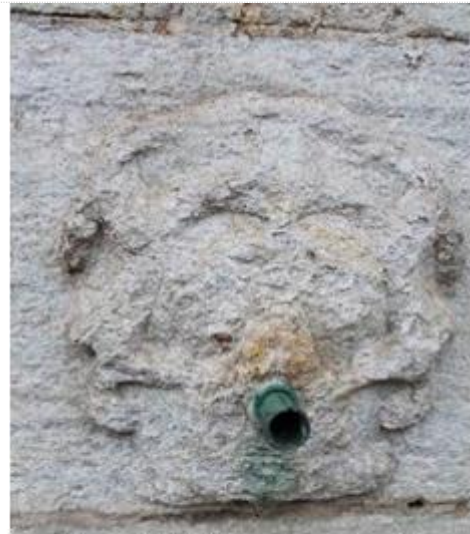
Figure 15: Scaling and erosion, with rounding of vertices and edges. Source: authors' file, 2021.

which causes, as the name says, the rounding of edges and vertices of the quartzite blocks, resulting in the loss of details and contours.

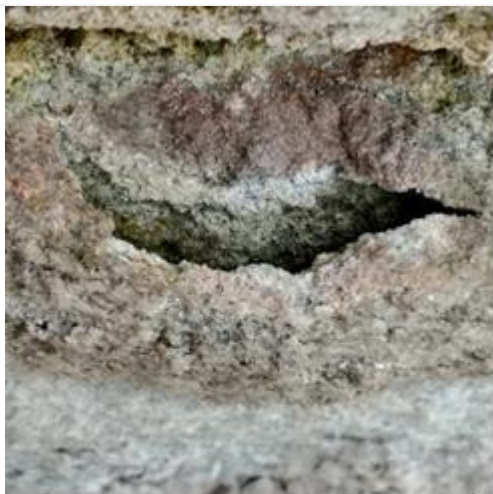
Figure 16: Blistering (stuffing). Source: authors' file, 2021.

In the places where these above-mentioned degradations occur, blisterings are formed (greenhouses) (Figure 16), that is, the detachment of a superficial layer of the stone originated by the formation of an elevation in a substantially hemispherical and hollow shape (Vergès-Belmin et al., 2008). The space generated by the greenhouse favors an environment conducive to the growth of microorganisms, with sufficient temperature, humidity and protection from the incidence of solar radiation. The presence of biological colonization, such as mosses and microalgae, can be noticed (Figure 17).

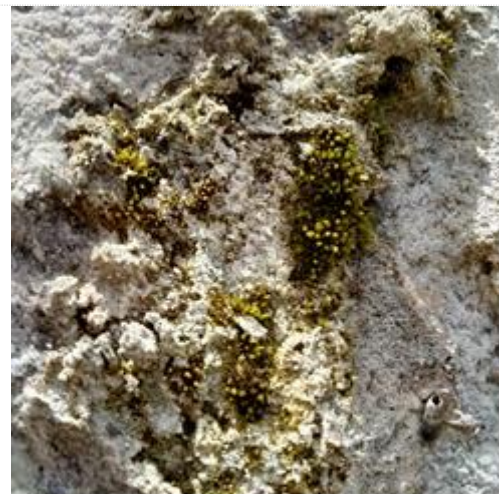
Figure 17: Colonization by microalgae and mosses. Source: authors' file, 2021.

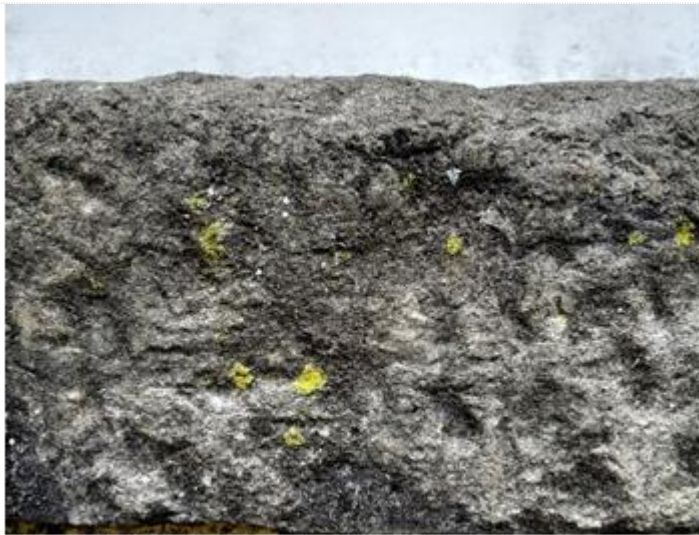
Figure 18: Colonization of the stone by lichens. Source: authors' file, 2021

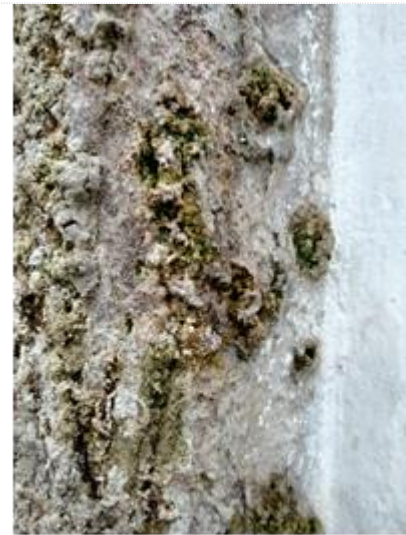
Figure 19: Colonization by microalgae. Source: authors' file, 2021

As already mentioned above, the microalgae are seen in the *Chafariz* as the greenish colonizations found under the places where there is flaking or swelling of the quartzite rock. They are also found where there is a higher concentration of moisture in the materials (Figure 18). Microorganisms, such as cyanobacteria and microalgae (Figure 19) form biofilms on the surface of the stone that are characterized by the heterogeneity of their community, by the interactions between its components, and by the production of different exopolysaccharides that protect them and allow them to adhere to the stone (Guiamet et al., 2008; Jayakumar; Saravanane, 2010; Madigan et al., 2016). These biofilms have varied thickness and colors, are strongly adhered to the substrate, and allow the deposition of organic residues that favor the growth of other organisms. In addition, they can cause dissolution of the rock (Tiano, 1998; Caneva et al., 2000; Prado et al., 2009).

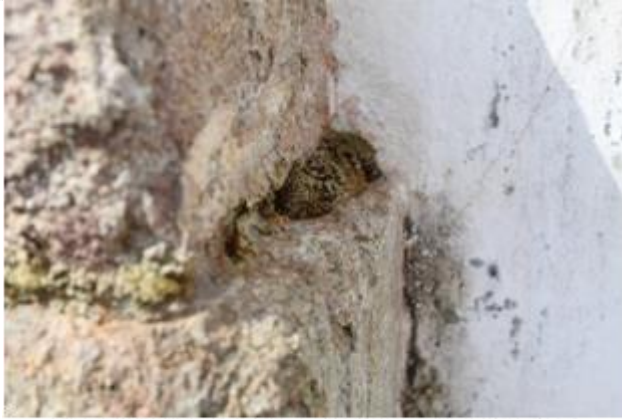
Figure 20: Colonization of moss at the column joint: authors' file, 2021.

As already reported by Prado *et al.* (2009), in Ouro Preto, the vegetation, especially herbaceous and bryophyte species, is quite conspicuous and commonly found in fountains, retaining walls, bridges, staircases and church roofs. Among the damages caused by these vegetations, it can be mentioned the formation of holes caused by the penetration of moss rhizodes and the mechanical and chemical action (acid exudates) of the roots of vascular plants (Guiamet et al., 2008). Mosses, which are avascular plants, can be found in open cavities on the surface of the stone. At the Fountain, it is possible to observe them mainly at the joints of the stones (Figures 20 and 21). In addition, in some points of the fountain, as such as the crown, central tank and on the retaining wall, the presence of a layer of dark colored biofilm associated with the presence of mosses is noticeable. However, with the direct incidence of solar radiation, currently, this layer is dry and brittle, therefore, inactive.

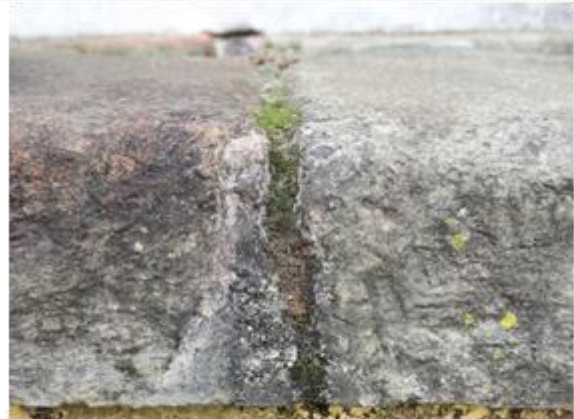
Figure 21: Colonization of moss in the joint between the stone parts of the tank: authors' file, 2021.

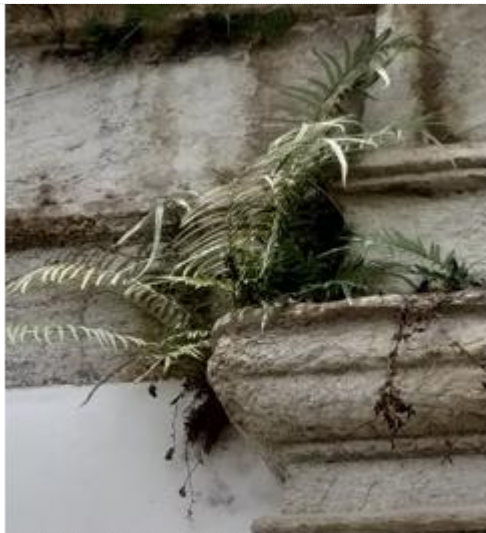
Figure 22: Presence of fern (*Pteris vittata*). Source: authors' file, 2021.

It is also possible to check the growth of ferns (*Pteris vittata* L.) and an invasive herbaceous plant, the species *Polygonum capitatum* Buch.-Ham (Figures 22 and 23). These plants can be seen in the fountain, mainly in the upper part, in the stones that have a flat and a horizontal surface. The presence of these plants in the Fountain is worrying, since their roots can develop in joints or in small fractures of the stones, causing their widening and, consequently, a rupture of the stone. In addition to this physical damage, the plants can cause chemical damage, besides retaining moisture, contributing to other degradation processes as such as saline efflorescence (Caneva et al., 2000; Prado et al., 2009).

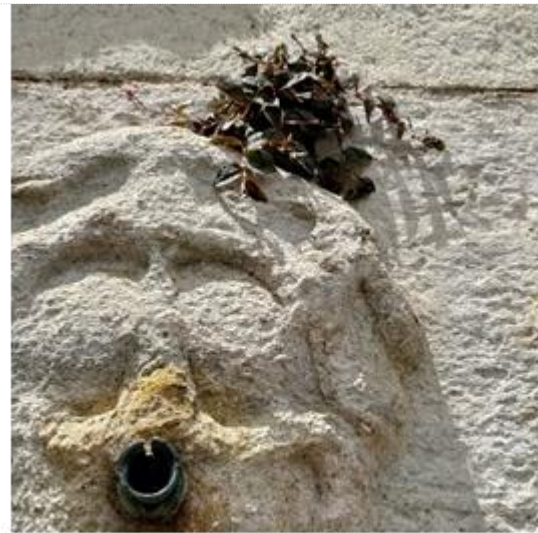
Figure 23: Presence of the *Polygonum capitatum* Buch-Ham plant. Source: authors' file, 2021.

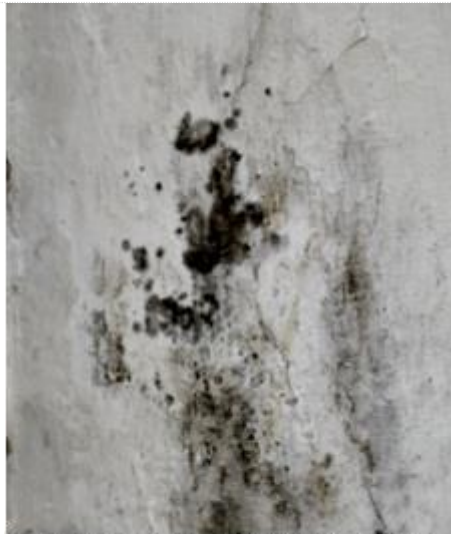
Figure 24: Fungal colonization. Source: authors' file, 2021.

Regarding the part of the fountain in masonry made of mortar stone, it is possible to notice spots of dirt, loss of the pictorial layer and fungal colonization. Fungi, part of the Fungi Kingdom, are multicellular except for yeasts, are chemoheterotrophic and acquire nutrients by absorption (Tortora et al., 2017). In general, the following deterioration actions caused by fungi can be highlighted: aesthetic damage by the formation of dark pigmentation biofilm, due to the release of pigments or the very presence of hyphae (Figures 24 and 25); metabolic production of acids with consequent solubilization of the stone, and penetration of the mycelium in the structure of the materials, increasing its porosity and enabling greater water retention (Gómez-Alarcón et al., 1995; Caneva et al., 2000; Videla, 2003; Ferrari et al., 2015).

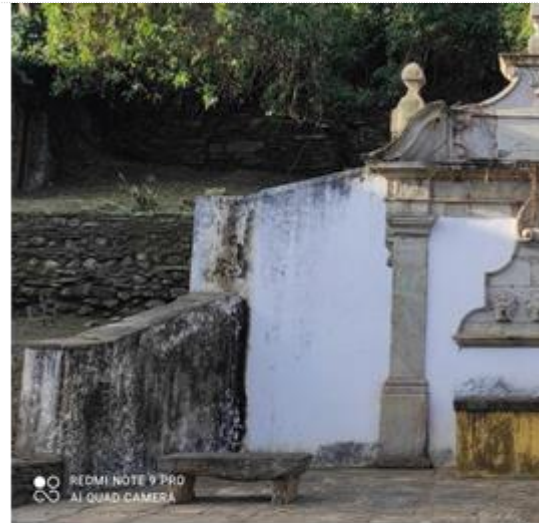
Figure 25: Generalized fungal colonization. Source: authors' file, 2021.

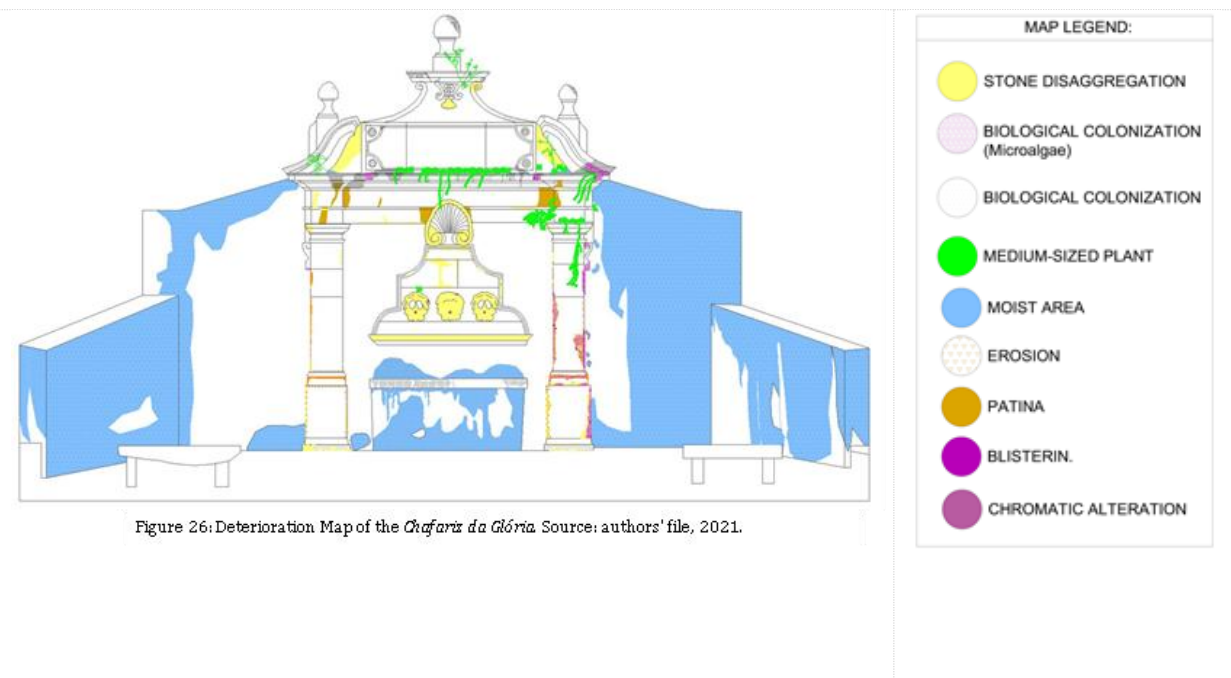
Figure 26: Deterioration Map of the *Chafariz da Glória*. Source: authors' file, 2021.

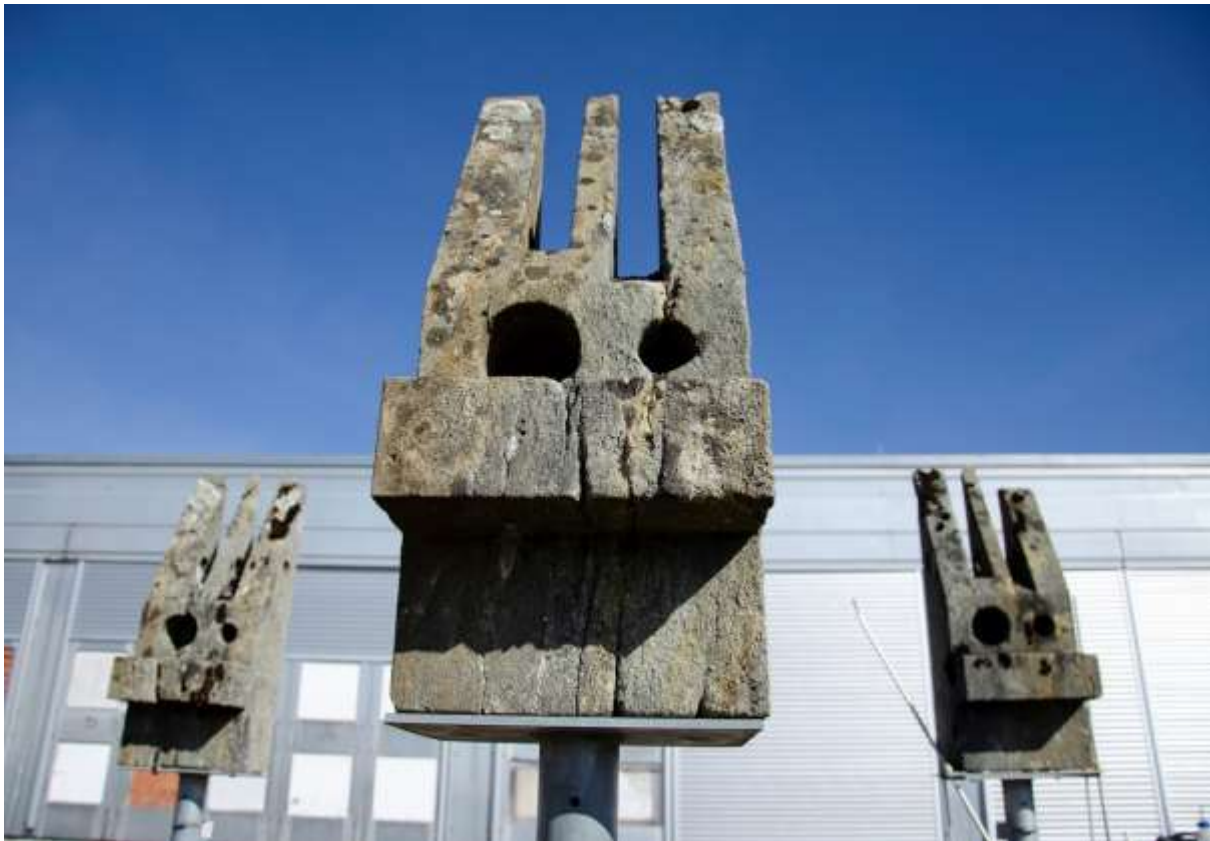
Figure 1. Holzkirchen (Germany) March 2019, outdoor test site with a selection of Asterixe specimen with the front facing West and the South side facing the Alps (middle foreground: Asterix No 4 was part of this study; ©Wilhelm 2019).

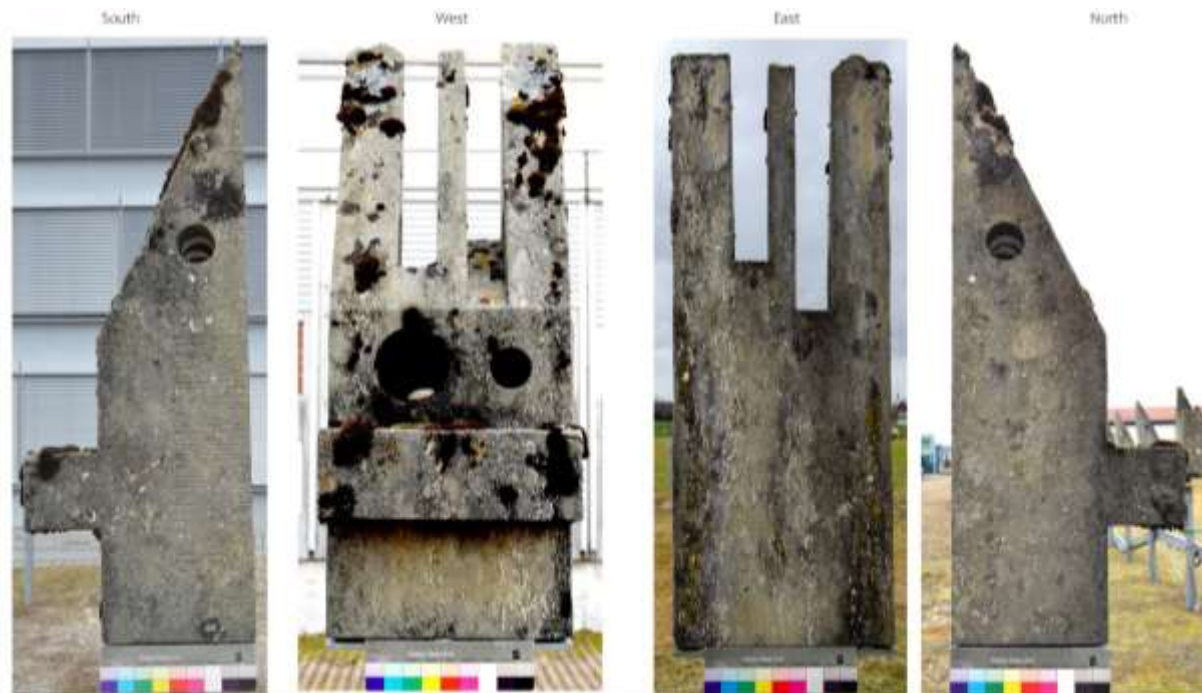
Figure 4. Asterix No 9 (non-consolidated) in 2019, from left to right: sides exposed to South (Alps), West, East and North. The East side shows a differentiated soiling pattern following the two different water run-off regimes facilitated by the different geometries of the incisions where the one on the left (southward) slopes towards West and the one on the right has a horizontal base.

This study observed common stone weathering patterns such as differential erosion (rounding and roughening), granular disintegration, fragmentation (the top pinnacles are particularly prone), biocolonisation and for Asterix No 4 crack formation (e.g. Grimm 1990; Behlen et al. 2008; Verges-Belmin 2008). The absence of scaling indicates that the consolidant was successfully applied with sufficient penetration depth and without a sharp transition zone between outer area and the core of the specimen; thus, not caused any secondary damage as might be observed with shallow penetration depth of consolidants (e.g. Meinhardt-Degen 2005). Overall, the material surface characteristics of the Asterixe have become more heterogenous and all (including the consolidated one) follow a similar trend of differential weathering according to the main weathering direction (South-West) and in relation to the complex geometry of the specimen. Figure 4 shows exemplary soiling patterns observed on all investigated Asterixe specimen in this study. Different water run-off regimes result in less soiling on the East exposed side beneath the incision which slopes westward (to where it guides the water) versus the area below the incision that does not slope (horizontal orientation) exhibits darker soiling as water flows off equally on both sides (East and West). Further on the East exposed side in a narrow zone following vertically the south- and northward edges, noticeable biological growth (lichens and biofilm) can be observed, indicating a beneficial balance between light and water supply. Similarly, the sloped top of the west-facing side also appears to have favourable circumstances for biological growth such as mosses and lichens.
