International Symposium Stone Consolidation in Cultural Heritage

Full Papers

Editors: : José Delgado Rodrigues and Marlucci Menezes

LNEC, Lisbon, 23-25 March, 2022

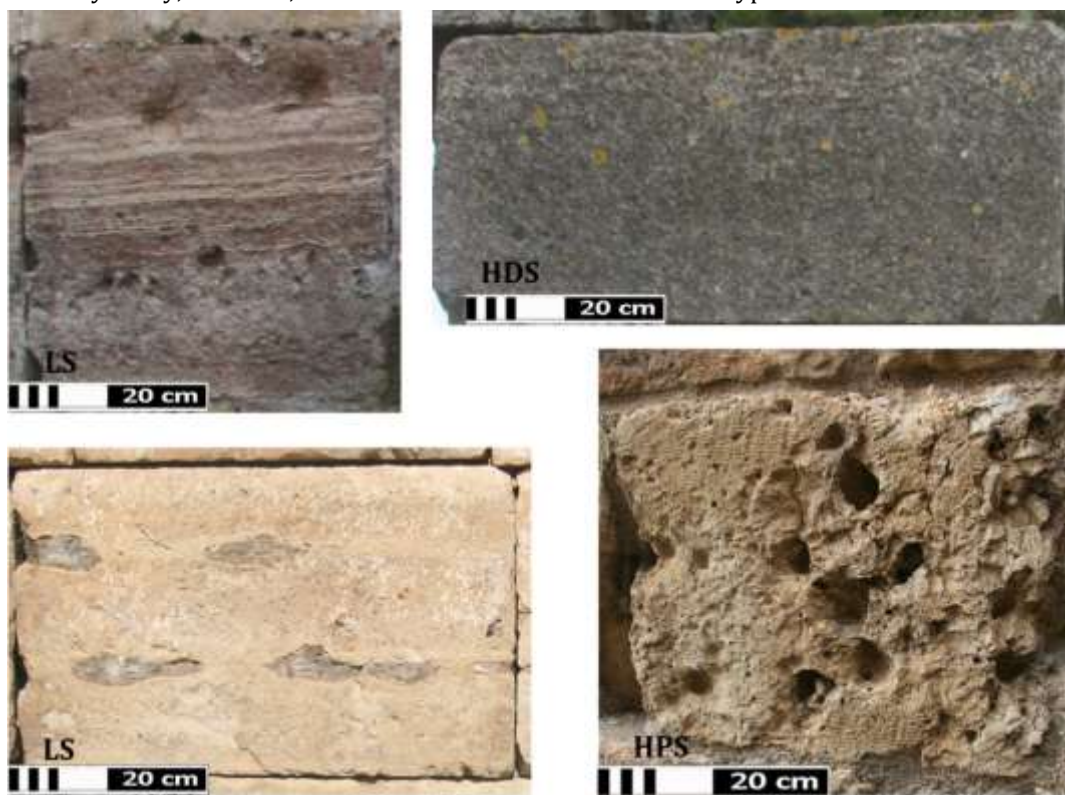
Figure 1 The lithotypes of carbonate stones used in Crac des Chevaliers.

The castle was built mainly of carbonate stones (limestone, dolomitic limestone and dolomite (Al-Khateeb, 2008)). It is challenging to distinguish these stone types on the site, so they are called carbonate stone by collective name. By the field investigation, the carbonate stones were categorised into four lithotypes as follow: 1) homogenous porous stones (HPS); 2) homogenous dense stones (HDS); 3) laminated stones (LS); 4) newly built stones (NBS). HPS is a homogenous carbonate stone with visible porosity, where its pores size range between 0.5 mm to 2 cm. HDS is a homogenous dense stone whose porosity is not visible to the naked eye. LS is a laminated carbonate stone where the sedimentary layers appear clearly on its surface with 10-20 cm in height. In some laminated stones, big flint particles can be found parallel to the sedimentary layers; and the size of the flint particles ranges from 3 to 10 cm (Figure 1). NBS are the stones brought to the castle from nearby quarries for restoration work. These newly built stones were rebuilt during the restoration work between 2002 and 2004. HDS and LS are more common at the castle compared with HPS. The percentage of newly built stone is very low. Some HPS and NBS types stones could be found without any decay; however, non-weathered stones of HDS and LS types could not be found at the castle.

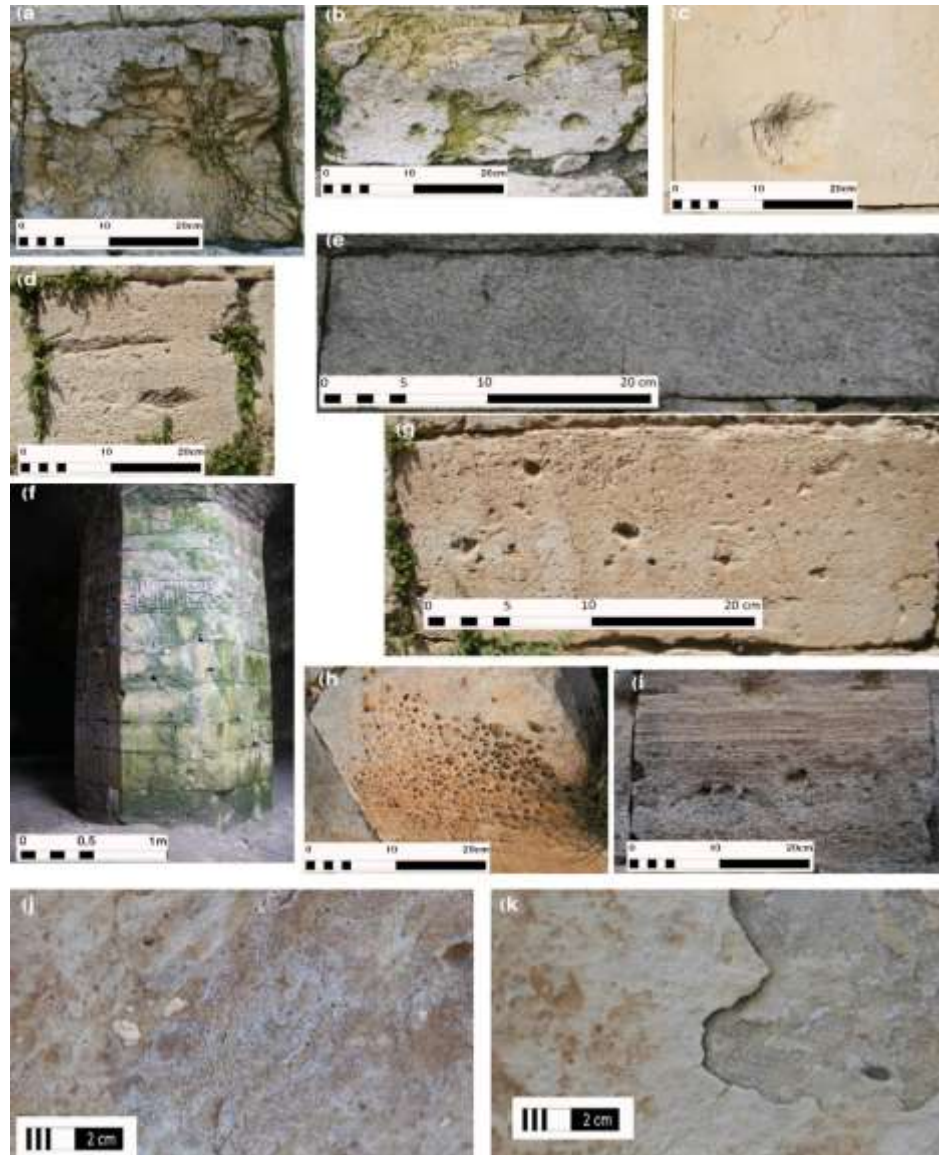
Figure 3 Deterioration cases at the castle. a) Demolished fragmented stone. b) stone exposed to missiles fragments. c) Stones exposed to a direct bullet. d) Growing of invasive plants in the joints. e) Deposition of grey microorganisms. f) Green microorganisms on a pillar exposed to water infiltration from the roof. g) Orange discoloration. h) Pitting. i) Deposition of red-orange microorganisms. j) Salt efflorescence. k) Scaling.

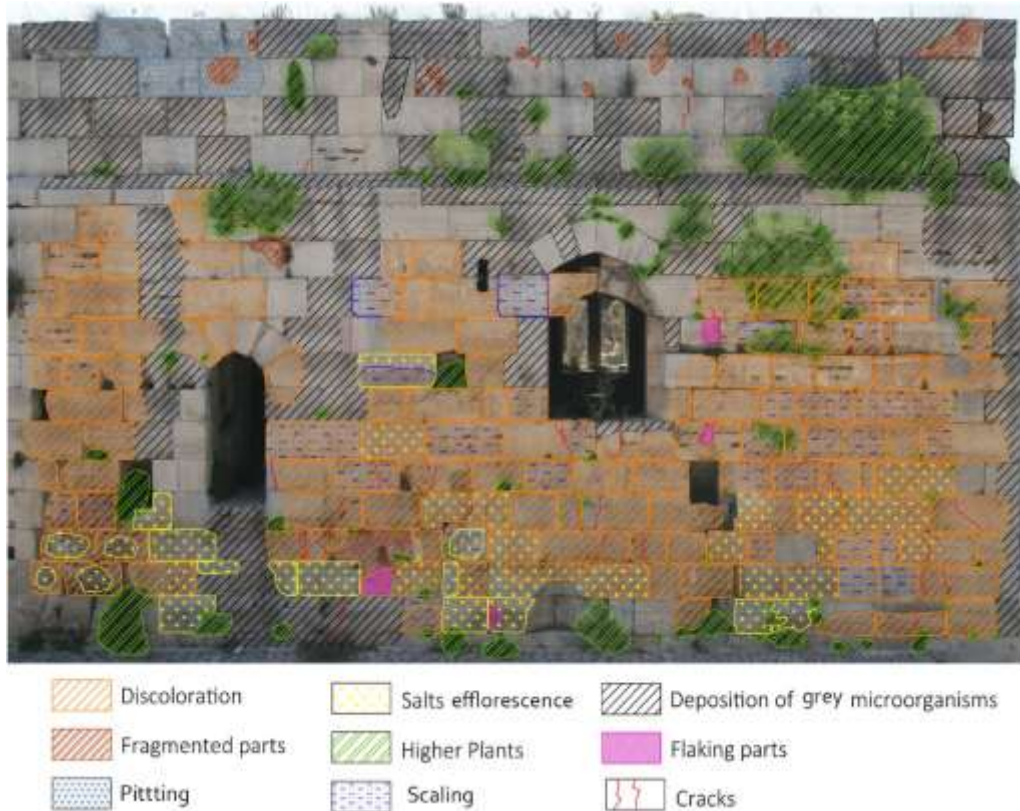
Figure 4 Deterioration mapping of the external east facade of the building (36).

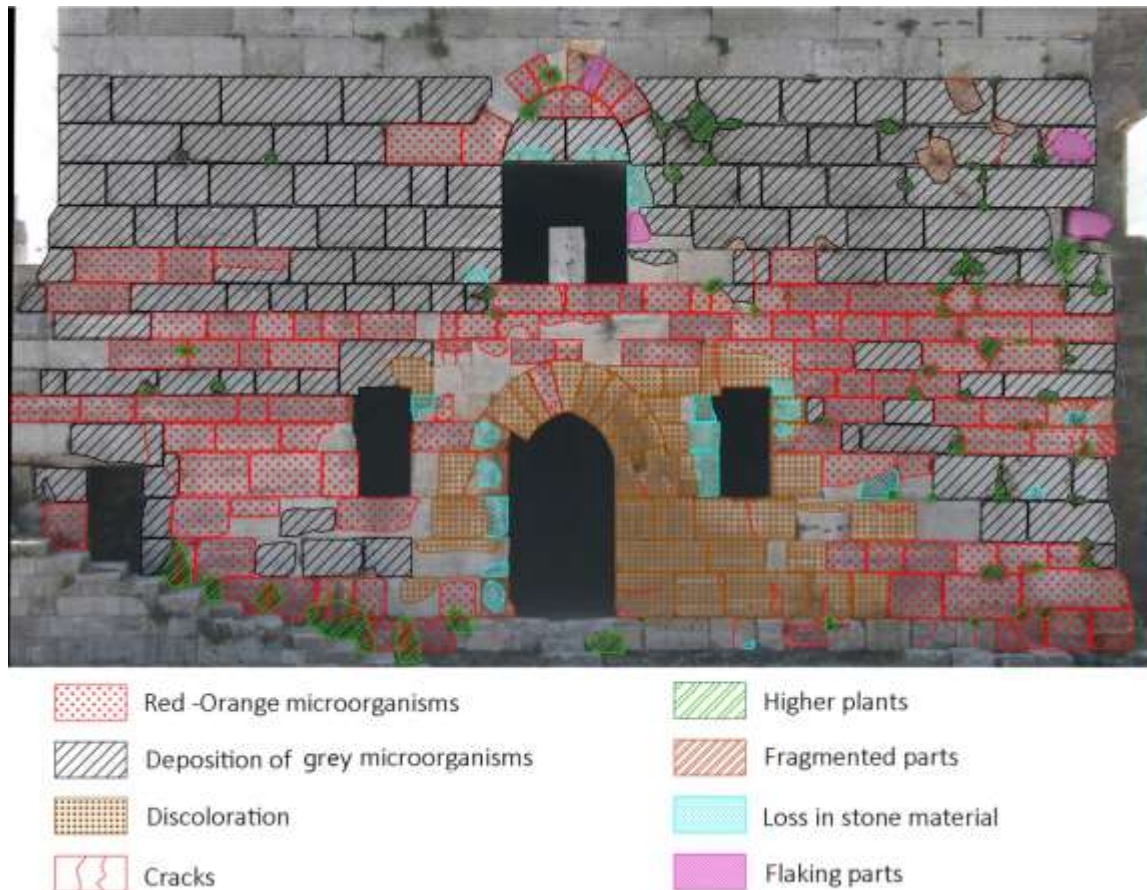
Figure 6 Deterioration mapping of the external north facade of the building (36).

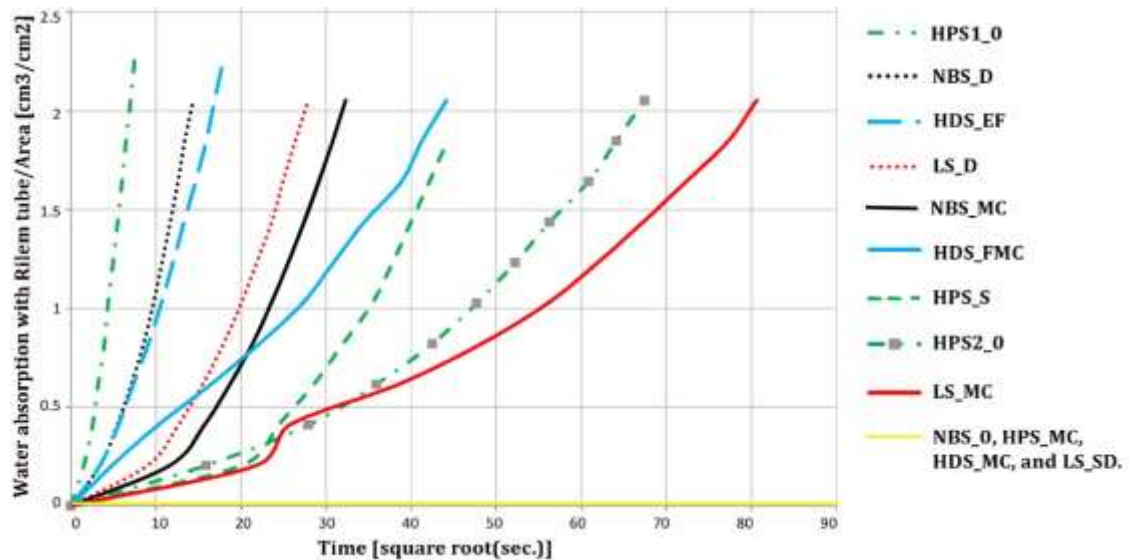
Figure 8 The absorption diagram of the tested stones by Rilem Tube.

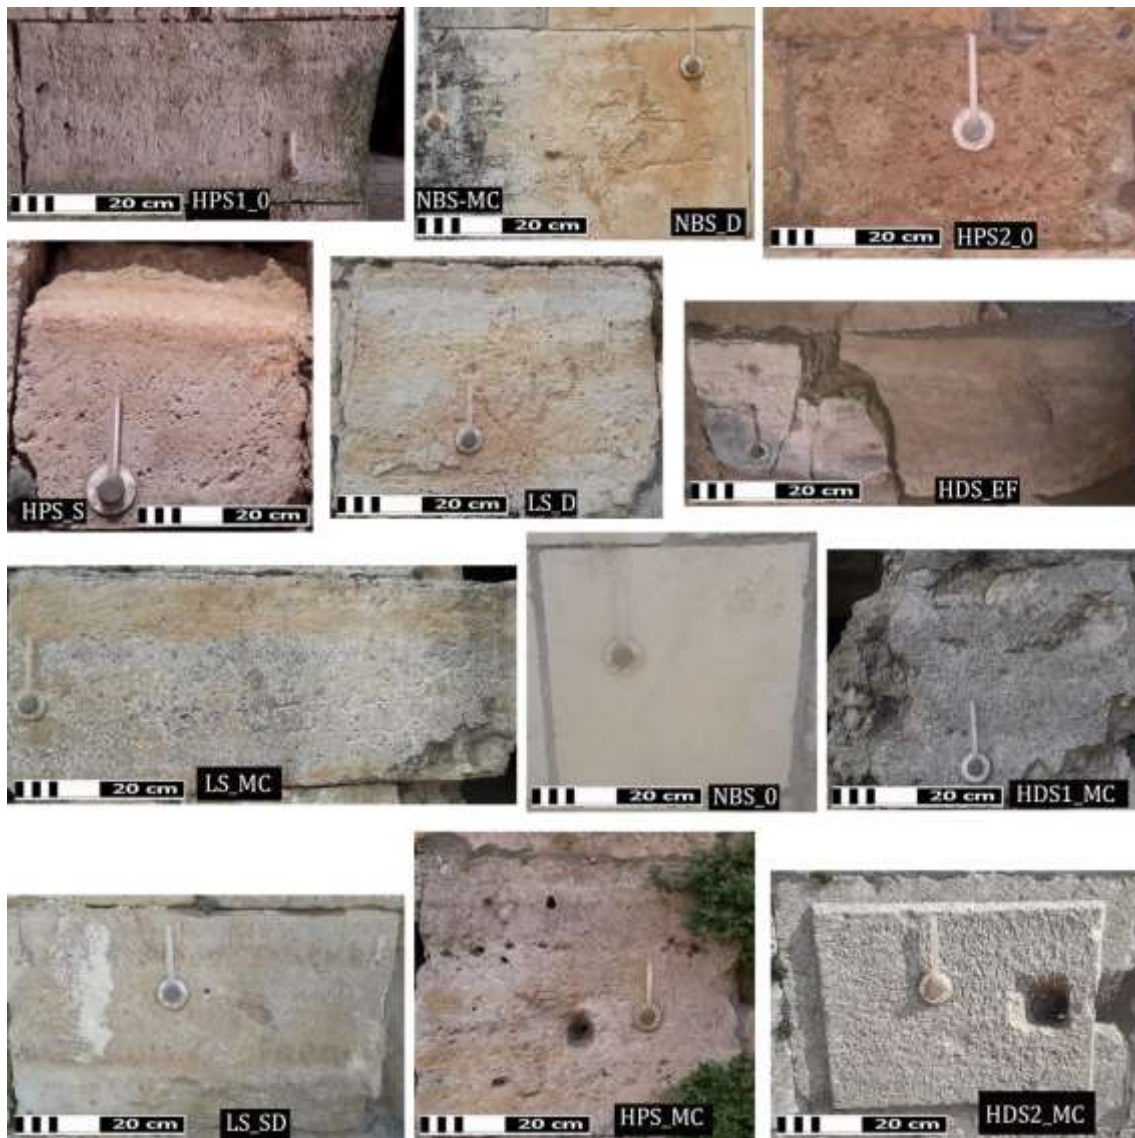
Figure 9 the tested stones by Rilem tube and Schmidt hammer.

The measured rebound value of this stone was 33 (see Figure 10) and its calculated uniaxial compressive strength was 28.5 MPa, see Table 1. Another homogenous porous stone (HPS2_0); with no distinct decay type (Figure 9) was located outdoors about 1 meter above ground on the north external façade of a building

on the ground floor level. The absorption rate of the stone was lower (Figure 8) and its rebound value was 6% higher than HPS1_0 (Figure 10), while its calculated compressive strength was 33.7 MPa. The homogenous porous stone with salt efflorescence on its surface (HPS_S, Figure 8) exhibited lower water absorption than HPS1_0 and higher than HPS2_0. Its absorption curve can be divided into two stages in which the absorption rate has changed from relatively low to moderate by approx. 400 sec. The low rate corresponds to the first cubic centimetre of absorbed water, while after that; the absorption rate has increased (Figure 8). The measured rebound value of this stone (HPS_S) was 12% higher than HPS1_0 and higher than HPS2_0 (Figure 10) and its calculated compressive strength was 38.3 MPa. HPS_MC was an outdoor homogenous porous stone colonised by microorganisms and revealed non-absorption behaviour. The measured rebound value of this stone was the highest compared with the other HPS stones: 24% higher than the rebound value of HPS1_0 (Figure 10). As such, the calculated compressive strength of HPS_MC was the highest among the HPS group and it was 49.8 MPa. The absorption behaviours and the rebound values of the two non-weathered homogenous porous stones (HPS1_0 & HPS2_0) were different. It seems that both stones are structurally different, which were reflected in their properties. The rebound values of the HPS were close to each other (about 14% difference in average), but the presence of microorganisms or salt on the stone surface reduced or prevented water from entering the stone and resulted in higher surface strength.

Among the tested stones, the three homogenous dense stones (HDS) with different decay types demonstrated different absorption behaviours and variety in their rebound values. HDS_EF was a very fragmented indoor stone with an eroded surface and cracks running the length of its height (Figure 9). This stone had a good absorption behaviour compared with two other tested homogenous dense stones (Figure 8). HDS_FMC was a stone in an external north façade of a building subjected to bombing shots. It had loss of material, fissures and fragmented parts, and its surface was colonised by microorganisms (Figure 9). This stone revealed moderated absorption rate, see Figure 8. On the other hand, the outdoor homogenous dense stone colonised by microorganisms (HDS_MC, Figure 9) did not absorb water (Figure 8). The rebound values of these HDS were different. The calculated compressive strength of HDS_FMC was 33.5 MPa, while for HDS_MC it was 88.7 MPa (Table 1). HDS_EF had the lowest rebound value and compressive strength (24.0 MPa) due to the fragmented and eroded surface. The rebound value of HDS_FMC was higher than HDS_EF and lower than HDS_MC (Figure 10). The mechanical shock due to

The investigated laminated stones (LS) exhibited different absorption behaviour depending on their decay type, but their rebound values and compressive strength were close to each other. LS_D was an outdoor, laminated stone with discoloured surface and secondary pores (Figure 9). The stone revealed moderate absorption behaviour (Figure 8). LS_MC was an outdoor laminated stone colonised with microorganisms (Figure 9). The absorption rate leapt after the stone absorbed the first cubic centimetre of water from the tube (Figure 8). The last laminated stone (LS_SD) was an outdoor stone with discolouration and salt efflorescence on its surface (Figure 9). This stone did not absorb any water. The rebound values of all laminated stones were very similar; where the difference between the lowest and the highest value is 9%. The calculated compressive strengths of LS_D, LS_MC, and LS_SD were 64.8, 60.8, and 75.3 MPa; respectively (Table 1). The surface strength of the discoloured stone surfaces was slightly higher than the surface colonised with microorganisms (Figure 10).

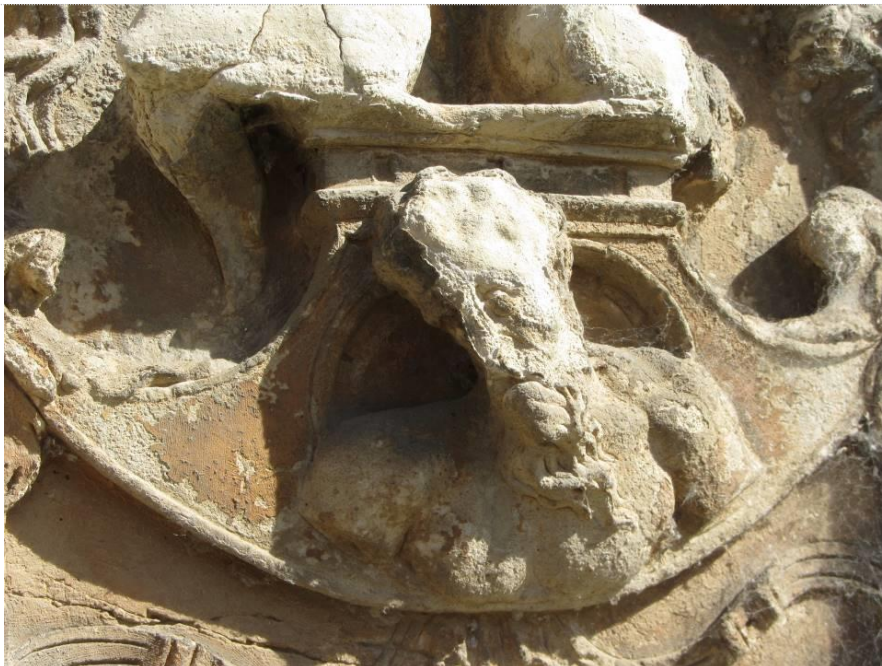
Figure 1 – A thin superficial indurated crust, possibly caused by a past consolidation treatment, often ends up failing by excessive incompatibility with the substrate, as happened in this very porous limestone

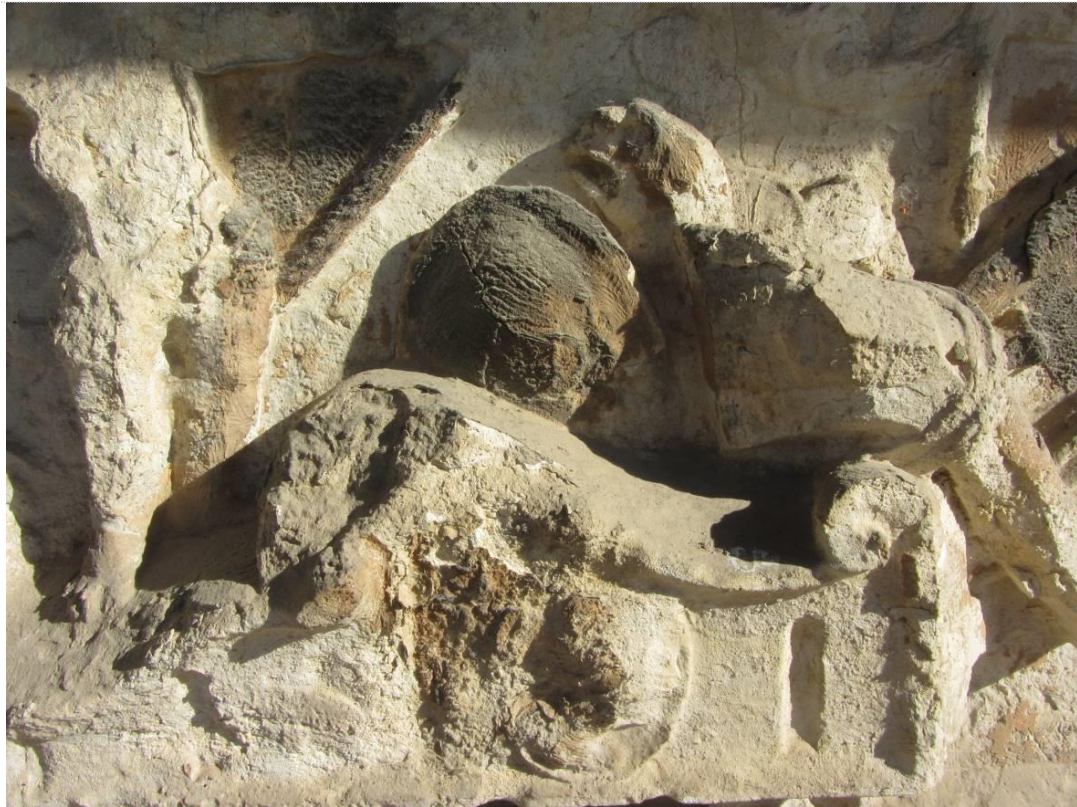
Figure 2 – Consolidation of a delicate surface showing strong signs of deterioration requires a slight increase in strength and with a very low degree of incompatibility. High-strength increments and very shallow impregnation depths, as this photo suggests, can compromise the entire surface in the medium to long term

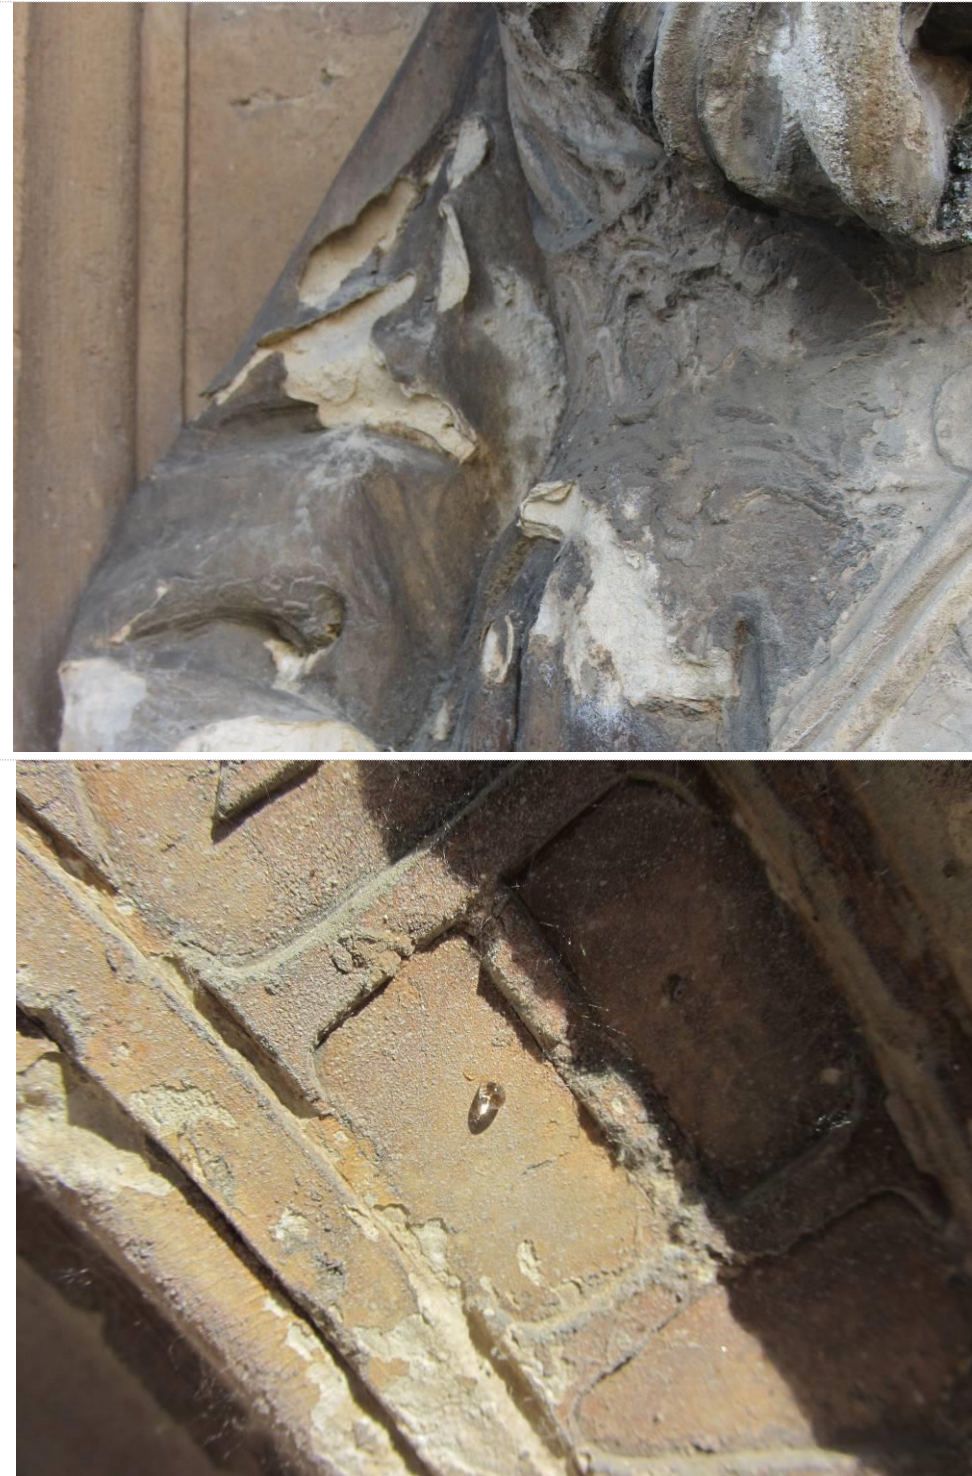
Figure 3 – Sound surfaces should not be consolidated as strength reinforcement is not logically justified, its presence is not innocuous and can compromise the long-term performance due to excessive incompatibility

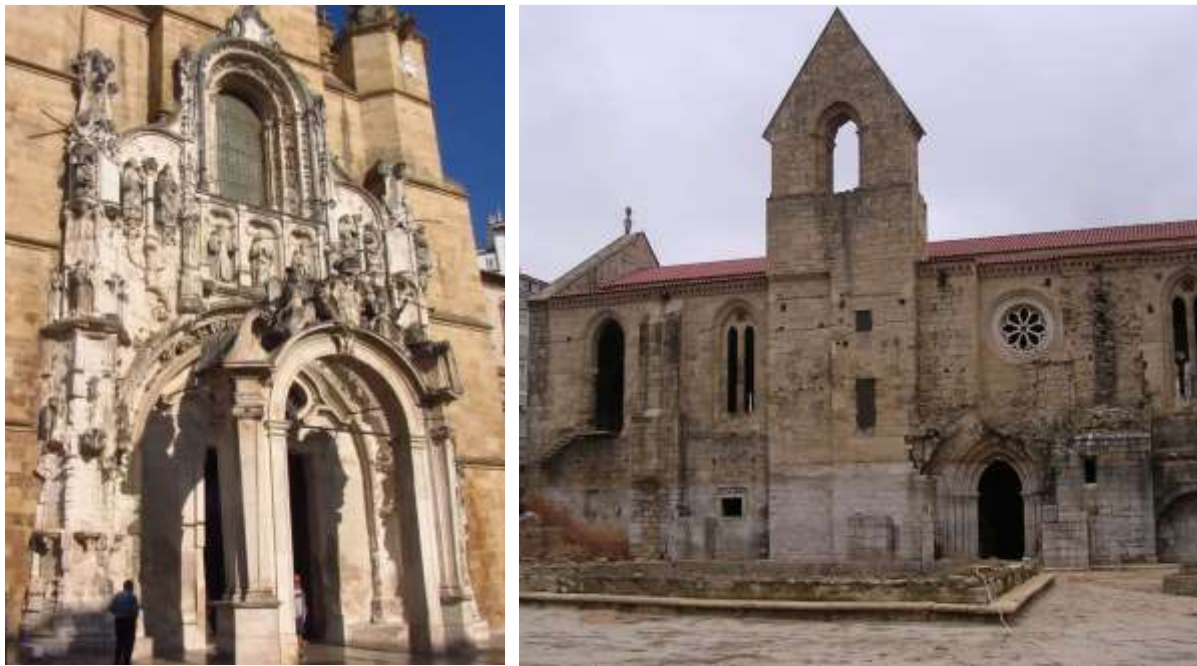
Fig. 1 – Aspect of “Ançã stone” in the Renaissance portal of Santa Cruz church, Coimbra (left), and of “Coimbra dolostone” in the Santa Clara old convent, Coimbra (right).

The two stone types are the “Ançã stone” and the “Coimbra dolostone”. The “Ançã stone”, herewith also labelled as AS, is a fine grained, micritic limestone, almost exclusively composed of microcrystalline calcite. Its porosity can range from 26 to 29% and the pore size distribution is unimodal with a relatively narrow radius ranging between 0.1 to 1 μm (Figs. 1, 2). The “Coimbra dolostone”, herewith also designated as CD, is a very heterogeneous stone, mostly composed of dolomite (a Ca-Mg carbonate), with minor amounts of clays and iron oxides. It is fine grained, with frequent calcite veinlets and conspicuous vacuoles. It has undergone an uneven dolomitisation process that left relevant fingerprints in the porosity and cohesion variations identifiable at a centimetre scale. The pore radius ranges from 0.01 to 1 μm while its total porosity ranges from 14% to 19% (Figs. 1&2). The representative pore size distributions of the more heterogeneous and less porous areas of the stone of Coimbra (CD-Z2) suggest that its pore network has pores larger than those existing in its more porous areas (CD-Z1), Fig. 2. This stone also has wide variations in its physical and mechanical properties, whereas Ançã stone is far more homogeneous, as can be observed in Fig. 3. For additional information of the properties of these lithotypes, see also (Ferreira Pinto 2002) and (Ferreira Pinto and Delgado Rodrigues 2008).

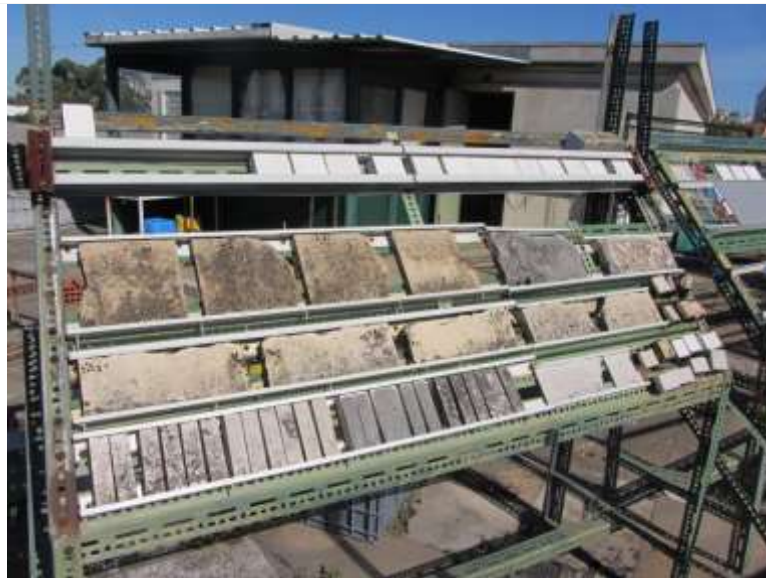
Fig. 4 – Example of outdoor exposure trial arrangements showing specimens of different sizes and shapes.

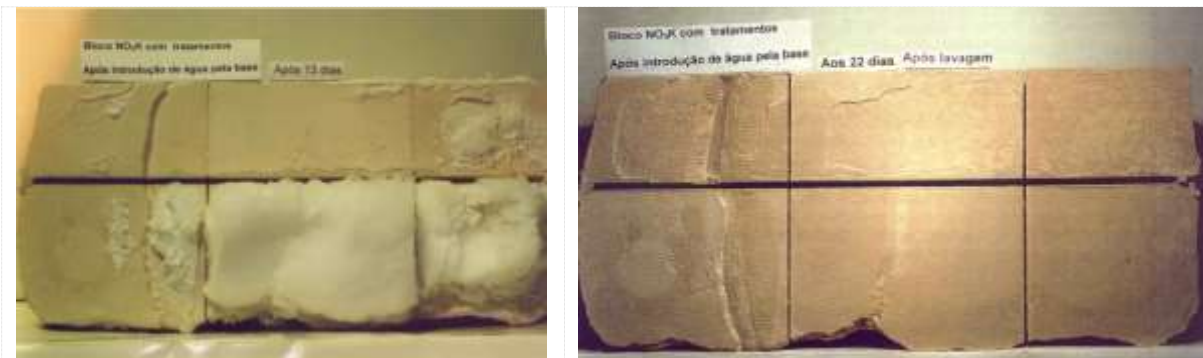
Figure 6 – Aspect of the AS block (28% porosity) treated with different products after forced percolation of a salt solution (left) and after removal of efflorescences (right). The central test area in the bottom row showing an intense salt blossoming is the zone treated with ethyl silicate. The central test area in the upper row was treated with Paraloid B72. The block is about 35 cm long

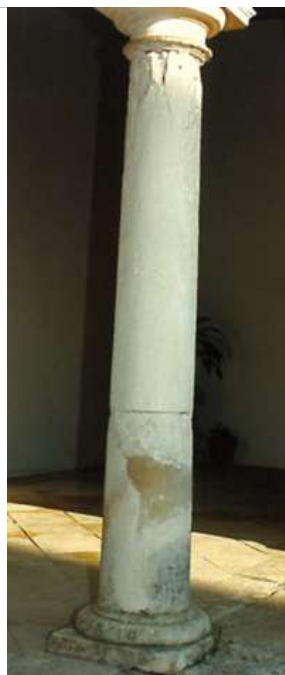
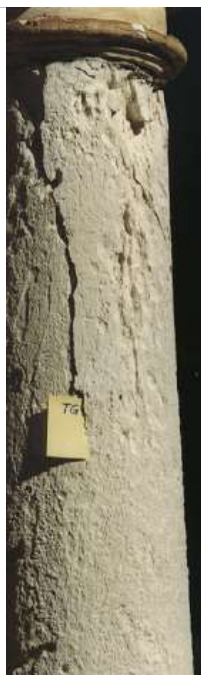
Column of AS before (left) and three years after (right) treatment with ethyl silicate. A significant mass loss was registered as a result of an acceleration of the pre-existing deterioration rate (Celas Monastery, Coimbra, Portugal).

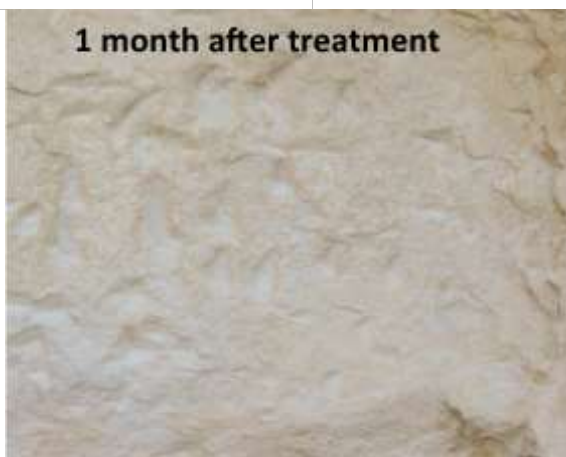
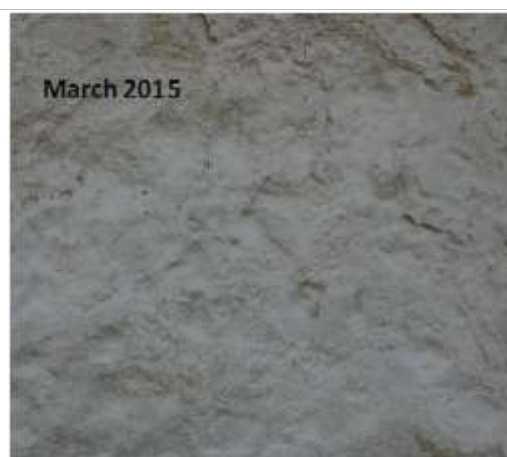
1 month after treatment

March 2015

Surface treated with ethyl silicate, one month and 6.5 years after treatment. The initially stable surface started showing conspicuous scaling affecting the entire surface (Gardens of Queluz Palace, PT)

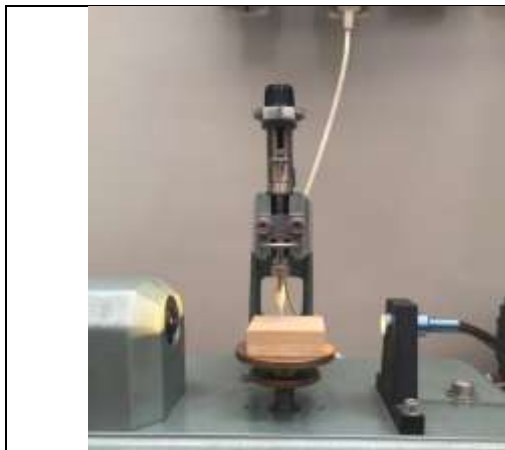
Fig. 9. Apparatus for the measurement of contact angle

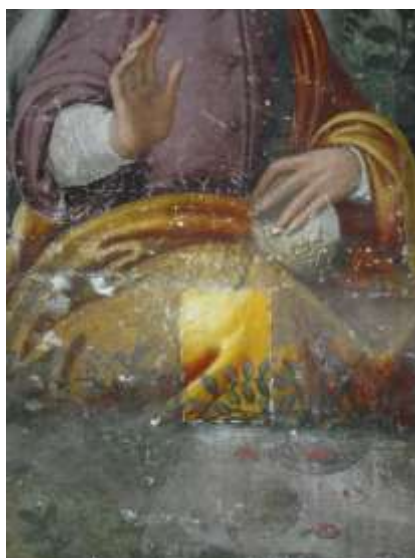
Fig. 15. Cleaning test area with ammonium carbonate

The use of highly acidic or alkaline substances is prohibited even if in the past numerous applications was carried out. Slightly alkaline or acidic substances in a pH range between 5.5 and 8.0 can be used. In this regard, ammonium carbonate and bicarbonate can be used, taking care to ensure that pigments containing copper, such as azurite, malachite, verdigris, are not present (Fig. 15).
