# Effects of anobiid damage on shear strength parallel to the grain in single step joints

**Keywords** Timber · Single Step Joint · Biological degradation · Anobiid infestation · Residual shear strength

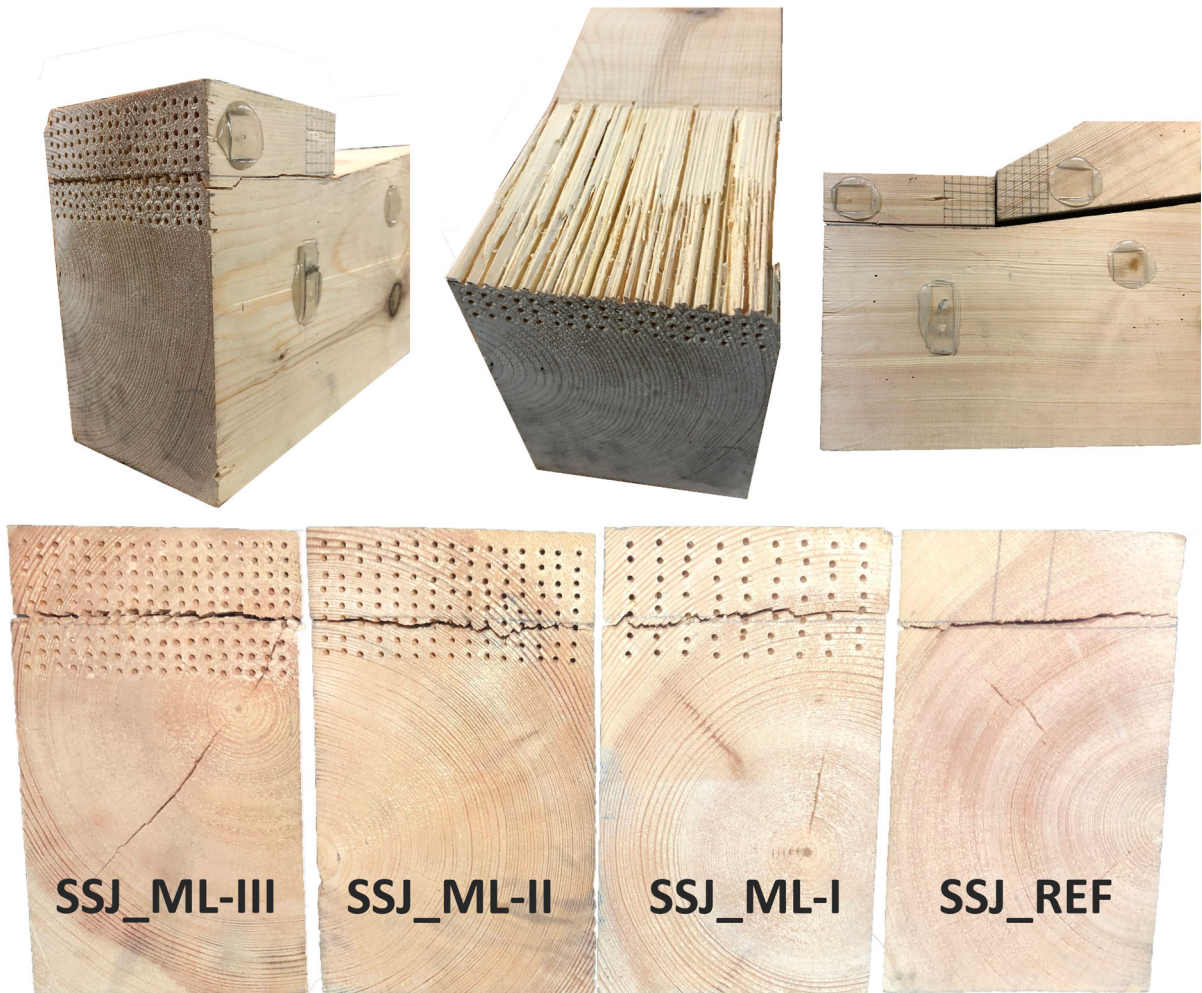
**Fig. 5** Characteristic shear failure on the tie beam-end observed in all Single Step Joints tested under compression

As aforementioned the geometry of the Single Step Joint specimen was defined to induce failure by shear parallel to the grain in the tie beam-end, based on the experimental results obtained by Verbist et al. [10]. Thus, all 40 specimens presented shear failure with no crushing parallel to the grain at the front notch or perpendicular to the grain at the bottom notch (Fig. 5).

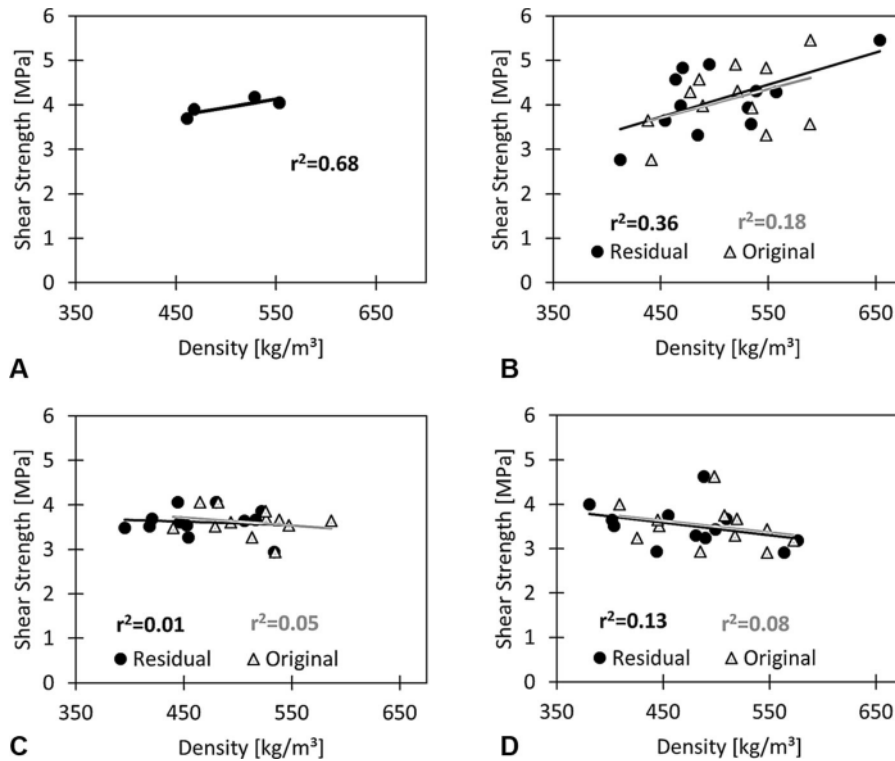
**Fig. 8** Correlations between shear strength and density for each degradation level group. **A** SSJ\_REF; **B** SSJ\_ML-I; **C** SSJ\_ML-II; **D** SSJ\_ML-III

The coefficients of determination ( $r^2$ ) presented agrees with the statement that, for lower levels of degradation, the wood density is still predominant in the behavior of the structure and a positive correlation is obtained, Figs. 8a and b. At more advanced degradation levels, the coefficient of determination decreases, and negative linear regression lines are obtained (Figs. 8c and d), indicating that density is no longer the principal independent variable.

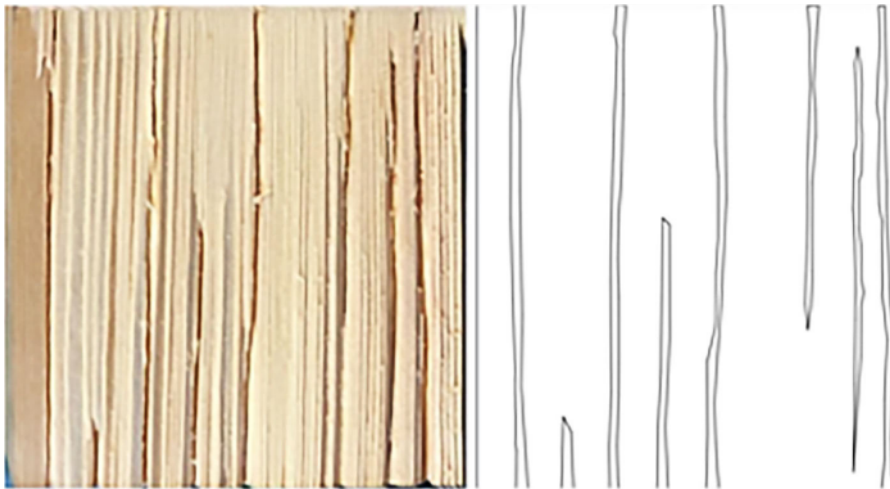
**Fig. 10** Quantification of the resistant area reduction

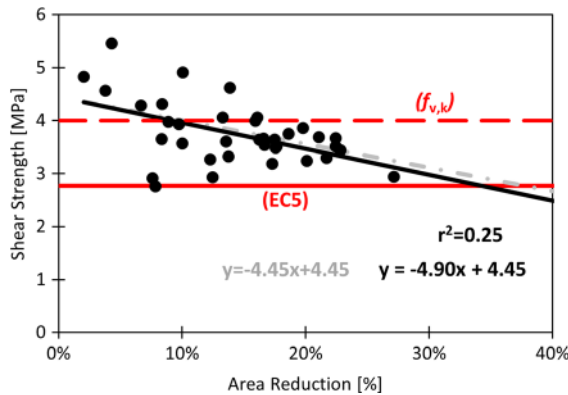
**Fig. 12** Correlation between the shear strength and the reduction of the resistant area, equation of strength reduction according to the reduction of the resistant area, characteristic shear strength (C24 [19]), and design value for the shear strength according to Eurocode 5 [29]

strength of 4.0 MPa [19]. Therefore, the characteristic shear strength ( $f_{v,k} = 4.0$  MPa), and the design strength of 2.8 MPa are represented in Fig. 12.

By the analysis of Fig. 12, it is observed that none of the specimens presented strength below the design value. The results point out that failure can occur for a reduction of the area between 35 and 37%. On the other hand, when considering the characteristic shear strength, some specimens present results lower than 4.0 MPa from 8% of area reduction. Additionally, from 16% of area reduction, all 17 specimens present resistance lower than the characteristic value. Analyzing the Table 1, a 16% of area reduction can correspond to a mass loss around only 6.7%. However, it is necessary to point out that the relatively low

element surface can often lead to more conservative diagnoses and unnecessary replacements. However, the effects on the shear strength becomes evident when comparing the results with the characteristic value for C24 softwood (Fig. 12).
