Article

Characterization and Assessment of Performance of Innovative Lime Mortars for Conservation of Building Heritage: Paimogo's Fort, a Case Study

Citation: Santos, A.R.; Veiga, M.d.R.; Santos Silva, A. Characterization and Assessment of Performance of Innovative Lime Mortars for Conservation of Building Heritage: Paimogo's Fort, a Case Study. *Appl. Sci.* **2023**, *13*, 4679. <https://doi.org/10.3390/app13084679>

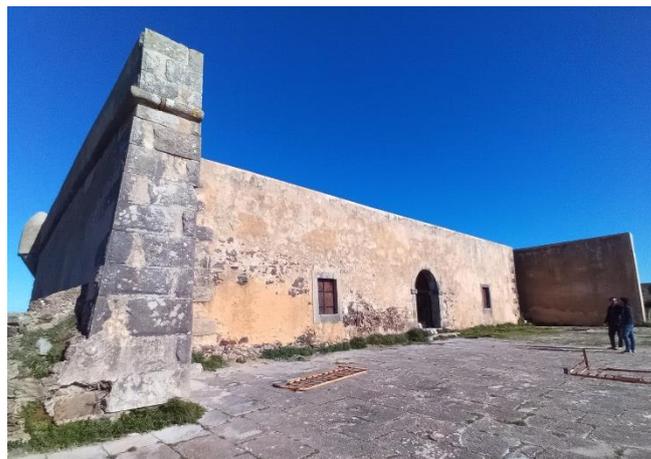
Figure 1. Paimogo's Fort, in 2023.

Located on the cliffs of Paimogo beach, in Lourinhã municipality, Portugal, Paimogo's Fort was classified as a Building of Public Interest since 1957. Designed to defend the north coastline of Lisbon from Cascais to Peniche, it was built in 1674, by decision of the 3rd Count of Cantanhede, and belongs to a large set of fortifications of the 2nd defensive line of Tagus River [1]. This historical construction, which was abandoned after the Liberal Wars (1832–1834), has been subjected to a very aggressive environment due to the proximity of the sea: salty water spray, high humidity, intense sun radiation, thermal shock, and strong winds. Mortar renders, whose main function is the protection of walls, are particularly exposed to such actions that make them especially susceptible to degradation over time (Figure 1).

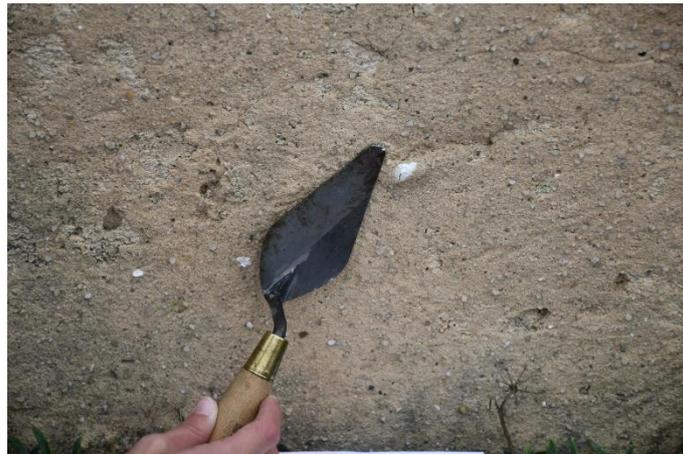
Figure 2. Lime lumps found in the renders of Paimogo's Fort.

Moreover, several lime lumps, measuring a few centimetres, were also found in the renders (Figure 2), suggesting that the lime was not well mixed during the mortar kneading or was prepared by a hot-mixing procedure [35]. Using a lower burning temperature could confer highly reactive lime with good plasticity and workability [36], as well as some physico-mechanical properties to the mixture, that favour the overall compatibility of the system [37].

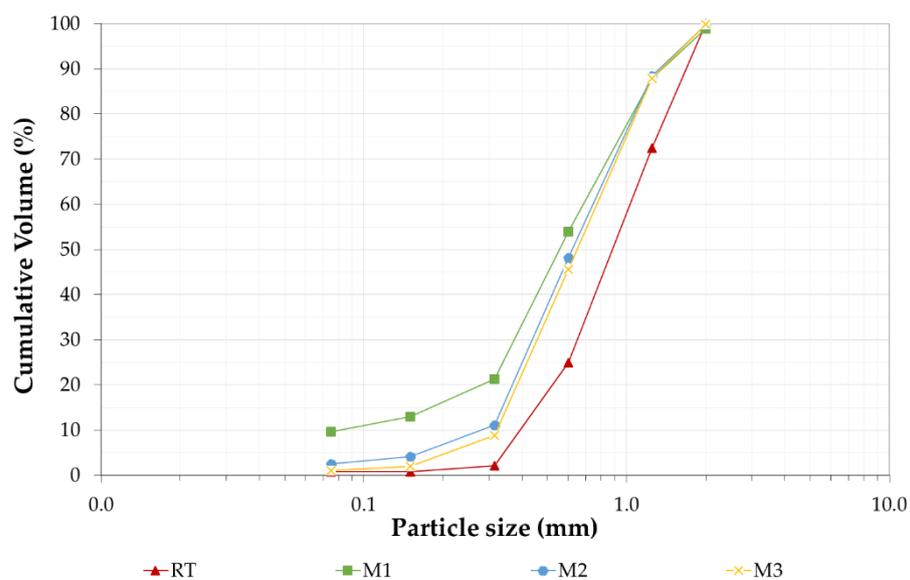
Figure 3. Grain size distributions of the used sands.

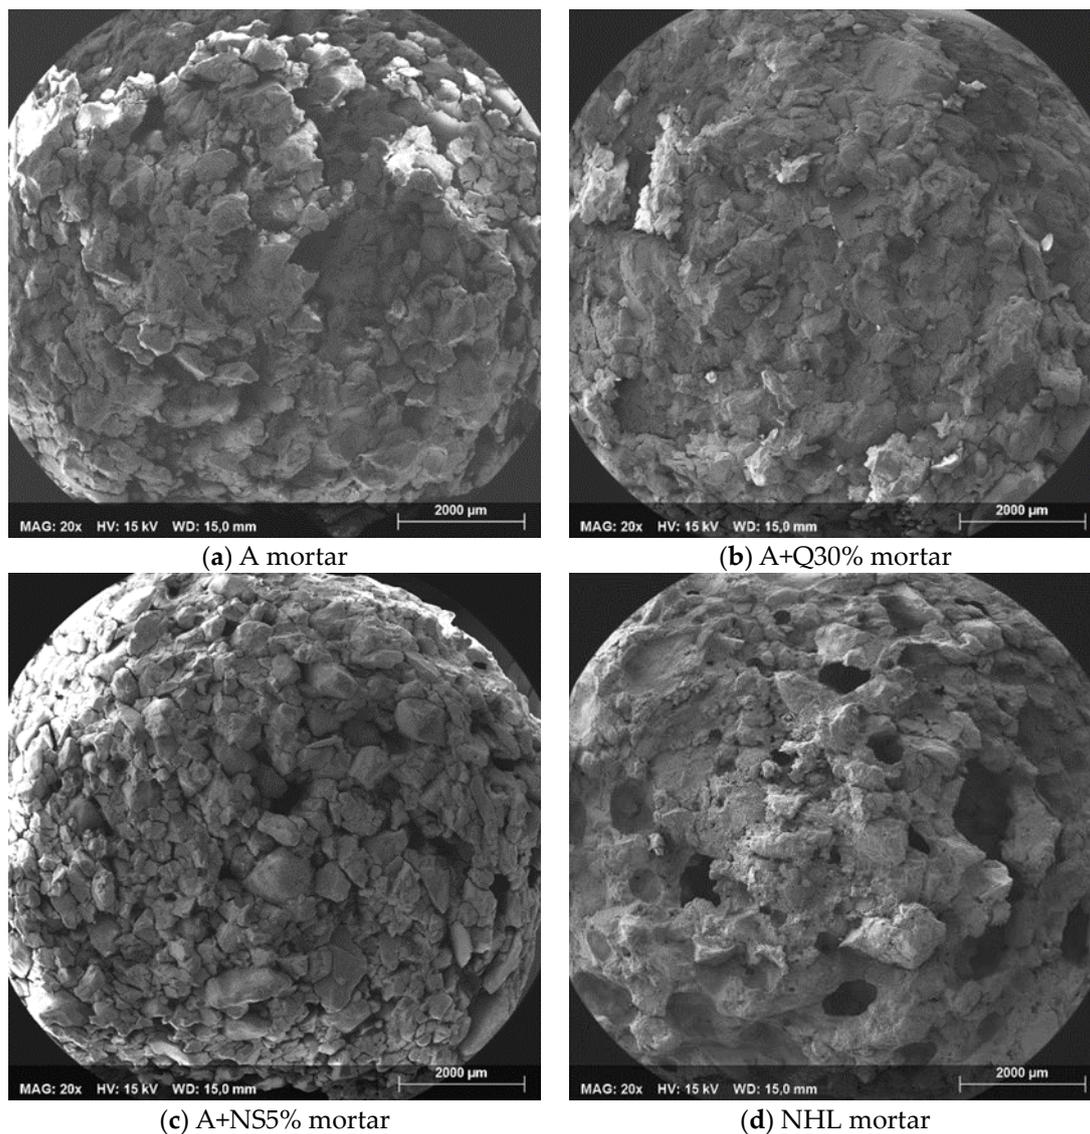
Figure 4. SEM images of the mortars' microstructure at low magnification, with a working distance (WD) of 15.0 mm. It is possible to observe the compact microstructure of the A (slaked air lime) mortar (a) and A+Q30% (slaked air lime with 30% of quicklime) mortar (b); the general microcracking on the A+NS5% (slaked air lime with addition of 5% of nanosilica) mortar is shown (c); as well as the heterogeneous microstructure of the NHL (natural hydraulic lime) mortar with few unconnected sub-rounded macropores (d).

As expected, the density and the porosity of the mortars varies with their compositions (Figure 4): the mortars with the addition of NS (A+NS) showed the lowest values of density and the highest porosity, while the natural hydraulic lime (NHL) mortar showed the opposite behaviour. However, despite the lower value of open porosity, the NHL mortar is characterised by a regular microstructure with heterogeneous unconnected sub-rounded macropores (Figure 4d).

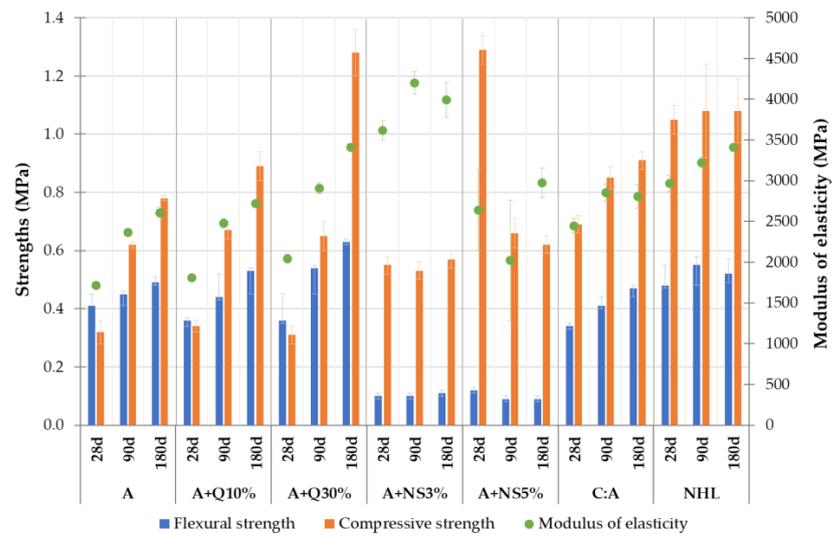
Figure 5. Mechanical properties of the mortars with siliceous sand.

Figure 5 shows the mechanical properties values of the mortars, with different binders with siliceous sand, at 28, 90, and 180 days.

The results presented in Figure 5 indicate that all mortar compositions show relatively low mechanical strengths and moderate values of modulus of elasticity. Nevertheless, the strengths and the modulus of elasticity, in general, increase with the curing age, which is attributed to the progression of the carbonation reaction. However, in A+NS5% mortar, a noticeable increase in the compressive strength values could be observed at early curing times, and then a steep decrease was recorded at longer curing times.

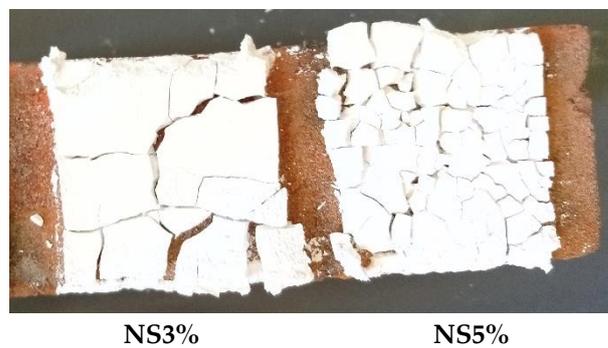
Figure 6. Cracking in lime paste applied on porous brick due to the effect of nanosilica.

Contrary to that observed in other studies with pozzolanic lime mortars [21,26], the additions of NS, namely with 5% wt, lead to a decrease in strength at latter ages as a result of drying shrinkage (Figure 6). This can be due to the pozzolanic reaction that absorbs a significant amount of water, associated with a dry curing, which negatively induces mortars microcracking, as shown in SEM images (Figure 7a), affecting its physical-mechanical properties [22,51].

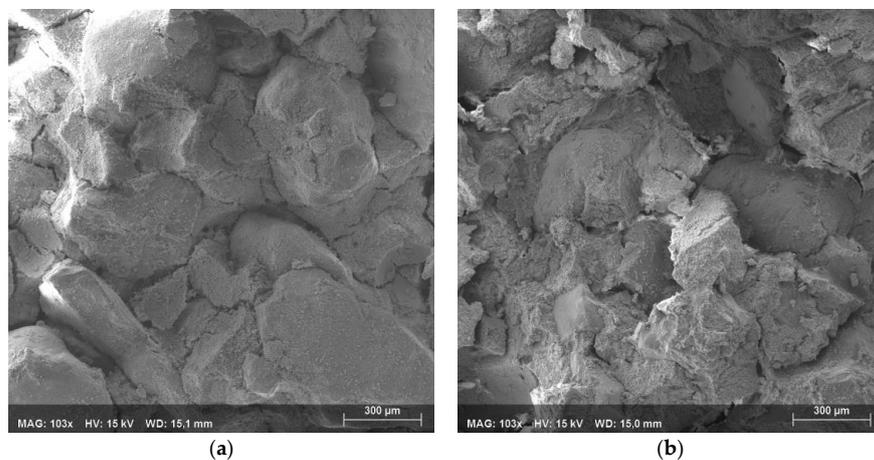
Figure 7. SEM images, at working distance (WD) of 15.0 mm, where it is possible to observe (a) the microcracking on the NS mortar; (b) compact microstructure of the A+Q30% mortar.

Mortar A is the most deformable; however, it has compressive strength values of the same order of magnitude as A+Q and A+NS mortars. Furthermore, if a small amount of cement is added (25%, in volume), the compressive strength of the mortars increases; however, the flexural strength is similar to that of lime mortar (A). The highest mechanical behaviour was obtained with the NHL mortar, and its strength is achieved at earlier ages compared to the air lime mortars. However, from 90 to 180 days, the A+Q30% mortar displays a significant evolution compared to other mortars compositions. This good behaviour of the A+Q30% mortar may confirm the literature argument [18] that quicklime absorbs the excess water from mixing in air lime mortars, thus reducing the drying shrinkage and consequently the microcracking during the drying process (Figure 7b), thus increasing the mechanical strength.

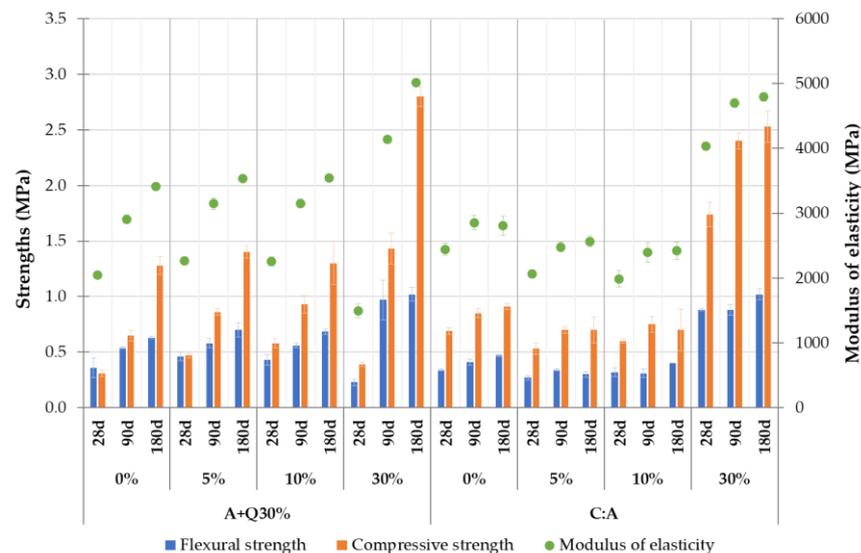
Figure 8. Mechanical properties of the A+Q30% and C:A mortars with substituting part of the siliceous sand by limestone aggregate.

In what concerns the mechanical performances of the prismatic specimens with substitution of part of the siliceous sand by limestone aggregate (Figure 8), it is observed that the substitution is beneficial to the A+Q mortars; however, for the C:A mortar, the incremental improvement of the mechanical performance is only observed with 30% of sand substitution. As seen in previous studies [52,53], lime mortars prepared with limestone aggregate showed an increase in their mechanical strengths due to the crystallographic continuity between the limestone aggregate and the lime matrix [52].

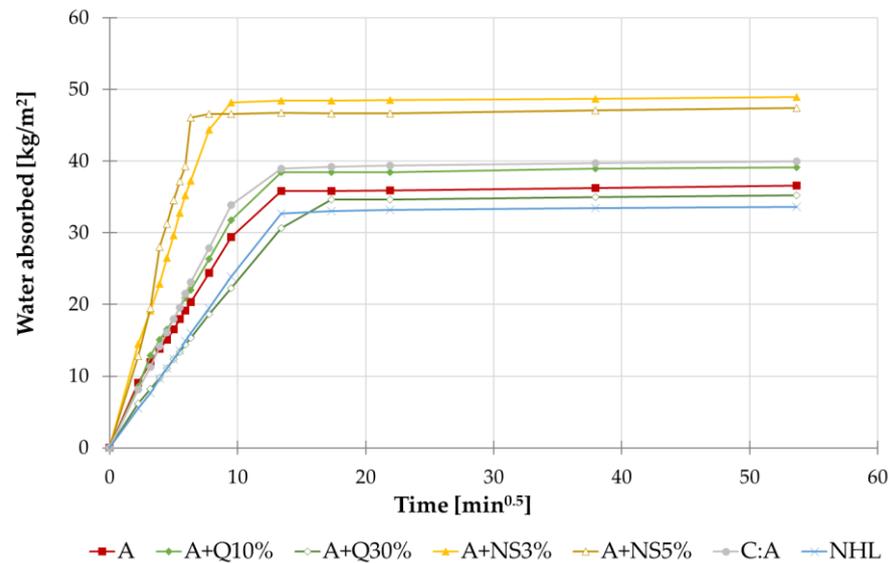
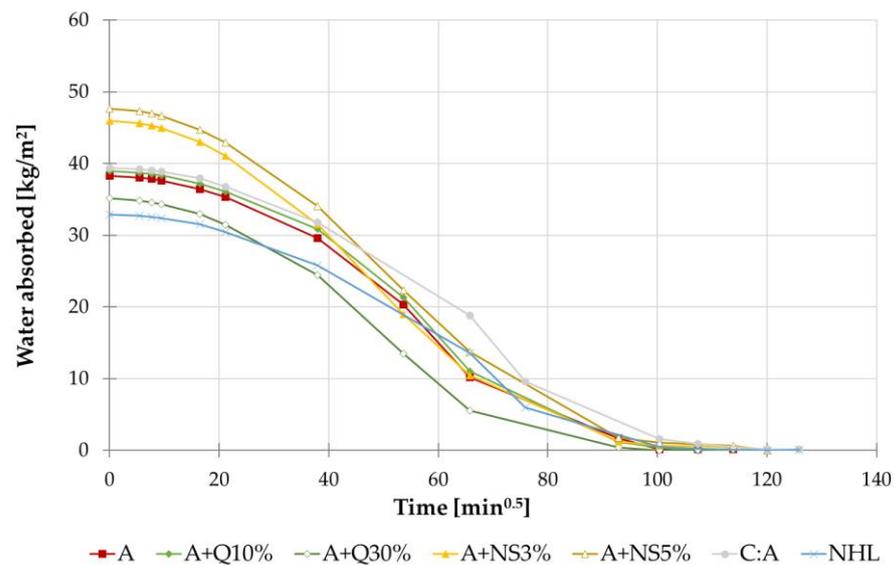
Figure 9. Capillary water absorption curves of the mortars with siliceous sand at 90 days: (a) water absorption; (b) water desorption.

As shown in Table 5 and Figure 9, it is possible to observe that all mortar compositions have a high rate of water absorption in comparison with the results obtained in the original mortars of the Fort (capillary water absorption coefficient between 0.4 and 1.7 kg/m²·min^{1/2} [6]), which can make them more vulnerable to degradation. Nevertheless, in some mortar compositions, the capillary water absorption coefficient tends to decrease with the curing time due to the progression of carbonation.

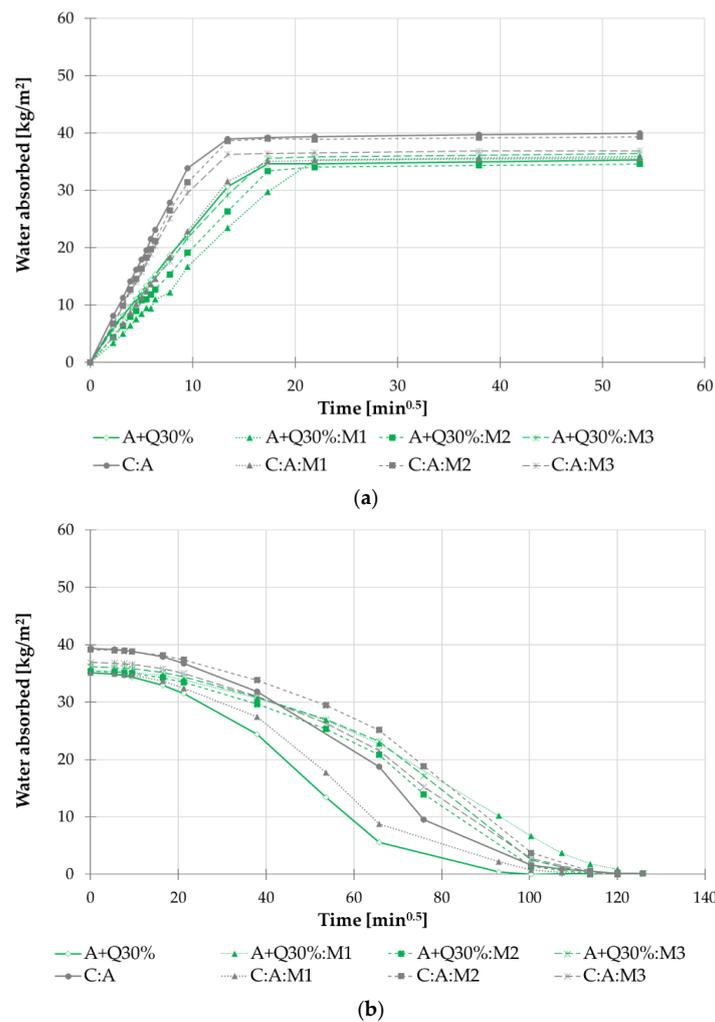
Figure 10. Capillary water absorption curves of the mortars with fine-tuning of the aggregate, at 90 days: (a) water absorption; (b) water desorption.

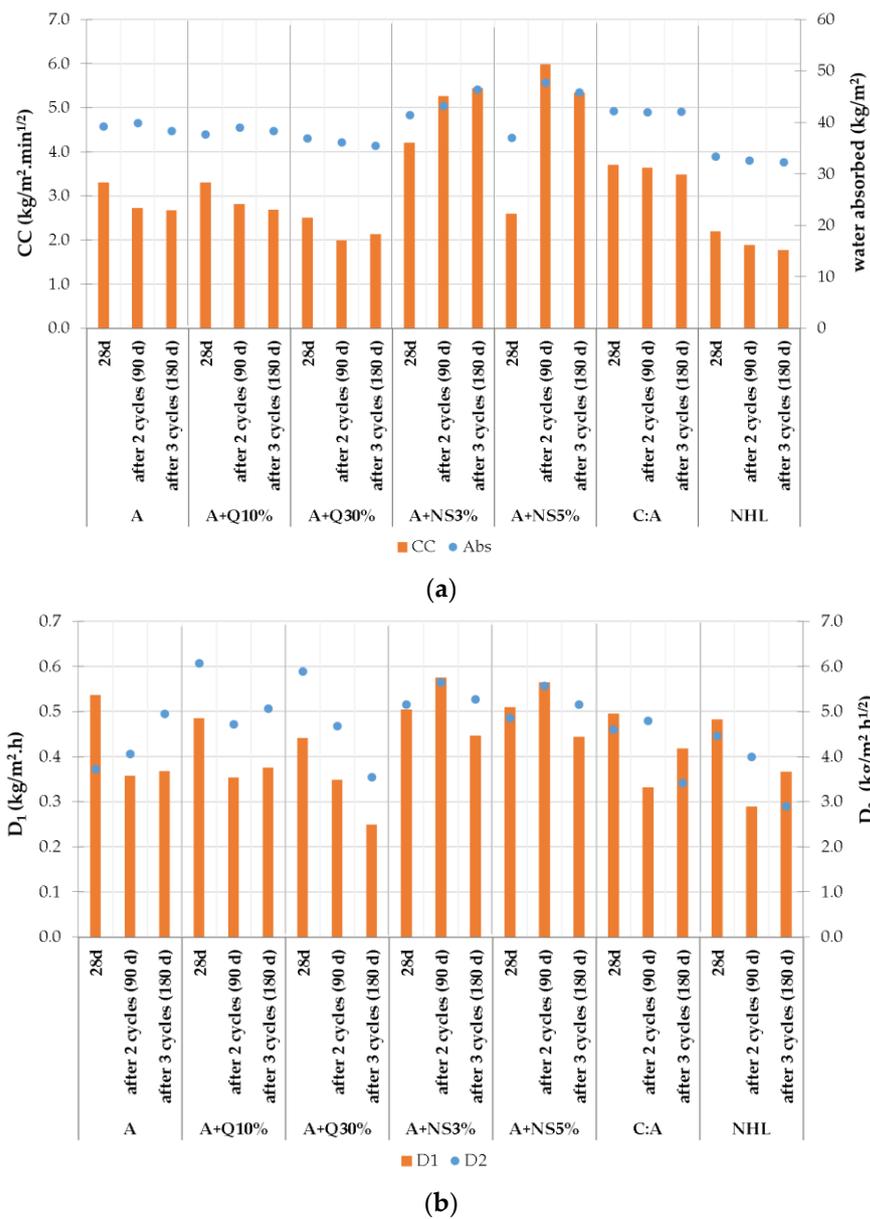
Figure 11. Hydric properties of the mortars with siliceous sand, after cycles of the water absorption: (a) water absorption; (b) water desorption.

For the drying cycles, this trend is not so clear; however, except for the A+Q30% and A+NS mortars, after the 2nd cycle, all mortars tend to have an increase in their first drying rate (D_1). This behaviour could be ascribed to the transformation of portlandite into calcium carbonate fulfilling the largest pores which, in general, increase the volume in the capillary porosity range, with a reduction in the main pore diameters [53].

The different behaviour of the mortars with NS is consistent with the previous mechanical and physical results. In fact, this performance can be attributed to the microcracking on the aggregate/binder interface, associated to shrinkage strains (Figure 7a), which leads to a coarsening of pore diameters [55,56]. Moreover, in the presence of water, the specimens with nanosilica became so fragile that they were broken during the measurements.

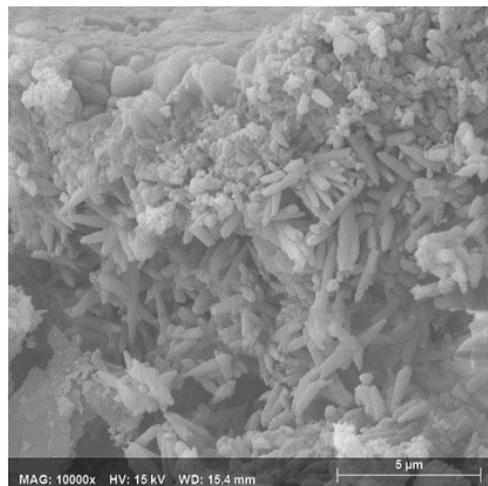
Figure 12. SEM image at high magnification (MAG: 10,000x), with a working distance (WD) of 15.4 mm, at A mortar surface where it is possible to observe the presence of different calcium carbonate crystals, some with an acicular shape attributed to phenomena of dissolution and reprecipitation of the carbonated binder.

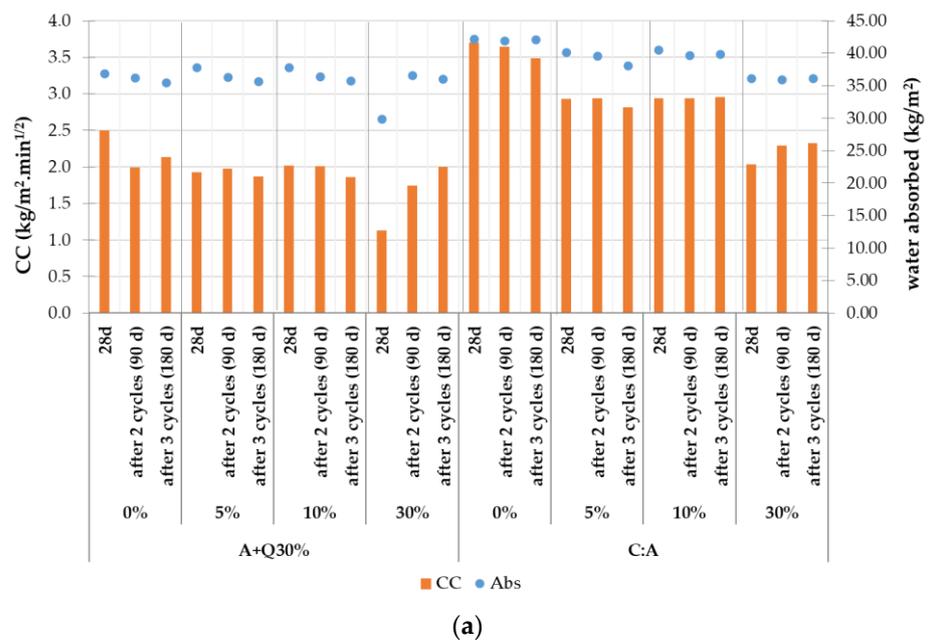
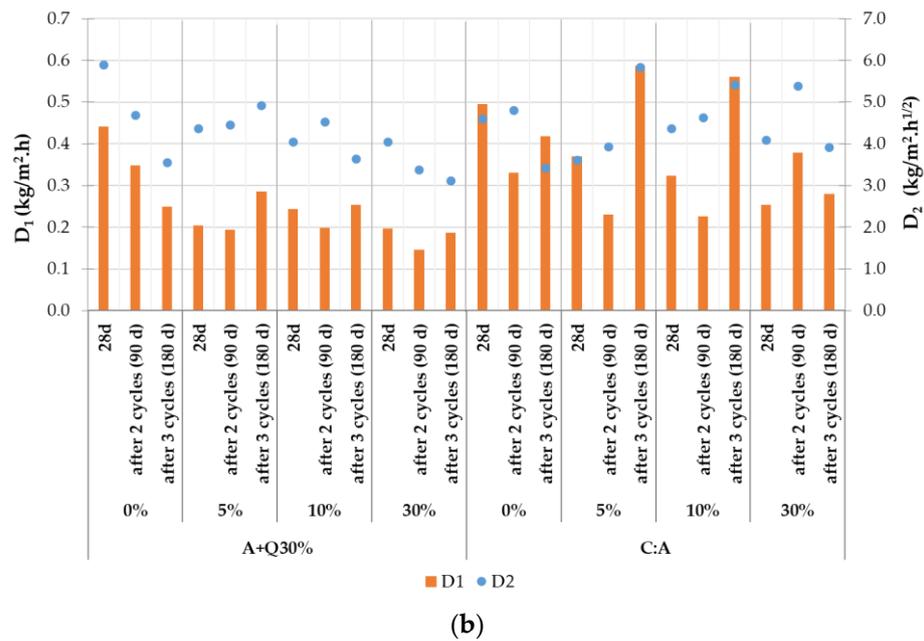
Figure 13. Hydric properties of the mortars with fine-tuning of the aggregate, after cycles of the water absorption: (a) water absorption; (b) water desorption.

Considering the use of limestone aggregate (Figure 13), as reported before, in general, the rate of water absorption of the two types of mortar decreases and the drying occurs slower. Furthermore, except for the sand substitution of 30% (M_1), the number of cycles improves the mortar performances with a reduction in the rate of absorption and of the total water absorption. However, there is a decrease in the water flow, and consequently a decrease in D_1 , and thus the values of D_2 increase from the first to the second cycle, which represents the reduction in liquid water transport and progressive increase in water vapour diffusion, probably due to the volume decrease in large capillary pores owing to the carbonation process (Figure 14).

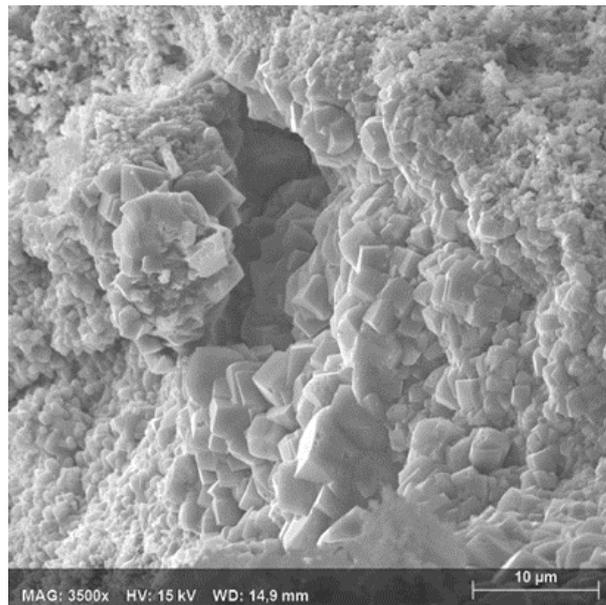
Figure 14. SEM image with a magnification of the 3500x and a working distance (WD) of 14.9 mm at A+Q30%:M₂ mortar where it is possible to observe the large capillary pores filled by carbonate crystals after cycles.

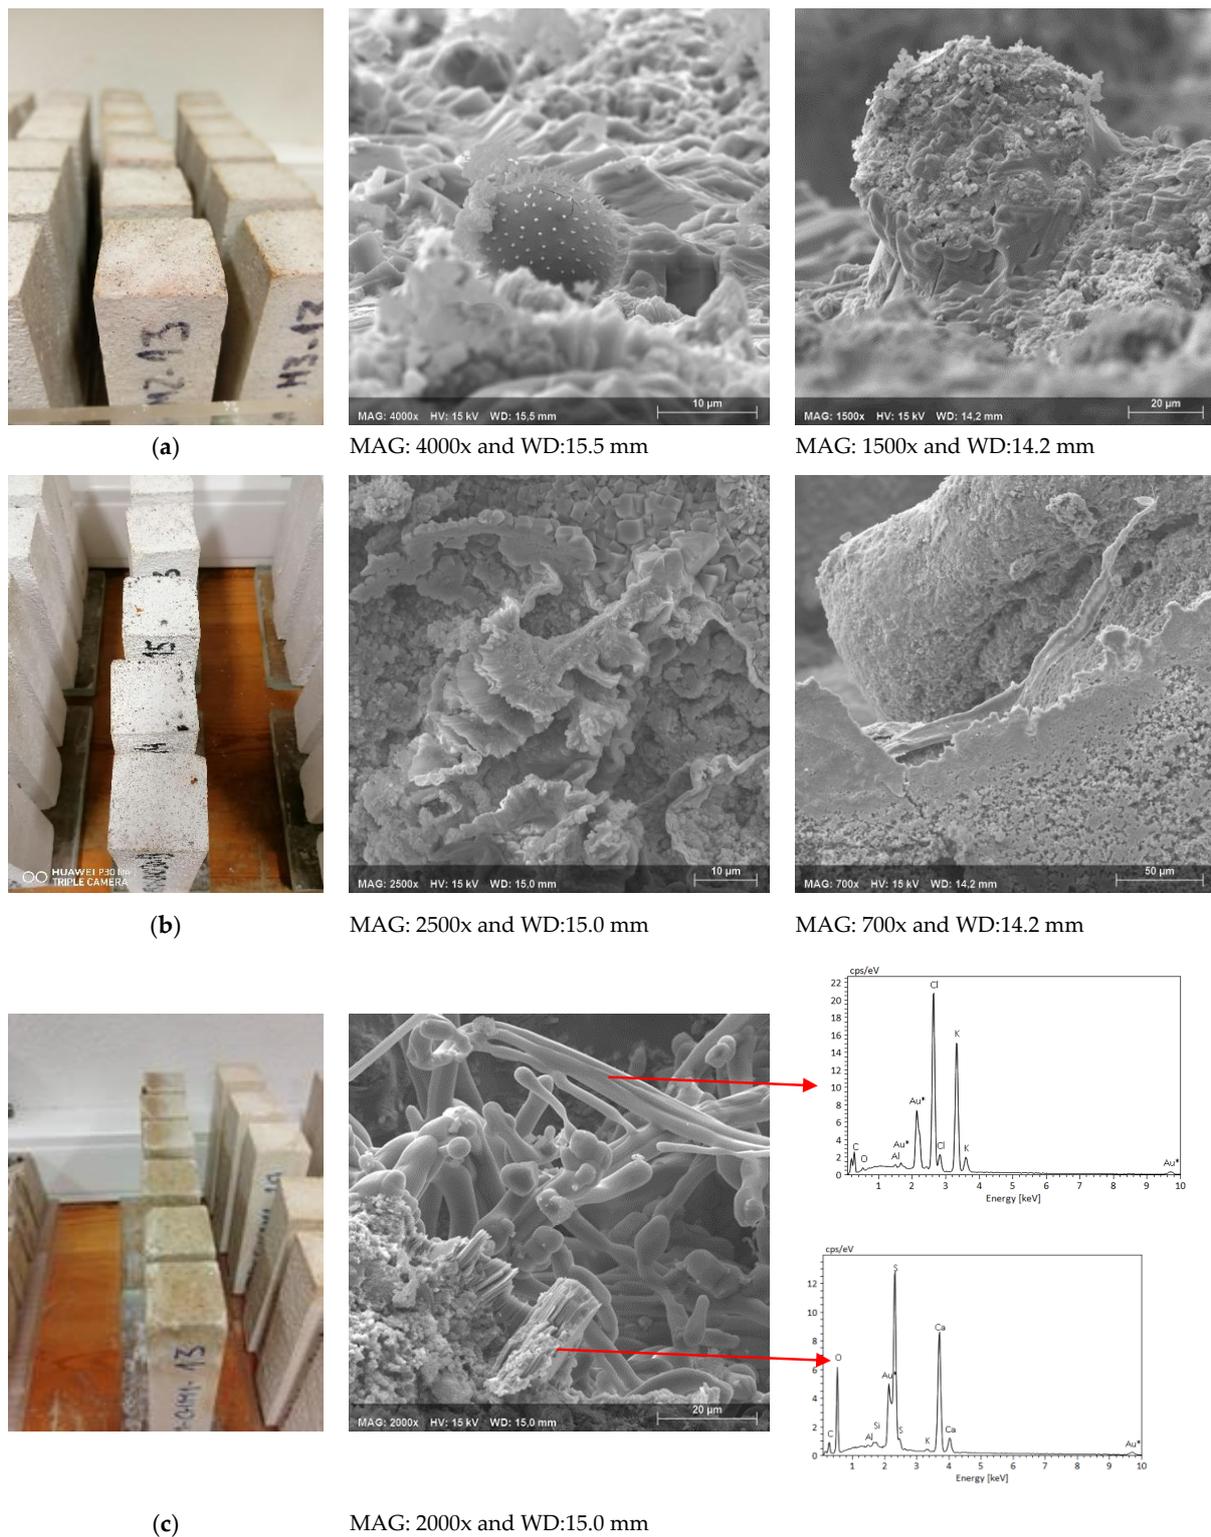
Figure 15. Damaging effect of the samples after the cycles: (a) rosy discolouration on the top of the C:A:M₂ and C:A:M₃ specimens and organic elements found at mortar surfaces in SEM observation; (b) black mould growth on the top of the A+Q10% and A+Q30% specimens and organic compounds found at mortar surfaces in SEM observation; (c) presence of salt efflorescences in the NHL specimens at SEM observation and EDS spectra, where the chemical element gold (Au*) is detected due to necessary recovering of the samples for the SEM analysis.

The visual assessment of mortars reveals that during the second cycle of water absorption, a pink colouration appears on the C:A:M₂ and C:A:M₃ mortar specimens (Figure 15a), probably due to the presence of microbiological contamination, able to produce coloured compounds such as *Rhodotorula S.P.* or those closely related, which could lead to a biodeterioration of the mortars [57,58].

Furthermore, after the 3rd cycle, during the drying stage, mortars with quicklime (A+Q10% and A+Q30%) present black mould growth on the top of specimens (Figure 15b), while on the hydraulic mortars (C:A, C:A:Mi, and NHL), salt efflorescence occurs (sulphate and chloride) on the drying surface of the specimens (Figure 15c).
