# Ultrasonic Pulse Velocity Testing for Monitoring the Degradation of Infill Masonry Walls and Access Their Impact on the Durability of the Envelope of Buildings with Reinforced Concrete Structure

JOSÉ MIRANDA DIAS  
Department of Buildings,  
National Laboratory of Civil Engineering (LNEC),  
Av. do Brasil 101, Lisboa,  
PORTUGAL

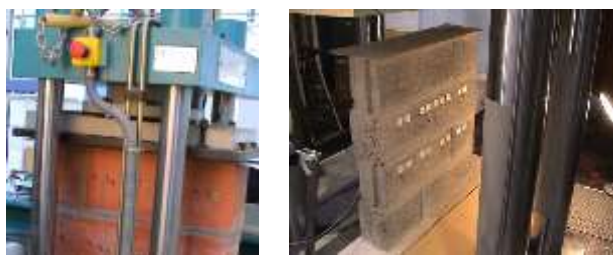
a) Specimen A1 (perforated ceramic blocks)  
 b) Specimen A2 (massive concrete blocks of expanded clay aggregates)

Fig. 3: General view of compression test of masonry specimens (view of the face A of the specimens)

UPV tests were made on masonry specimens subjected to axial compression, aiming to assess, in a laboratory-controlled setting, the advantages and limitations of their use for detection of sub-surface and surface cracking in URM infill of buildings, [5]. Two specimens were tested: Specimen A1 made of vertically perforated ceramic blocks (Figure 1); Specimen A2 made of massive concrete blocks of expanded clay aggregates (Figure 2). These two masonry specimens were subjected to axial compression, until they reached a state of significant cracking, but without reaching a global collapse. Due to the different dimensions of Specimen A1 and Specimen A2, the tests were made in two different compression press machines, which were, for each of the specimens, considered more suitable (Figure 3, Figure 4, Figure 6 and Figure 8).

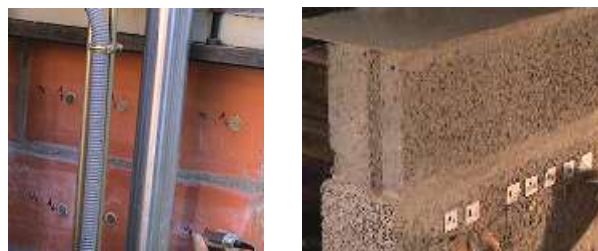
a) Specimen A1 (perforated ceramic blocks)  
 b) Specimen A2 (massive concrete blocks of expanded clay aggregates)

Fig. 4: UPV testing in the compression test of Specimen A1 and Specimen A2

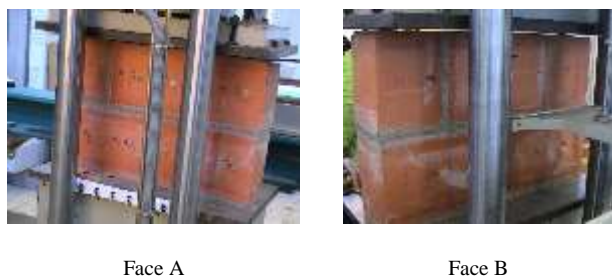
Fig. 6: The phase of preparation of Specimen A1 for the compression test (view of the face A and B of the specimen)

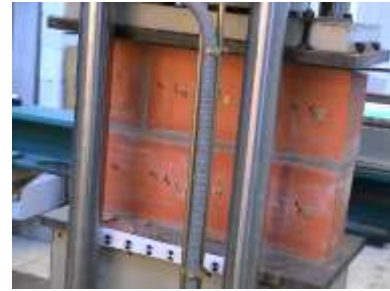
Fig. 9: Aspect of the face A of the Specimen A1 in the compression test, with signs of local fragmentation of the top part of specimen (left side of the specimen)

After reaching the maximum load of 470 kN (Applied vertical stress of 11.59 MPa), with the collapse of the specimen (Figure 9, Figure 10, Figure 11 and Figure 12), the test was halted and the specimen was discharged.

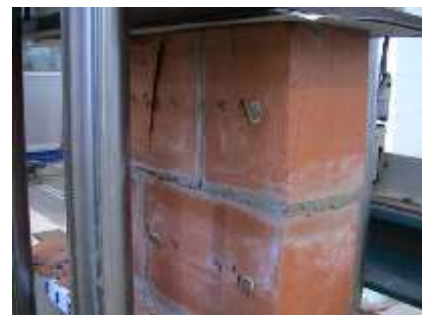
Fig. 10: Aspect of the face A of Specimen A1 at the end of the test after discharge of a load of 470 kN

Figure 14), especially in the left part of face A of the specimen (Figure 10 and Figure 11), with fragmentation of the top of corner zone. The right part of face B of the specimen (Figure 12, Figure 13 and Figure 14) was also severely damaged, with fragmentation of almost the entire corner zone of the specimen and with a near vertical crack of the of the upper brick near the referred corner zone.

The values of ultrasound velocity (direct method), in this phase of load of the Specimen A1 test generally decreased, with the exception of U4-U4' and U6-U6'. That increase was particularly relevant for U1-U1' and U2-U2', which is a sign that extensive surface cracking of the upper left part of the face A of the Specimen was in course which was evident at the end of the test (Figure 10 and Figure 11).

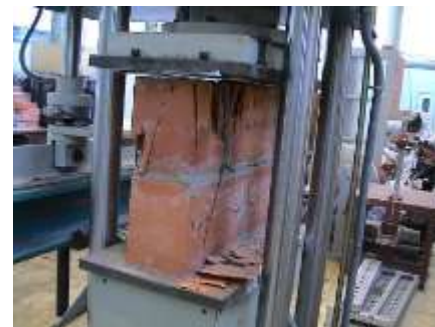
Fig. 11: Aspect of the face A of Specimen A1 at the end of the test with the collapse of the specimen

The values of mean ultrasound velocity in the face A (indirect method), namely the reading from U1 to U5, for the load of 400 kN, showed a considerable decrease in relation to the previous reading (for 300 kN of load). The exception was U1-U4 and U6-U8 readings, which had an increase of mean US velocity. That agrees with the findings of the direct method, that extensive surface cracking of the specimen was in course, especially in the upper left part of the face A of the Specimen. At the end of the test, the situation of extensive surface cracking of the upper left part of face A of Specimen A1 was fully revealed (Figure 11).

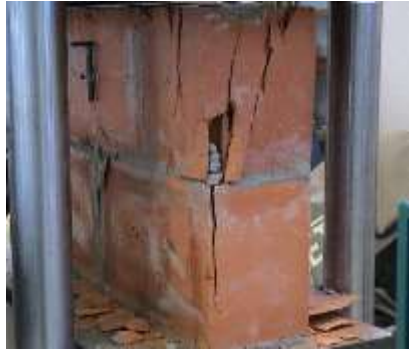
Fig. 12: Aspect of the face B of Specimen A1 at the end of the test

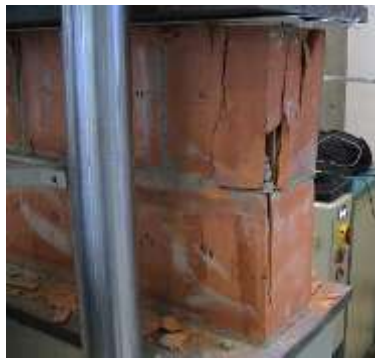
Fig. 13: Aspect of the face B of Specimen A1 at the end of the test

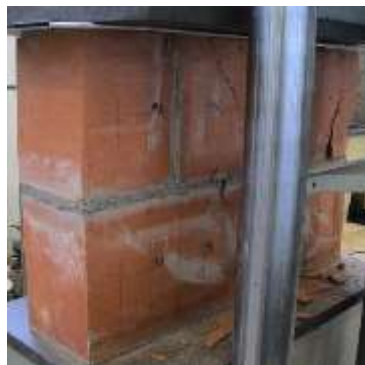
Fig. 14: Aspect of the face B of Specimen A1 at the end of the test

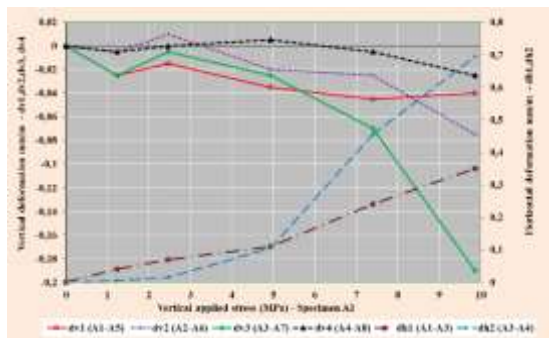
Fig. 18: Results of deformations measurements in the compression test of Specimen A1, for increasing levels of vertical applied stress - vertical deformations (dv1, dv2, dv3, dv4) in the left vertical axis; horizontal deformations (dh1, dh2) in the right vertical axis

The results of the measurement of deformations in Specimen A1 show that, after the initial phase of the test (initial phase between 0 and 50 kN) until a load of near 300 kN, the overall variation of horizontal and vertical deformations corresponded, respectively, to a gradual horizontal expansion and vertical contraction of the specimen. These measured deformations are presented in Figure 18 and Figure 19. These variations of the vertical and horizontal measured deformations during the test of Specimen A1 are relevant to help in the analysis of the UPV testing results, and their detailed analysis is developed in the following sub-chapters 7.1 to 7.3.

In this phase of load between load zero and 100 kN (2.47MPa), the vertical and horizontal deformations did not reveal an appreciable change of values (Figure 18 and Figure 19), and no significant signs of visible surface cracking were detected. The variation of the vertical deformations (dv1, dv2, dv3, and dv4), in the test of Specimen A1, show an initial phase of slight contraction of the specimen, from load zero to 50 kN (1.23 MPa), with increasing negative moderate values (Figure 18). That was followed by a vertical expansion, from 50 kN (1.23 MPa) to 100 kN (2.47 MPa), with a reduction of the negative values (expansion) and a positive value being reached for 100 kN of load (Figure 18), in the particular case of dv2 measurement (left side of face A, in the upper course of bricks).

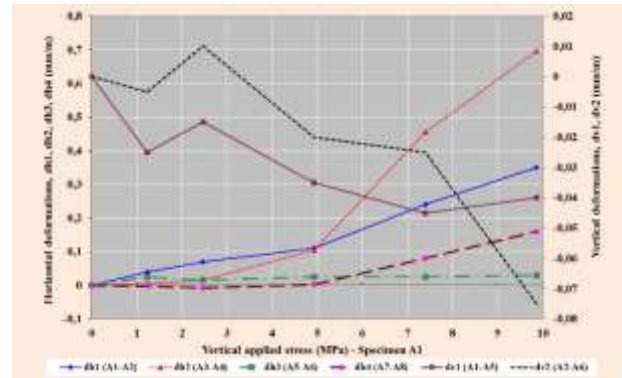
Fig. 19: Results of deformations measurements in the compression test of Specimen A1, for increasing levels of vertical applied stress - horizontal deformations (dh1, dh2, dh3, dh4) in the left vertical axis; vertical deformations (dv1, dv2) in the right vertical axis

For this range of load between 100 kN and 300 kN, horizontal deformations in the upper and lower course, (Figure 19), show increase positive values (expansion), although especially moderate in case of lower course when compared with that of upper course, which suggests that micro sub-surface cracking in the face A of the Specimen was growing. That micro sub-surface cracking could be spreading in the face A, especially in the upper course, although still not very relevant and not clearly visible.

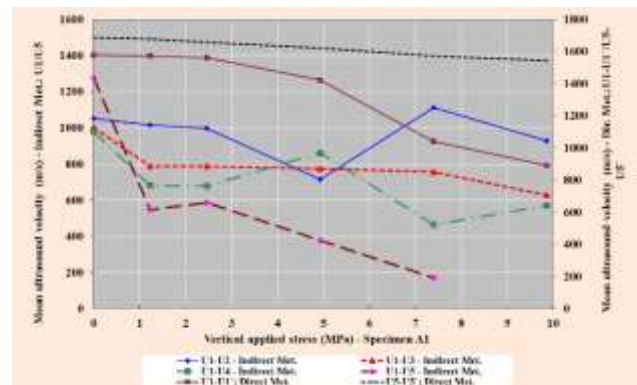
Fig. 24: Ultrasound velocity (indirect method: U1/U5 and direct method: U1-U1, U5-U5) in the compression test of Specimen A1

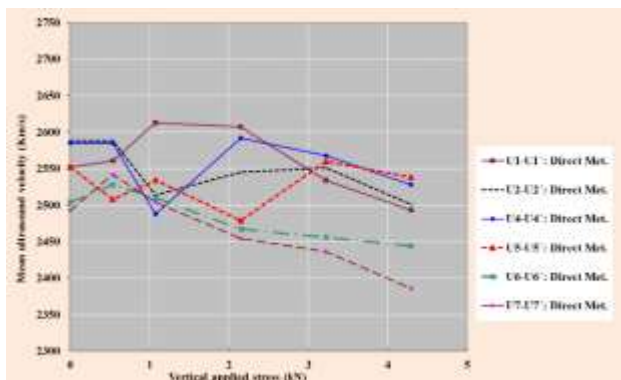
Fig. 35: Ultrasound velocity (direct method) for increasing levels of vertical applied stress in the compression test of Specimen A2

The UPV testing results in this phase of the test of Specimen A2 reveal an acceptable correlation between mean time and the distance of measurement in the upper course, U1 to U5, for the readings made before the start of the test (0 kN of load - Figure 32a); in first load step of 50 kN (Figure 32b); and the load step of 100 kN (Figure 32c), indicating a constant decrease of ultrasound velocity. The correspondent correlation for the lower course, U6 to U9, was also acceptable (Figure 33). With respect to the results of UPV testing in this phase of the load until the step load of 100 kN (1.07 MPa), there was not a clear tendency for the evolution of ultrasound velocity in the readings of the direct method and indirect method (Figure 34, Figure 35, Figure 36 and Figure 37).

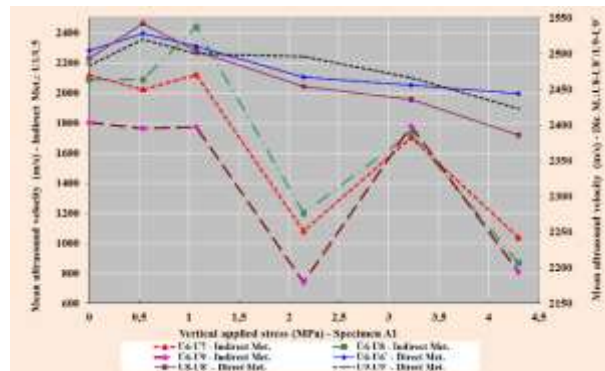
Fig. 37: Mean ultrasound velocity (indirect method: U6/U9 and direct method: U6-U6, U8-U8 U9-U9 ) in the compression test of Specimen A2

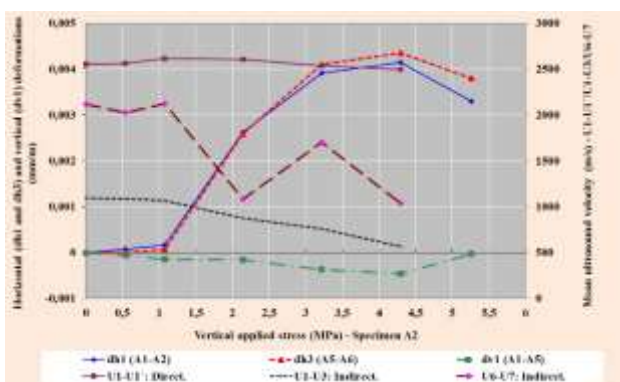
Fig. 43: Results of deformations measurements in the compression test of Specimen A2, for increasing levels of vertical applied stress - horizontal (dh1, dh2) and vertical (dv1) deformations in the left vertical axis; Mean ultrasound velocity (indirect method: U1/U3, U6-U7 and direct method: U1-U1) in the right vertical axis
