# Decay of historic azulejos in Portugal: an assessment of research needs

*SUMMARY: LNEC's next quadrennial research programme is being prepared and one of the new research themes will be centred on the conservation of historic glazed ceramic tiles. Since one of the aims of this seminar is to identify research needs in the field, we present in this paper an overview of a recent investigation that included on-site observations, laboratory work, and numerical simulations. That investigation is the subject of this paper and aimed at identifying research needs and establishing research goals on major issues related to the decay mechanisms of azulejo panels, as well as paths to be pursued towards a scientifically-based approach to their conservation.*

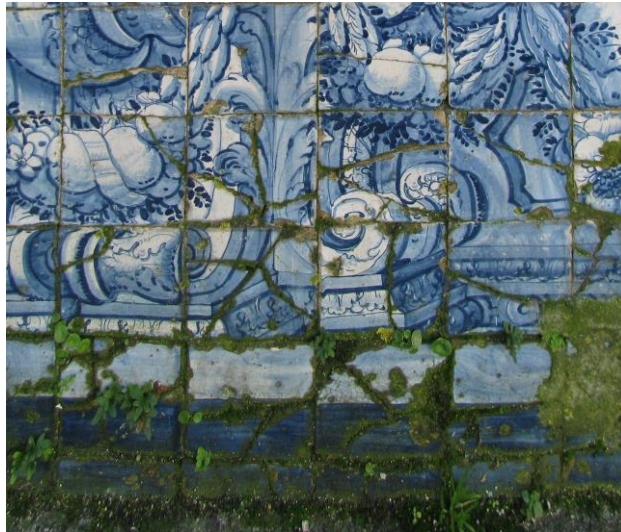
**Figure 1-** Decaying panel in a now exposed area (Oporto Cathedral, upper cloister gallery)

A first impression one gets from on-site inspections is that azulejo panels are very durable. Indeed, only a few cases show widespread decay. However, it must be borne in mind that panels made from tiles that were, so to say, factory-flawed, must have decayed away and been replaced long ago, particularly when exposed to aggressive conditions. Thus, what we find today are those that are either in a dry environment, or else have proved themselves in a real-life long-term durability test much beyond our laboratory simulations. However, when conditions change and moisture intrudes, azulejo panels that seemed durable enough may actually decay fast, apparently even in the absence of salts, as happened at the Oporto Cathedral (figure 1) when a cover that once protected the upper level of the cloister was removed, exposing the azulejo panels to conditions from which they had previously been protected.

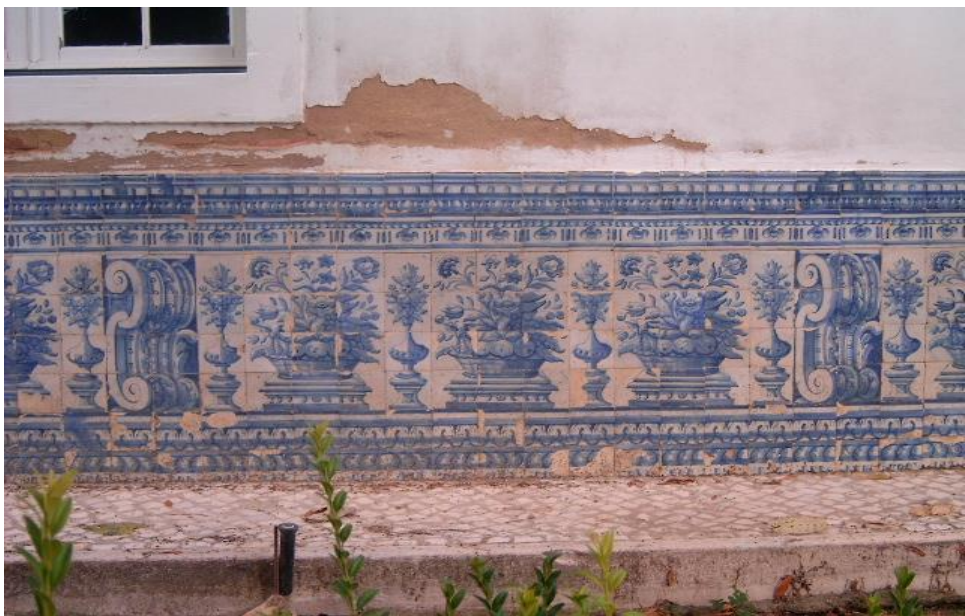
A typical example of the results of an unfavourable external exposure may be seen at Casa dos Patudos in Alpiarça. Figure 2 shows peeling of the paint above one of its external azulejo panels. This is a pattern characteristic of capillary rise from the ground, leading to salt crystallization above the panel, which is little permeable to water vapour. A closer inspection shows that some of the tiles are also affected and that their glaze is scaling off.

**Figure 2-** Salt crystallization above a street azulejo panel at Casa dos Patudos (photo by Manuel Anastácio, Wikimedia)

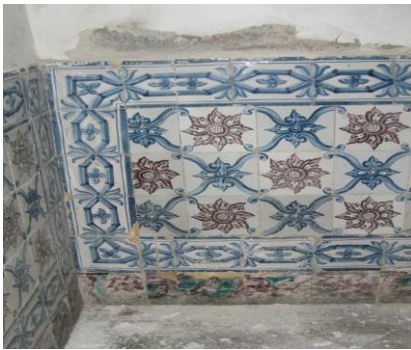
But interior panels may be equally at risk, particularly when water with dissolved salts ascends in the wall. Figure 3 illustrates a case at the Old University of Coimbra. Again, the paint is peeling above the azulejo panel (3a) but in this case the glaze of the tiles is cracked, offering an alternative way out for the moisture, and the fissures of each azulejo are highlighted by efflorescence (3b).

**Figure 3a-** Interior azulejo panel (Coimbra)

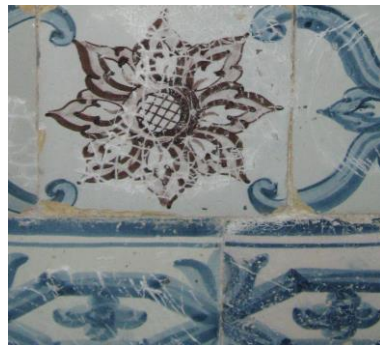
**Figure 3b-** Efflorescence at the same panel

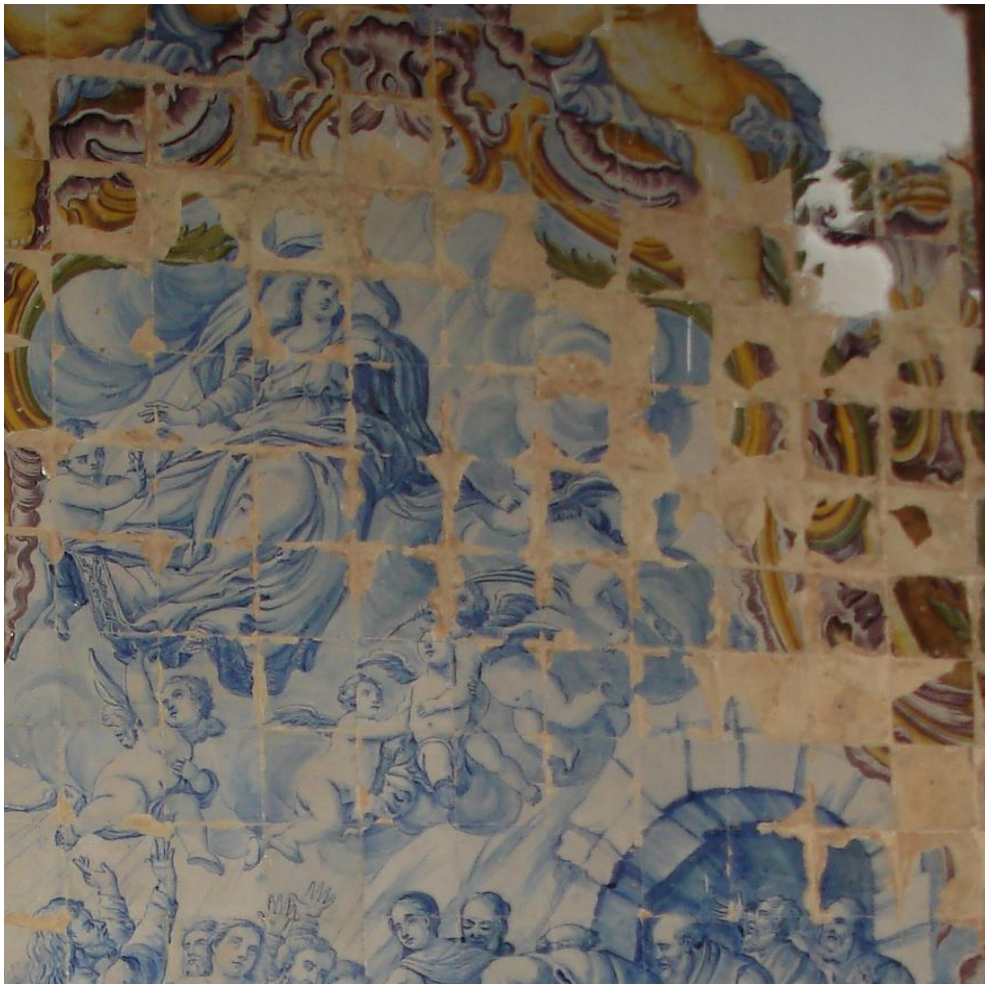
A case that illustrates plainly the full consequences of moisture in walls is to be seen at the Church of the Convent of Jesus in Setubal, Portugal. Figure 4 shows one of the XVIII century panels inside the Church.

**Figure 4-** Generalized decay at the wet zone of an interior panel (Church of Jesus, Setubal)

The wall is moist at the top of the panel and paint peeling is again apparent in some areas suggesting that salt crystallization is active. The photo shows that decay propagates from the edges and corners of the affected tiles. However, it does not attack all tiles equally and, in fact, some individual azulejos are free from decay, at least at a macroscopic level. In other cases, decay affects only three edges of an individual tile, but not the fourth, suggesting that it starts at weak points that may be absent from some tile edges. Finally it was noticed, in this and in other cases, that tiles are often affected by the pair whenever decay progressed from edges (figure 5), or by three or foursome when decay progressed from corners (figure 6).

Returning now to the decaying panel of figure 4, it is not possible, based on the available information, to state why decay started in each individual tile. As decay propagated, the original evidence was progressively erased. But even for the azulejos where decay is macroscopically beginning, a sound diagnosis would require a set method, not yet established, which takes us back to the theme of the present research needs.

From the cases known, we may hypothesize that decay always starts at a critical point: a defect, albeit microscopic, where water finds an easier penetration path into the interface beneath the glaze. Whenever the joint is, so to say, “sealed”, the decay process starts much later, accounting for the different performance of individual tiles in the same decayed panel. Indeed, as the scale is reduced, weak points will always be apparent, but some are critical in the sense that they present an immediate danger in the existing environment, while some are not.

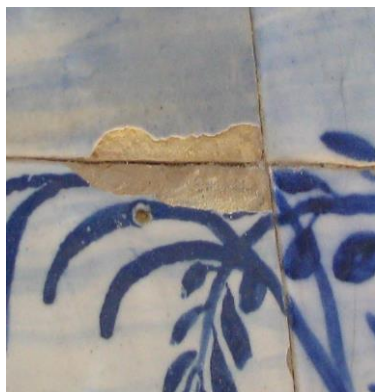
**Figure 5** - Decay progressing from edges

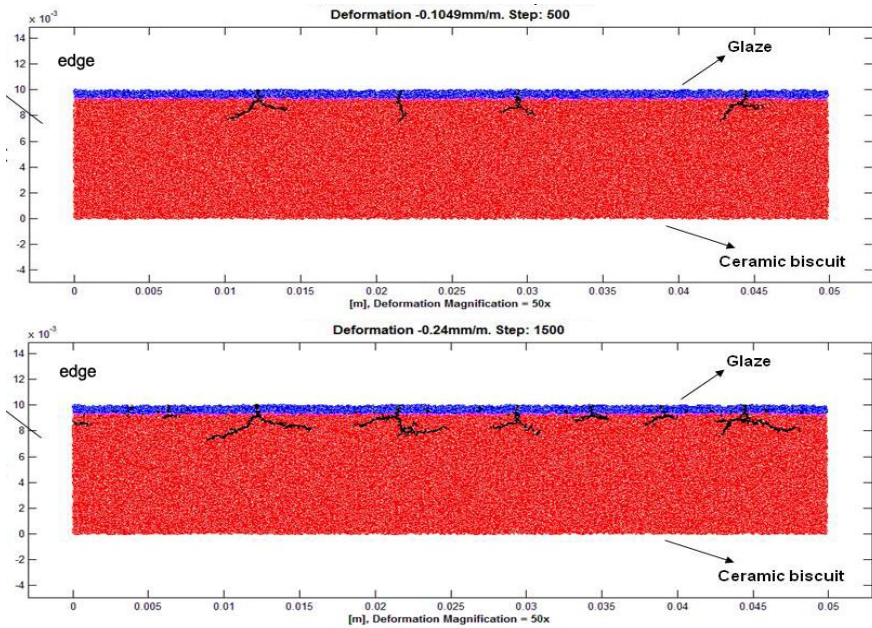
We have simulated azulejo crazing with a numerical model based on a Delft lattice [13] on a Matlab environment. Figure 11 illustrates two steps of the evolving process when the bound between the glaze and the biscuit is considerably stronger than the cohesion of the biscuit itself. In this case the larger vertical cracks may propagate more or less extensively into the biscuit.

**Figure 11** - Two steps of the graphic result of a numerical model of cooling tile crazing with a strong glaze/biscuit bound

Cracking patterns that resemble those obtained by numerical simulation (figures 11 and 12) were indeed found in actual azulejos. Figure 13 shows a XVII century azulejo where the glaze cracking propagated into the biscuit, while fig. 14 shows a case of the same vintage where the crazing crack propagated mostly in the glaze/biscuit interface. In extreme cases of this last instance, the glaze will form “islands” that are only bound to the biscuit at their central part, and eventually fall-off in patches.

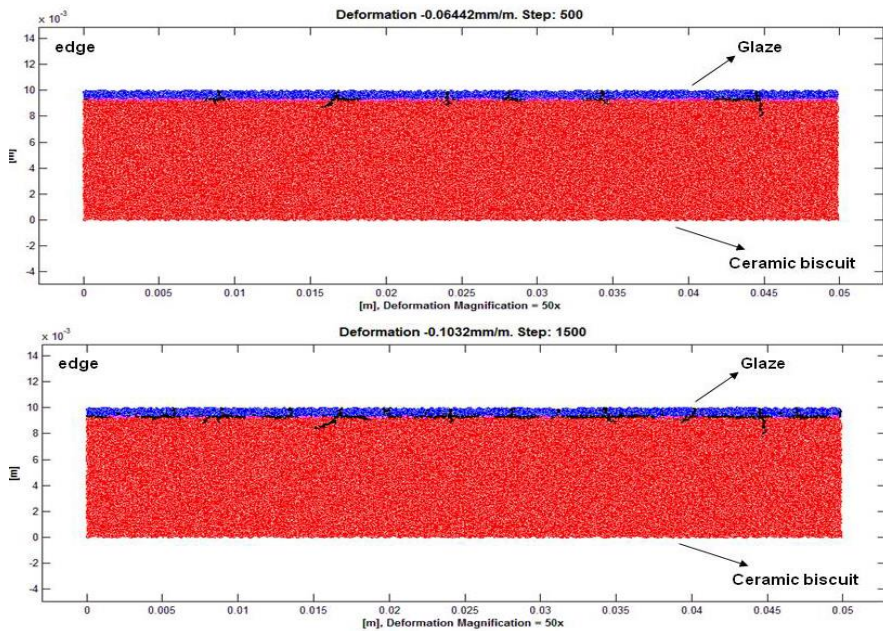
When, however, the bound between glaze and biscuit is of the same magnitude or lower than the cohesion of the biscuit, the cracking will follow the path of less resistance under the glaze and detach it locally from the biscuit (figure 12).

**Figure 12** - Two steps of the graphic result of a numerical model of cooling tile crazing with a relatively weak glaze/biscuit bound

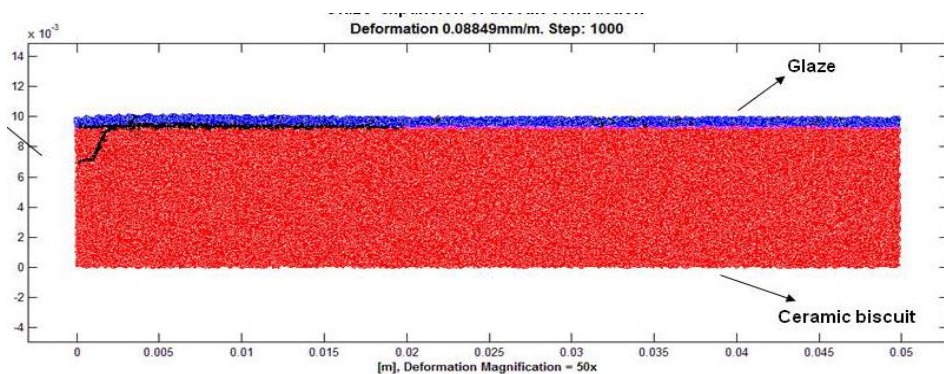
A less known but potentially very noxious defect is shivering, which stems from the opposite situation: during the cooling phase, the biscuit contracts considerably more than the glaze. Due to the resulting compression tensions, the glaze may suffer small cracks or detach from the biscuit. Characteristically, shivering causes glaze nicks at the edges and, when severe, may possibly result in extensive detachment of the glaze. The results of a numerical simulation (figure 15) show that, due to the arising stresses, the glaze may separate locally from the substrate and break, cause vertical cracking of the clay biscuit or, indeed, even suffer extensive detachment.

**Figure 15** - One step of the graphic result of a numerical model of cooling tile shivering
