Mortars and their compatibility for the conservation of masonry walls in Tróia Archaeological Site

Historical Mortars Conference

Characterization, Diagnosis, Conservation, Repair and Compatibility

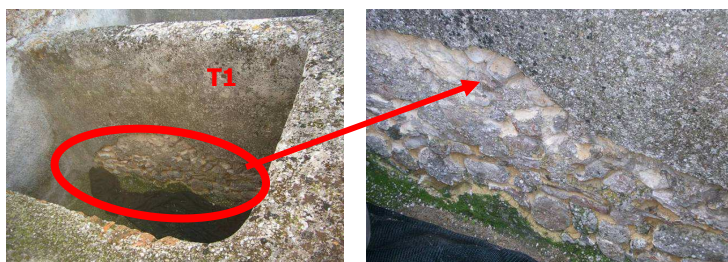
Figure 2 – Application of T1 mortar in the *Cetariae* in the inland area

The mortars studied in the laboratory were afterwards prepared onsite and applied on a few areas in the walls of the *cetariae* in the harbour and inland areas. The conservation mortar T1 was applied on the interior wall of the *cetariae* at the inland fish processing structure (Figure 2). The conservation mortar T2 was applied in the wall of a *cetariae* in the harbour area (Figure 3). The conservation mortars T3 and T4 were applied in the floor and in the vertical walls of the *cetariae* in the harbour area (Figure 4). Also a set of two brick panels were covered with mortar T1 and T4 and placed at the interior fish plant and at the harbour to monitor their behaviour.

About five months after the mortars application, an inspection to the site was carried out to assess the performance of the new mortars and to collect samples for laboratory analysis. The visual inspection of the new mortars applied in situ showed that all the four types presented good adhesion to the substrate and that they can be removed from the substrate without damaging it significantly. T3 and T2 were the hardest when pressed with nail, indicating that they have high strengths and suggesting that fly ash might have incremented the mortar strengths, a fact known from the bibliography but that we could not prove in the lab tests, possibly due to insufficient curing time. In the seashore, even the strongest T4 mortar underwent a significant erosion loss and T1 applied on the brick panel was

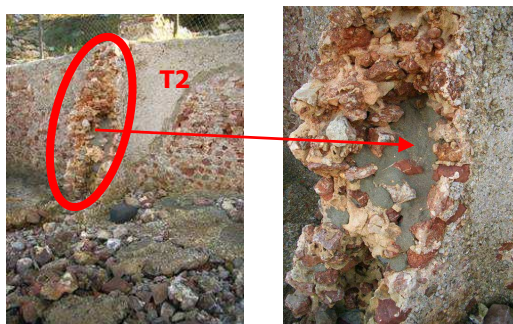
Figure 3 – Application of T2 mortar in the wall of a *cetariae* in the harbour area

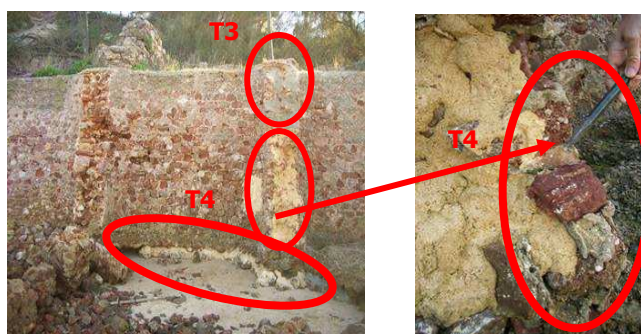
Figure 4 – Application of T3 and T4 mortars in the *cetariae* in the harbour area
