An experimental approach to the treatment and consolidation of degraded timber elements from a XIX century building

Dulce Franco Henriques¹, Lina Nunes², Jorge de Brito³

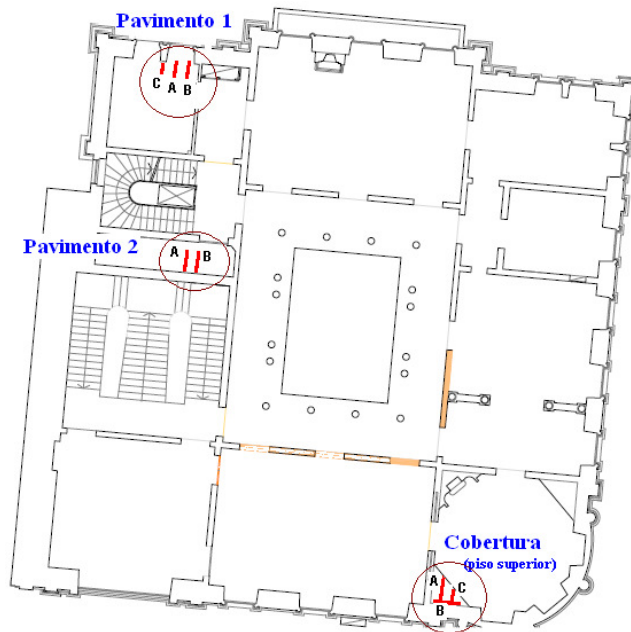
Figure 3 – Test areas where treatment and consolidation was conducted (plan: East Banc).

Within the building three replicate test sites (Pavement 1, Pavement 2 and Roof – Figure 3) were selected each with three elements that would be tested: (A) one showing early rot symptoms (B) one heavily rotten, for comparison, and (C) one apparently sound as control. In Pavement2 only two elements were tested as no sound wood was available.

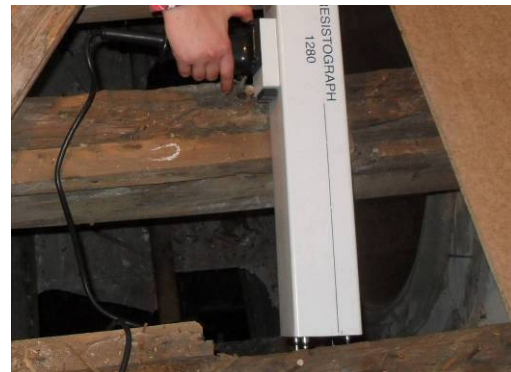
b. *Resistograph* in Pavement2 beam

Both tested beams showed by visual inspection a higher degree of degradation than the ones of pavement 1 and that was supported by the NDT measurements.
