Case-studies in plastering and rendering mortars. Sampling and testing for salts

Teresa Diaz Gonçalves

Lecture contents

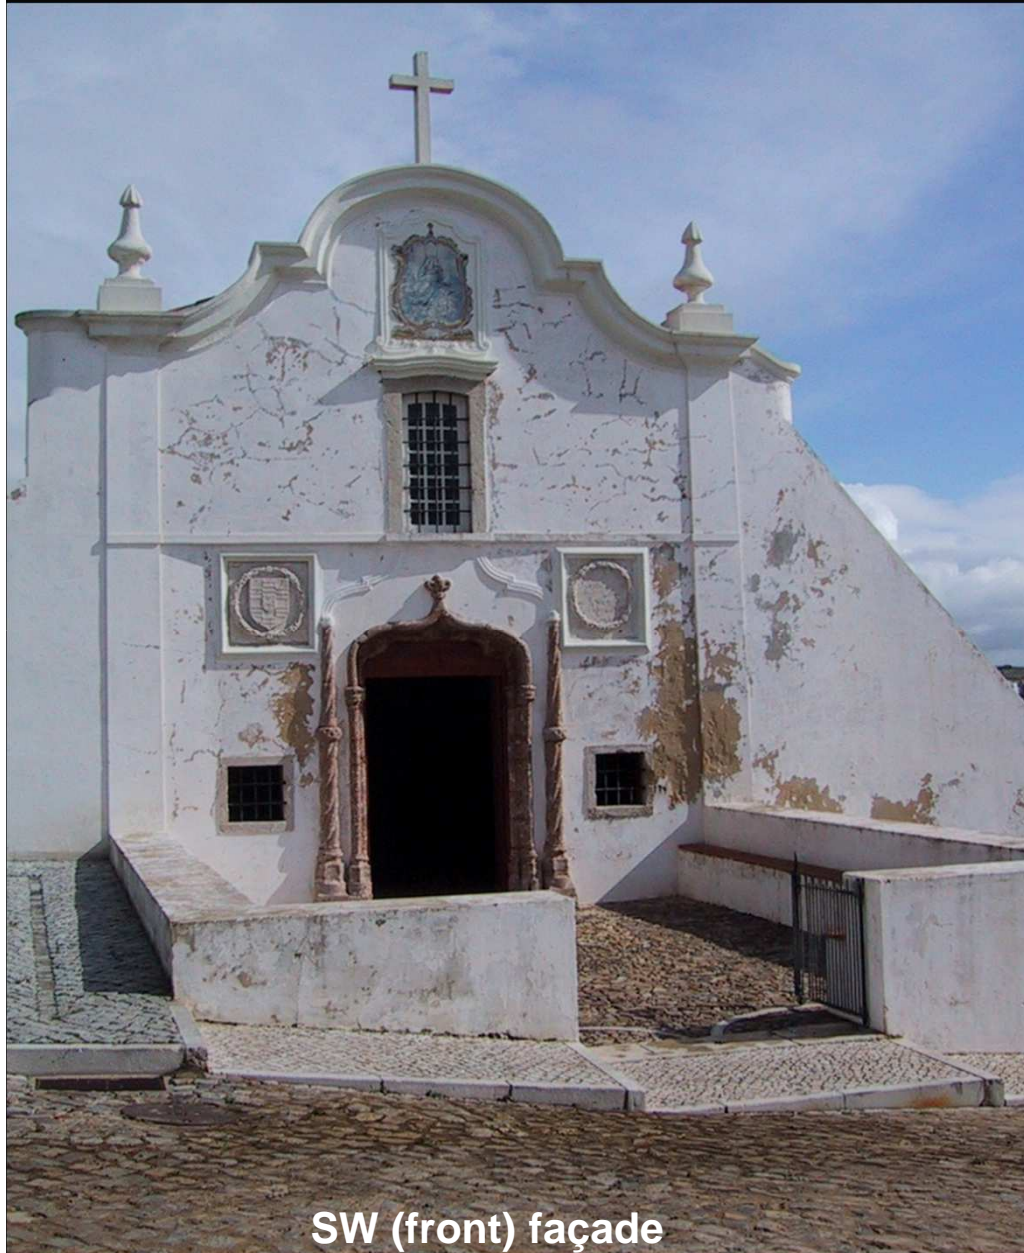
SW (front) façade

Damage (2004):

- cracking, sanding of the render, erosion
- 60% of the surface damaged
- reached more than 4 m height
- mainly at the walls middle height

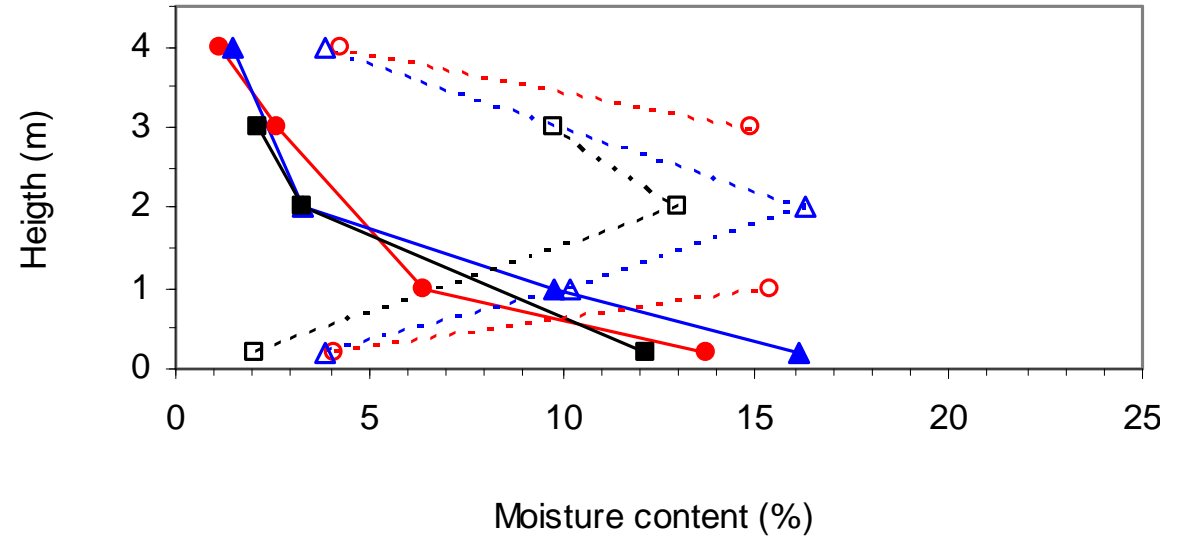
Salvas - Back façade

- MC => rising damp seems very significant:
 - at the base of the wall, the MC is very high (and much higher than the HMC)
 - MC decreases with the distance to the pavement
- HMC => the stronger accumulation of salt occurs at around 2m from the pavement
 - close to the ground the moisture content is very high => stage I conditions => efflorescence (washed out ...)

- Prevent the ingress of chloride => hardly feasible ...
=> **Prevent rising damp** (prevents also the access of the nitrate):
 - investigate possible contribution of the old fountain
 - damp proof course ?
- Use a plaster that allows drying of the wall (salt transporting)
- Use a paint with good adherence (some surface decay is still expected) ... silicate?

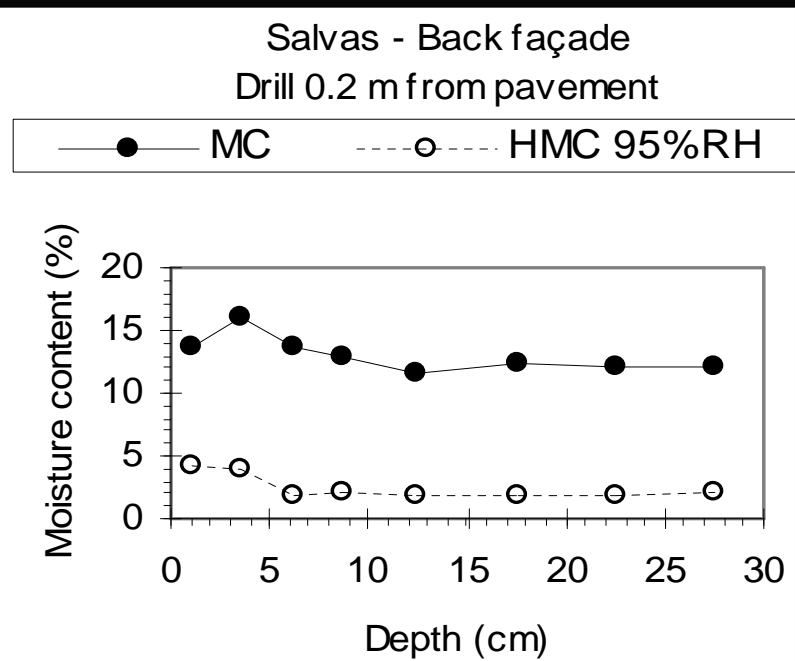
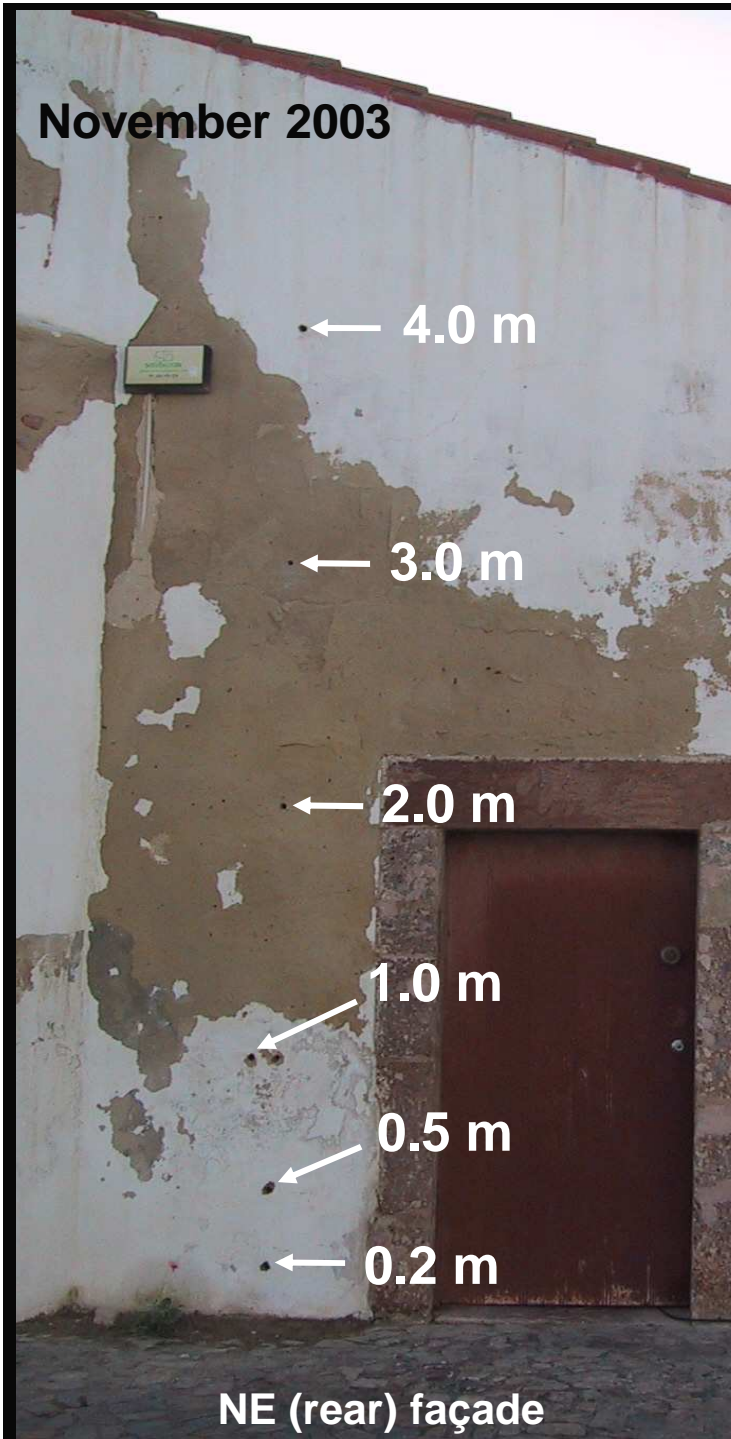
In-depth analysis at the lower drilling hole
(0.2 m from the pavement)

- both the MC and the HMC are constant inside the wall
- the MC is high and much higher than the HMC

Features characteristic of rising damp...

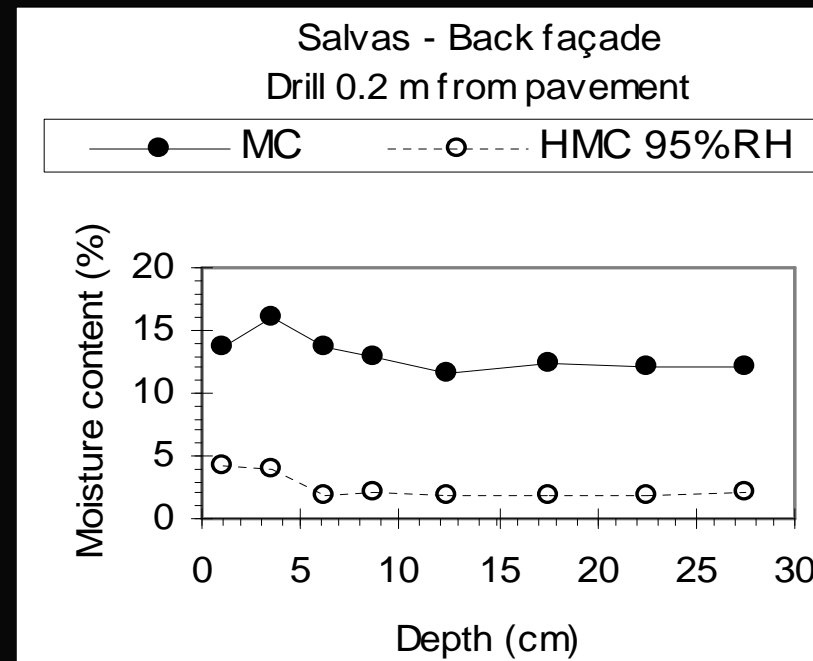
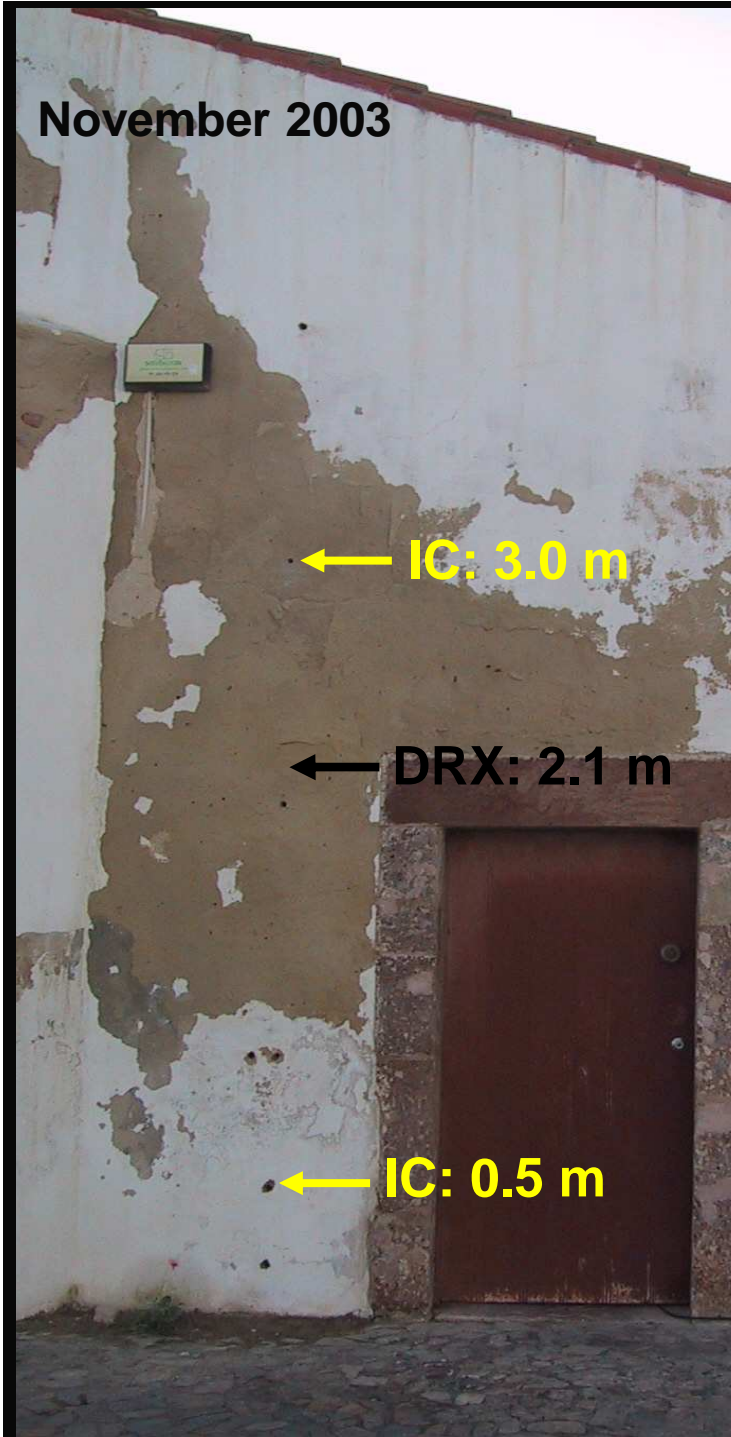
XDR/EDS on the fine fraction
(3 mm thick sample)

Halite (NaCl)	+ / ++
Calcite, CaCO ₃	+++
Quartz, SiO ₂	++
Feldspars	vtg / +
Mica	vtg

- DRX/EDS => halite (sea water ... marine fog ...)
- IC => chloride (sea) + some nitrate (ground)

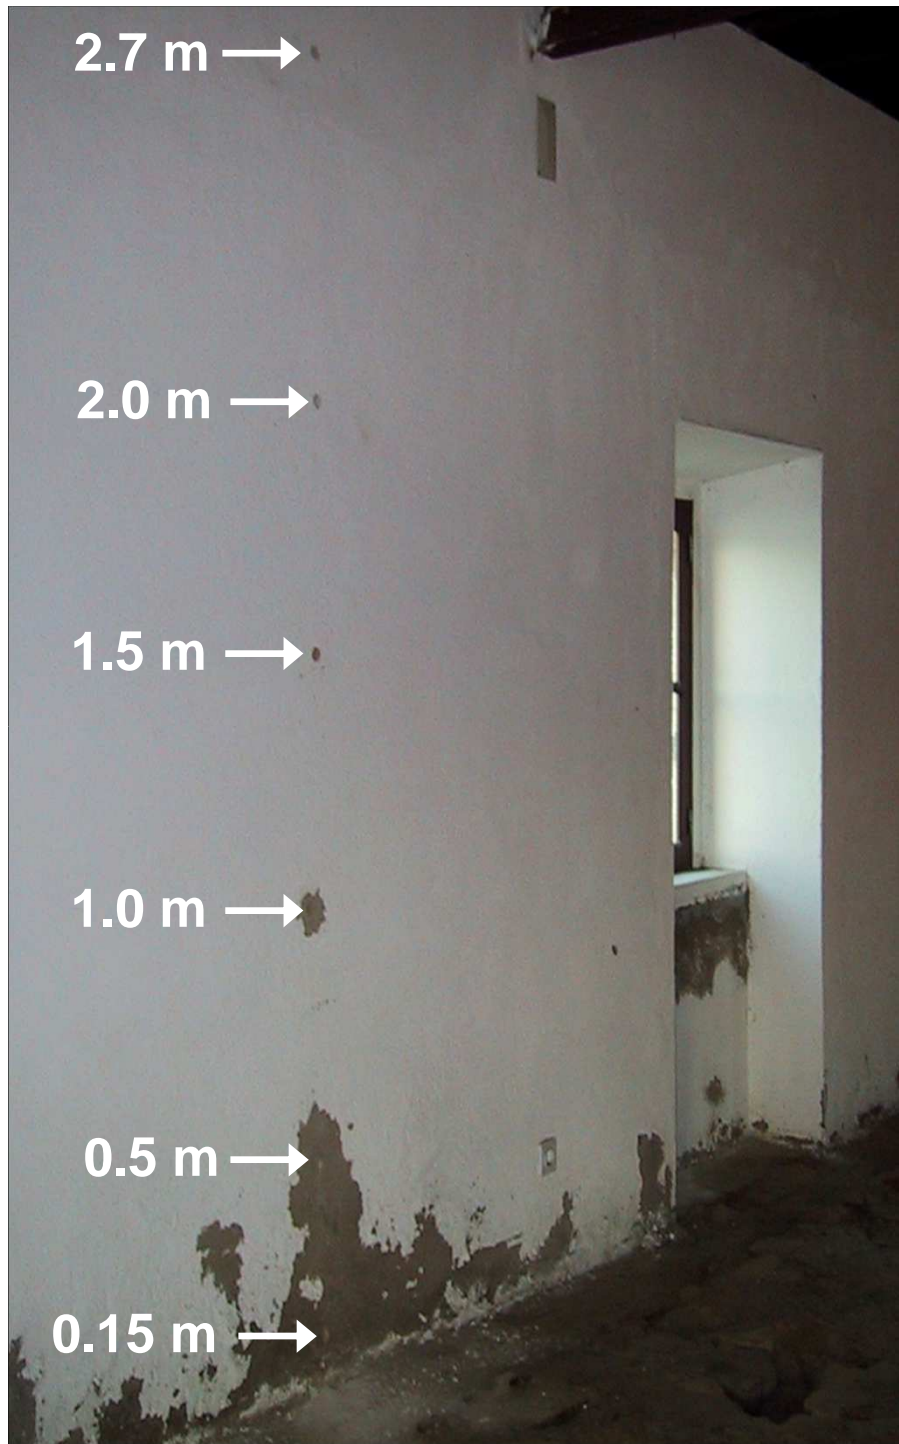
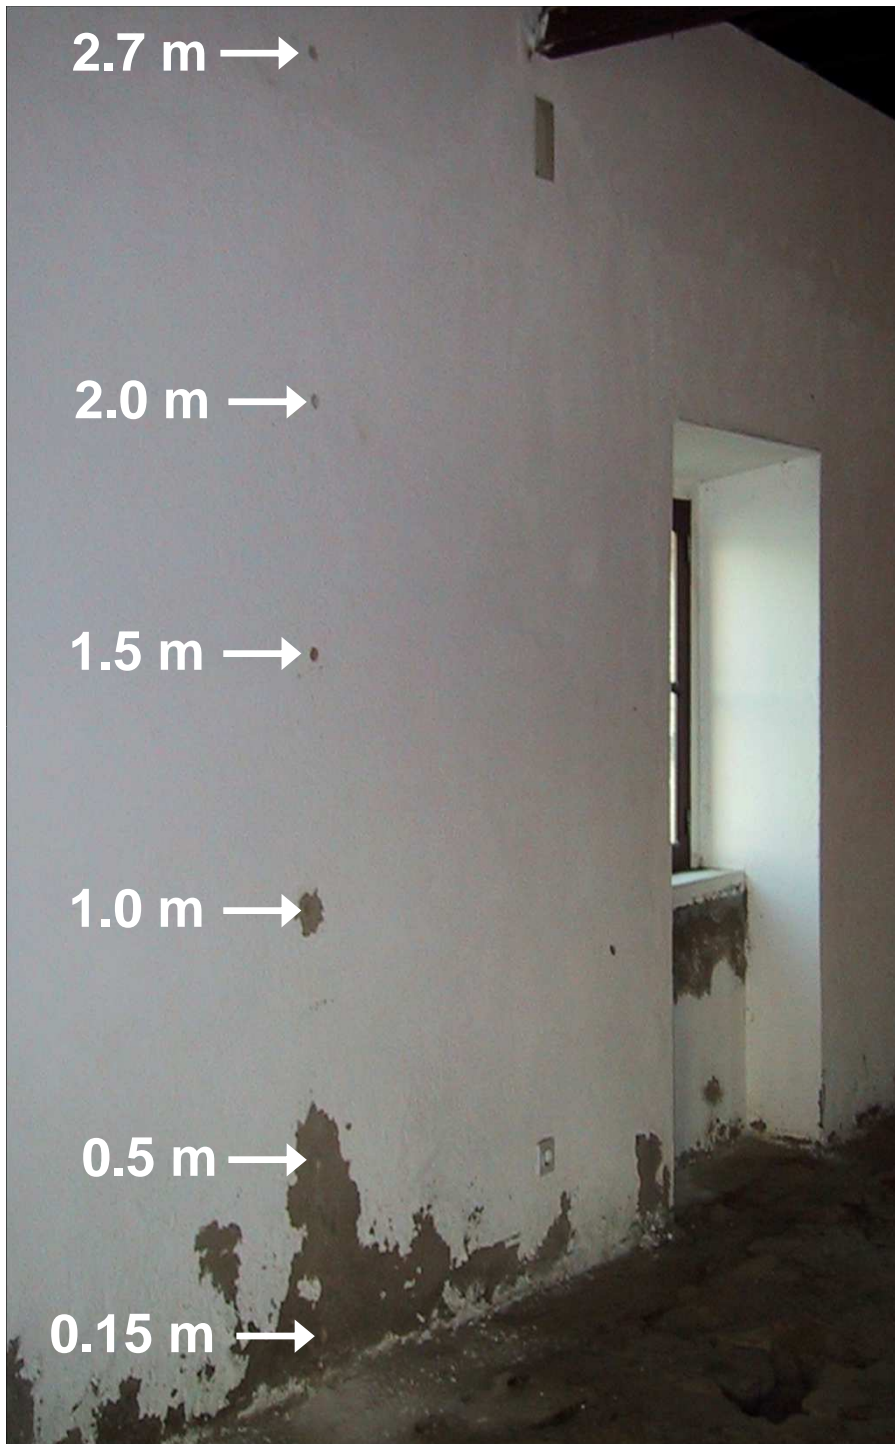
XRD

- sodium chloride:
 - probably carried by some capillary rising moisture or by salt mist
- efflorescence mainly composed of alkali-carbonate salts:
 - derive probably from the plaster (artificial hydraulic lime...)

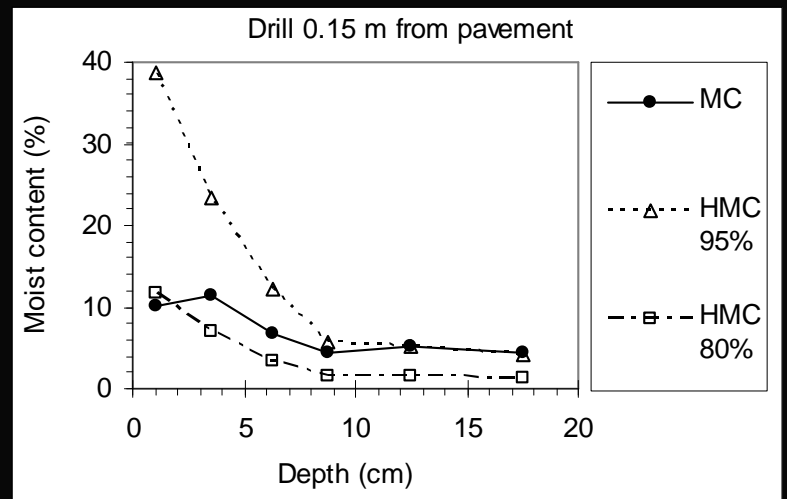
the MC is low inside the wall:

=> rising damp is not the main problem, despite the direct contact of the mill foundations with the river water

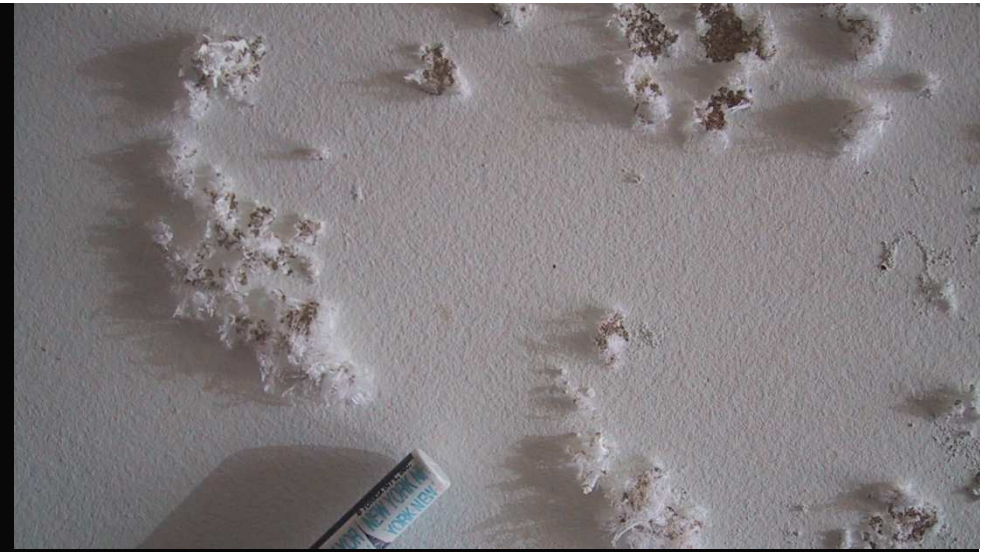
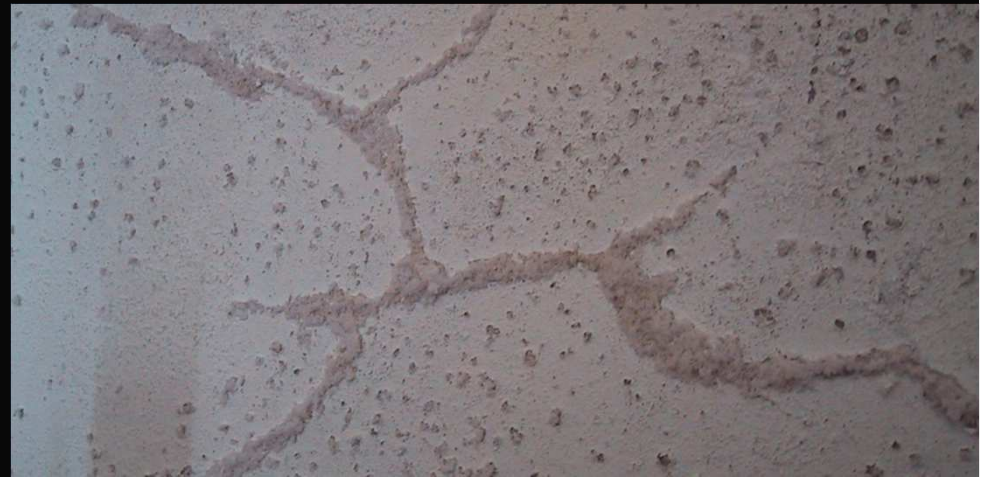
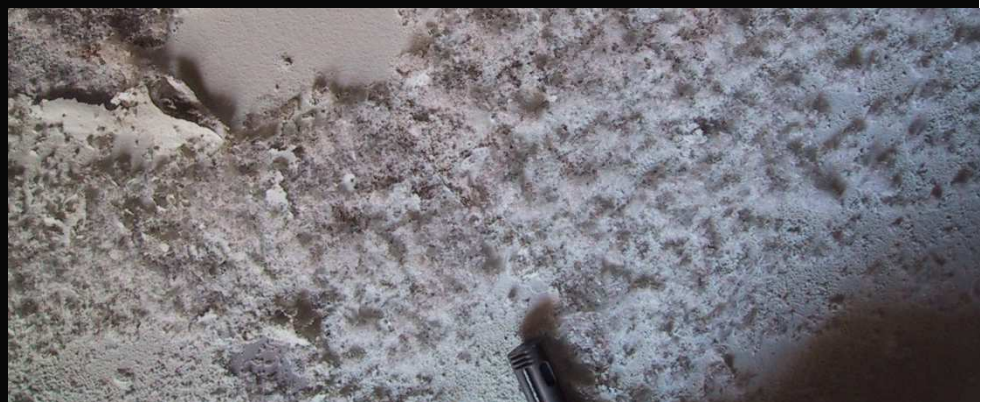
- few months after the works ended...
- affects 50% of the plastered area
- cracking + efflorescence
- affects upper part of walls (1.0/1.5 - 2.7 m)

- 1) efflorescence develops at the interface plaster/paint
- 2) the crystals push the paint layer and cause its rupture
- 3) long needle-like crystals appear + sanding of the plaster

plaster cracks = critical points where the degradation first starts and develops faster

- plaster of low alkali content (no cement-based adhesion layer...)
- do not use hydrophobic paint
 - hydrophobic surface layer => lower evaporation rate (stage II conditions)
 - subflorescence disrupts the paint layer (rather, let the salt go out...)

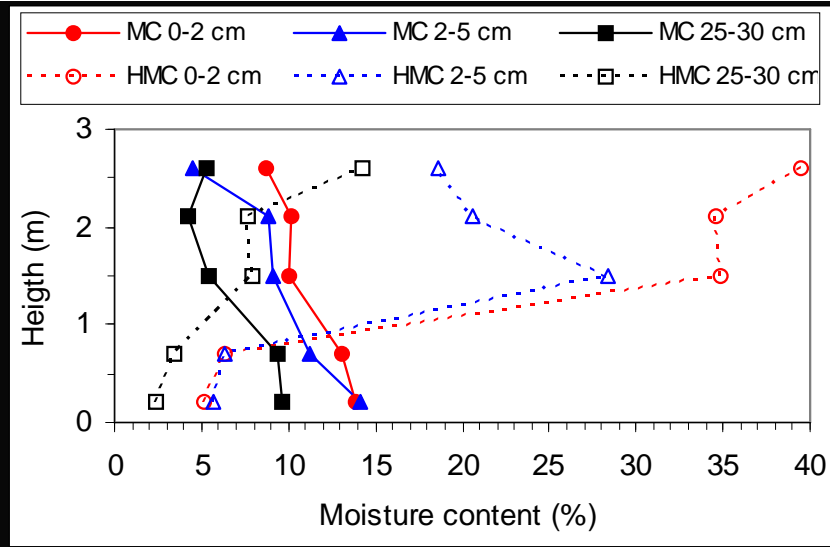
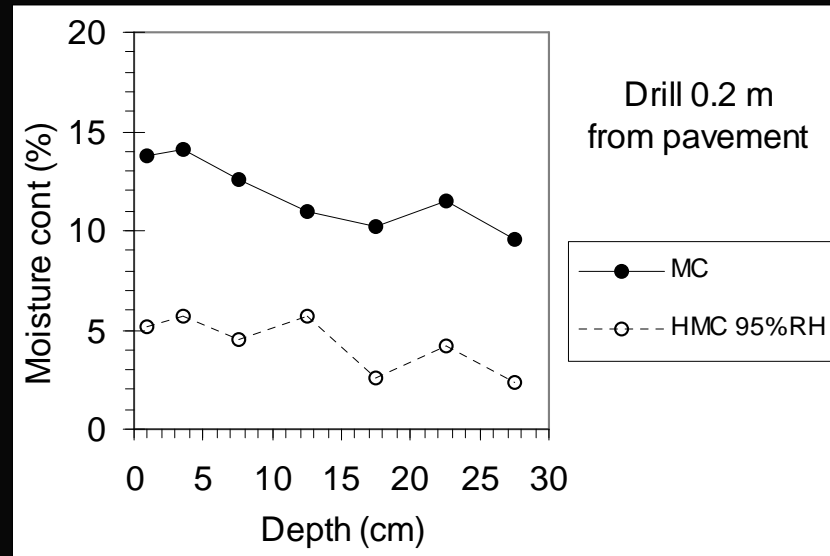
Significant amount of moisture exists inside the walls

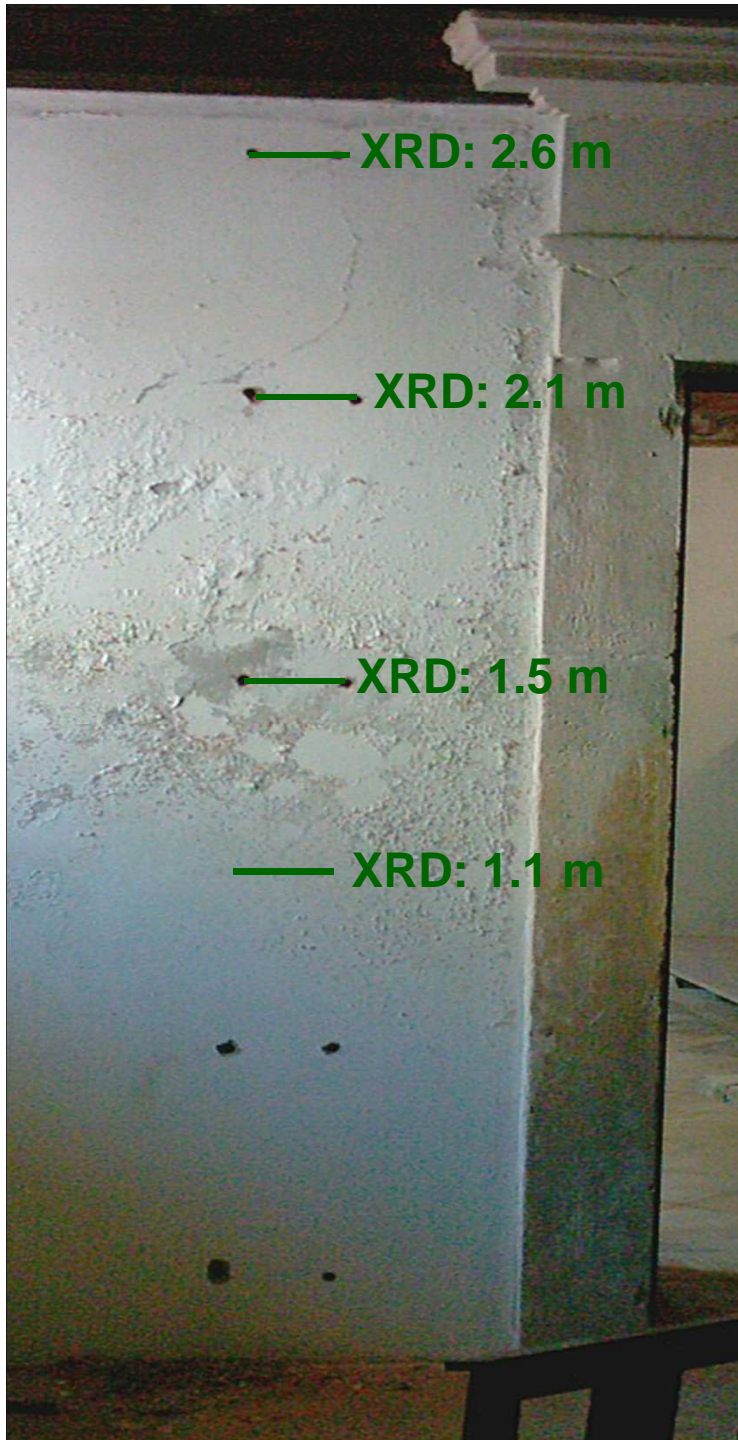
XDR on efflorescence

Crystalline compounds	Sampling height (m)			
	1.1	1.5	2.1	2.6
Hydrous sodium carbonate, $\text{Na}_2\text{CO}_3 \cdot 7\text{H}_2\text{O}$	++	+	-	-
Natron, $\text{Na}_2\text{CO}_3 \cdot 10\text{H}_2\text{O}$	+	++	-	-
Gaylussite, $\text{Na}_2\text{Ca}(\text{CO}_3)_2 \cdot 5\text{H}_2\text{O}$	-	+	+	++
Quartz, SiO_2	-	-	vtg	-
Cristobalite, SiO_2	?	?	+	+
Calcite, CaCO_3	+	+	++	+ / ++
Rutile, TiO_2	+	+	++	++

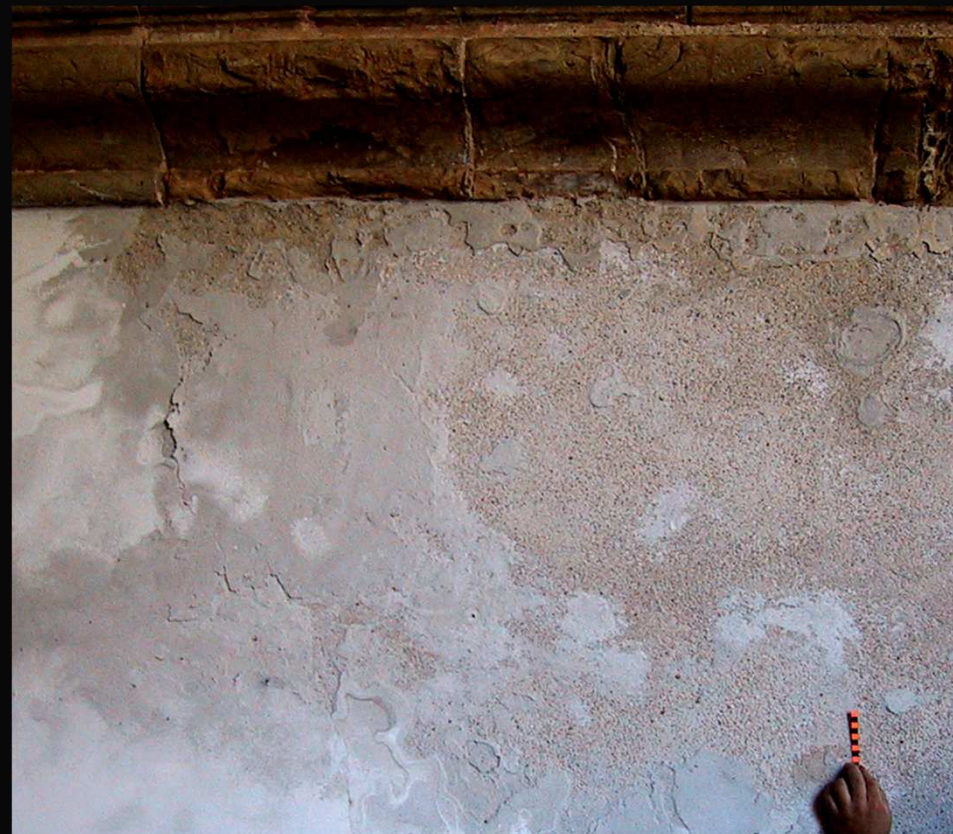
Damage up on the wall

XDR on sanded surface material (NE wall)

Trona, $\text{Na}_3\text{H}(\text{CO}_3)_2 \cdot 2\text{H}_2\text{O}$?/vtg
Gaylussite, $\text{Na}_2\text{Ca}(\text{CO}_3)_2 \cdot 5\text{H}_2\text{O}$	+
Niter, KNO_3	?/vtg
Calcite, CaCO_3	+++
Dolomite, $\text{CaMg}(\text{CO}_3)_2$	+
Quartz, SiO_2	+

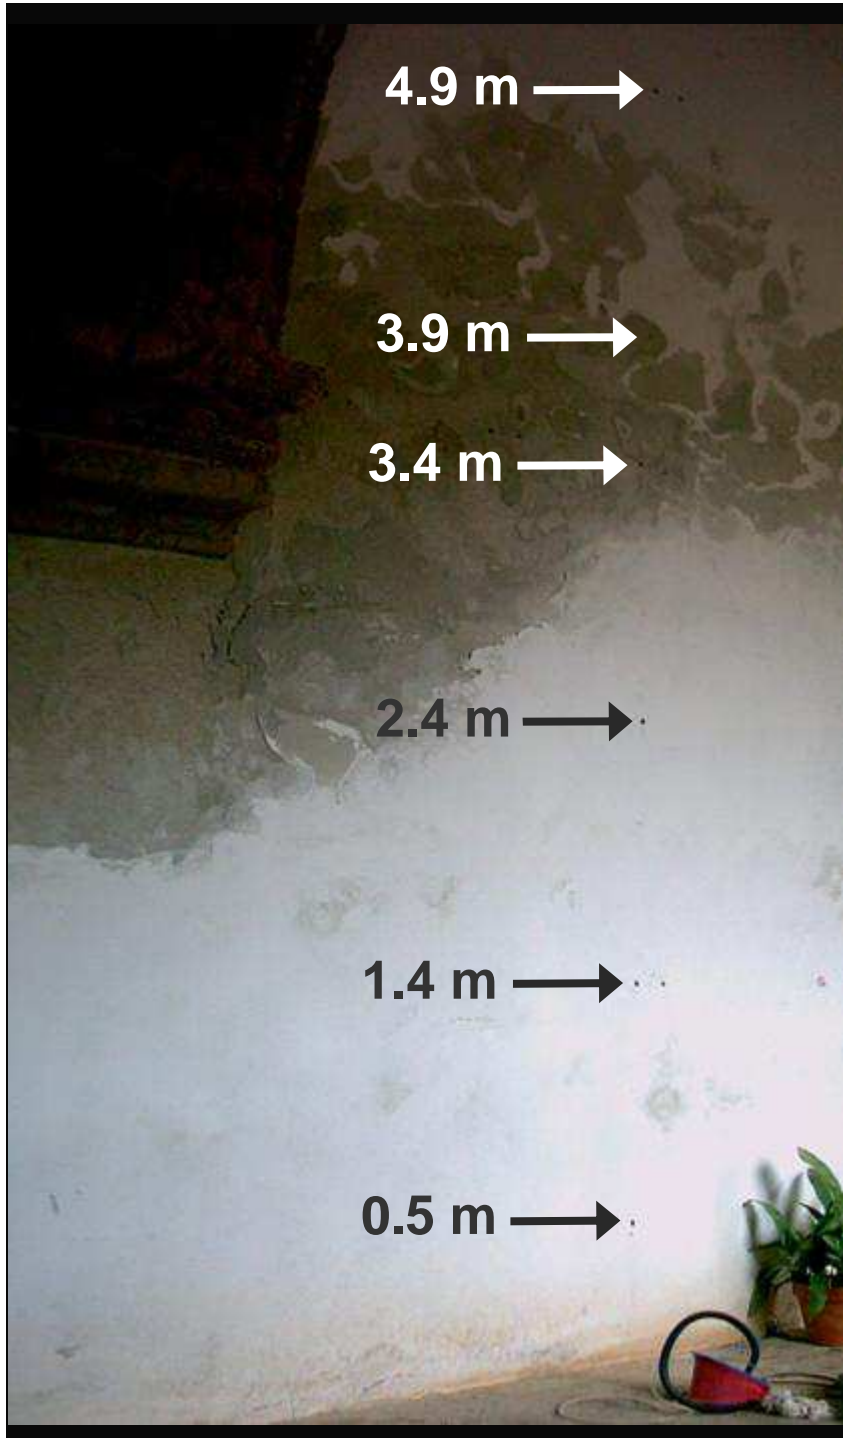
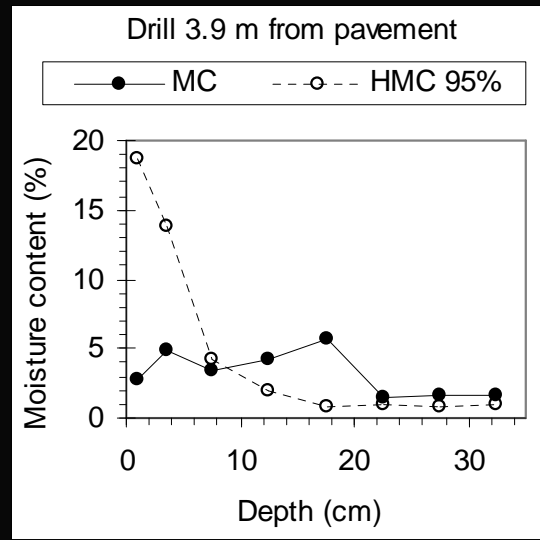
- Rising damp seems limited (< 5% inside)
 - In-depth MC/HMC profile at the level of maximum damage => MC decreases towards the interior of the wall (at the deepest points, MC ≈ HMC)
- => superficial source of liquid moisture is likely
