## THERMAL IMAGING OF CONCRETE DAM SURFACES TO SUPPORT THE CONTROL OF THE EVOLUTION OF PATHOLOGIES

Maria João Henriques\* and Pedro Ramos†

\* Laboratório Nacional de Engenharia Civil (LNEC)  
Av. do Brasil, 101, 1700-066 Lisboa, Portugal  
e-mail: mjoao@lnec.pt, webpage: <http://www.lnec.pt>

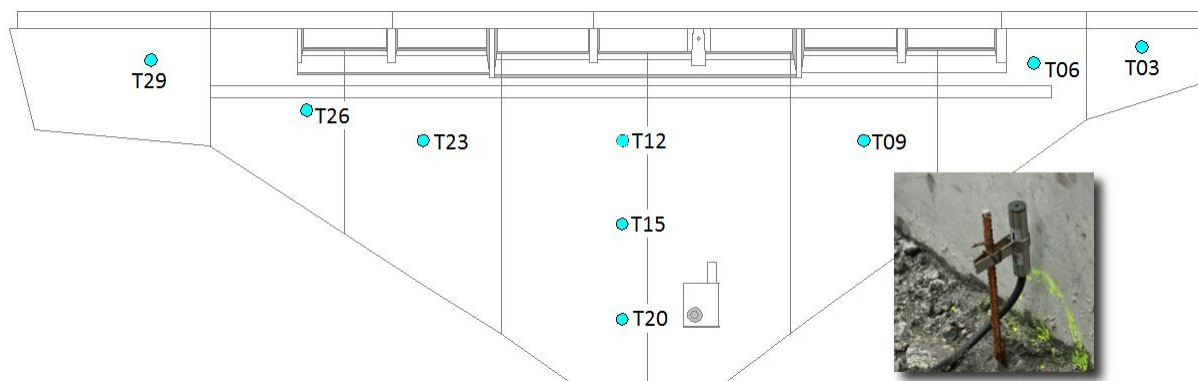
Figure 12: Alto Ceira II dam: location of the nine thermometers near the downstream face. Placement of one thermometer before the concreting.

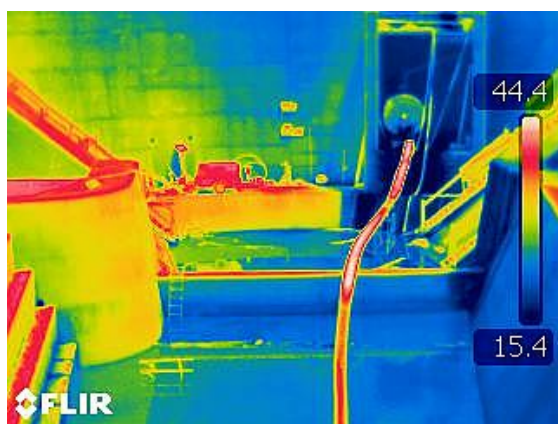
Figure 15: Thermal image. It includes the chromatic scale.

At the office it was made a comparison between the temperatures from the thermal images and the temperatures measured by the thermometers. For this it were selected the images that included points near those instruments. One of the images selected is presented in Figure 15, since it includes the area near T20; other is the one presented in Figure 19, because it includes the area near T26. In each of those images it was read the temperature in one point, the point nearer the thermometer, using software FLIR ThermaCAM. As there is information about the hour on which the image was acquired it was possible to relate the “thermal image” temperature with the values measured by the thermometers embedded in the concrete since there was also information of the time of these readings. After, it were computed the differences of the temperatures and, for each point, the average of these. The values of the averages are presented graphically in Figure 18. In this Figure is also presented the shaded areas, at two different hours.

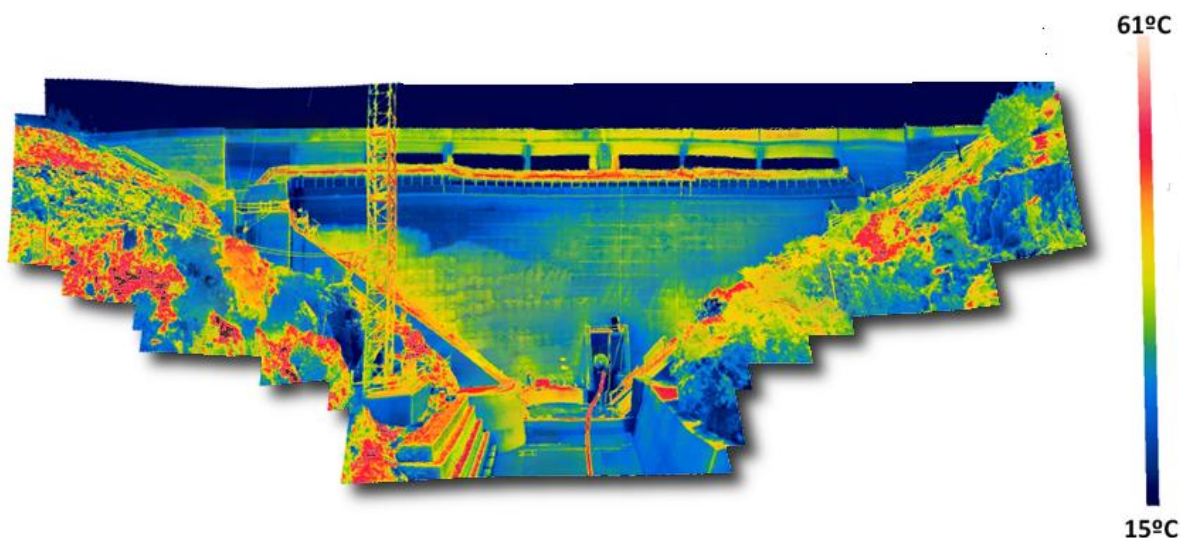
Figure 17: Thermal panoramic image of Alto Ceira II dam.

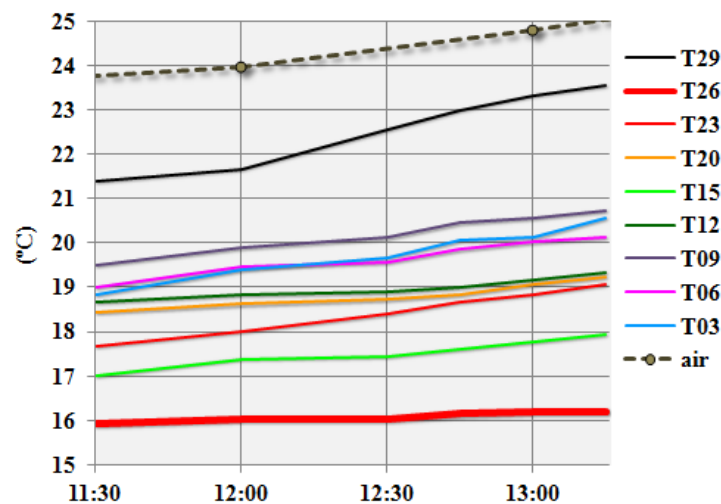
Concerning the five thermometers in the shadow, the differences are small, with the exception of T26. But even this one can be explained. Near the area of thermometer T26 was installed a tube to carry water from upstream to downstream, water needed for construction works that were going on near the foundation, on the downstream side. This tube had losses and for this reason some areas of the surface were wet. In Figure 19 one can easily notice these areas because they are cooler, since their colour is dark blue. Some of these areas can't be detected in the visible image, presented in Figure 20. The wet concrete of the surface was cooler and, by heat transfer, the concrete around T26 was also cooler, as can be noticed in the graph of the Figure 19, where the temperature measure by the thermometer T26 is compared with the temperatures measured by other thermometers. In this graph is also included the "air" temperature measured by a thermometer placed a few meters away from the dam.

Figure 21: Temperatures measured by the embedded thermometers.
