# Influence of Exposure Conditions and Particulate Deposition on Anodized Aluminum Corrosion

Isabel Rute Fontinha \* and Elsa Eustáquio

Laboratório Nacional de Engenharia Civil, Avenida do Brasil 101, 1700-066 Lisboa, Portugal

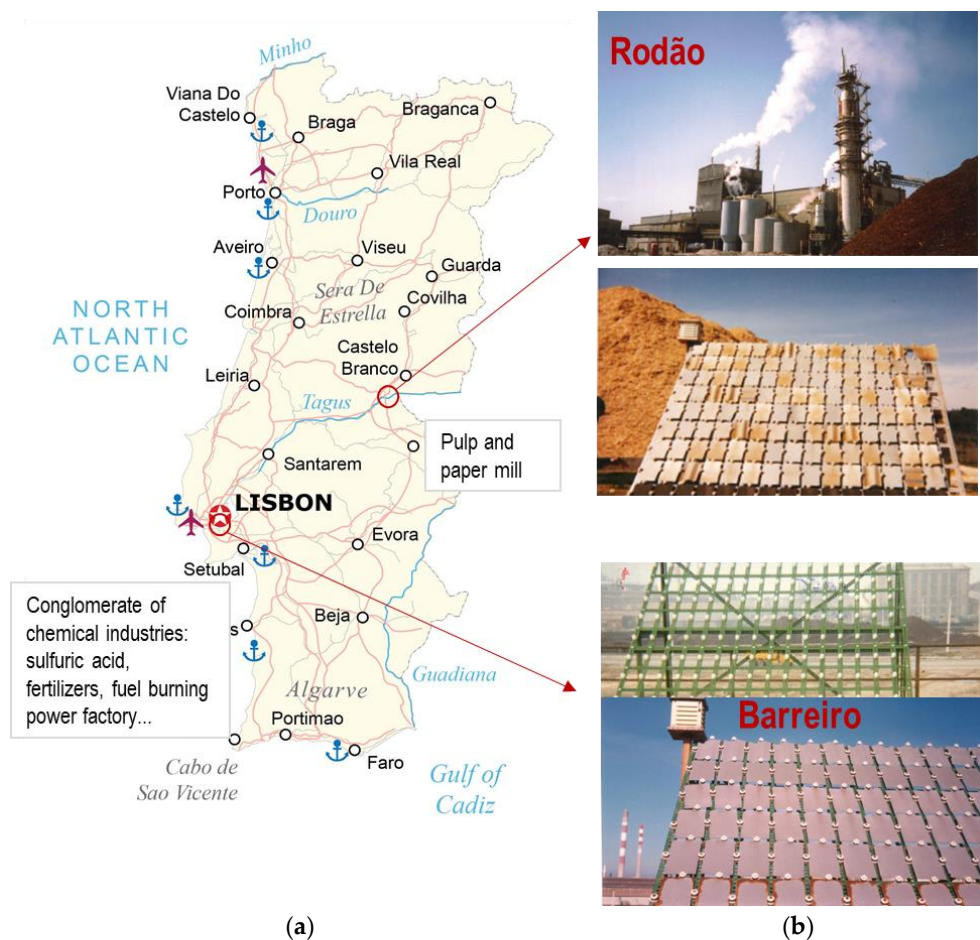
**Figure 2.** Exposure test sites. (a) Map of Portugal [27] with the locations of the test sites (b) Photos of the exposure sites: Rodão (top) and Barreiro (bottom), which show solid waste deposits of industrial waste near the racks and the coloration of the test specimens' surfaces due to the deposition and accumulation of waste particles.

At this last site, the exposure racks were initially placed very close to wood-chip deposits, the deposition of which was clearly visible on the test specimens' surfaces, as shown in Figure 2. The racks were relocated after 1 year of exposure.

After ten years of exposure in the industrial–marine test site at Barreiro, the anodized aluminum specimen surfaces (both faces) acquired a reddish-grey hue (this was observed for all the exposed materials, as can be seen in Figure 2) and showed deep pits mostly on the edges and back faces, and the coating surfaces were slightly rough to the touch (Figure 3a).

The significant carbon contents found in the more recessed zones of the damaged coatings of these test specimens imply the retention of other carbonaceous products in addition to lime. One possible source would be residues of wood chips piled nearby that had been deposited on the specimens' skyward surfaces, mainly during the first year of exposure (Figure 2), before the relocation of the exposure rack.
