## CORRECTIVE MEASURES OF THE RIVER BED PROTECTION DOWNSTREAM A DAM FOUNDED IN DEEP ALLUVIA. THE CASE OF CRESTUMA-LEVER DAM

Crestuma-Lever dam, completed in 1985, is located in Douro River. A large design flood of 26,000 m<sup>3</sup>/s involves 8 gated spillway bays with stilling basins directly founded on the alluvial river bed. Regular river bed surveillance downstream of the spillway evidenced unexpected progressive erosion of riprap.

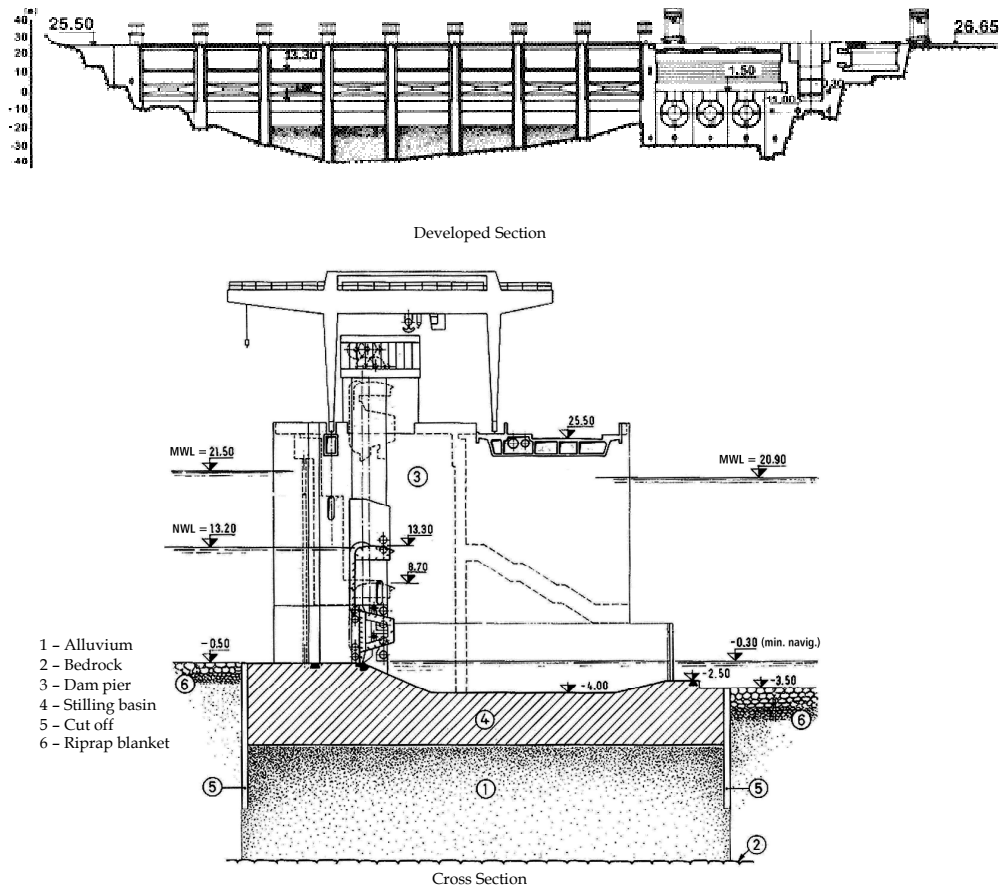
Figure 3. Spillway main features.

In fact, the dam eight spillway bays have their concrete slabs directly founded on the alluvial river bed. This solution makes them particularly sensitive to any abnormal scouring of the river bed downstream that might induce high gradient seepage flows through the alluvial foundation, increasing the risk of piping erosion (Figure 3).

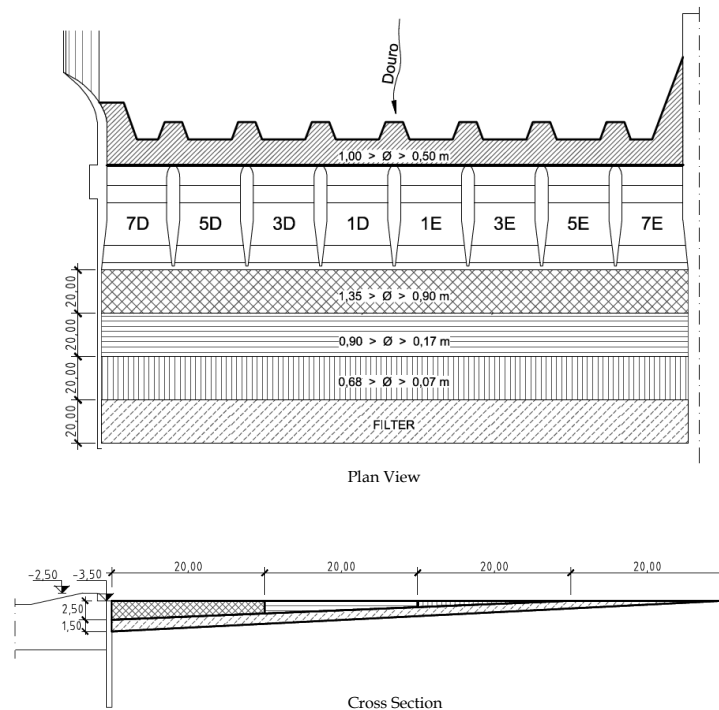
Figure 4. Riprap protection downstream of the spillway.

To prevent the development of river bed uncontrolled scouring, a heavy riprap protection was provided extending 60 m downstream of the spillway. The riprap was built on top of a two layer filter that stretches an additional 20 m downstream, totalizing 80 m of protected river bed (Figure 4).

A survey made in 1998, after the floods of the winter of 1995/96, evidenced some additional erosion in the vicinity of the spillway and after the floods of 2000/01 surveys evidenced the development of some erosion in the left side of the river and, more significantly, in the central part of it, whereas the right side didn't evidence much change. However, raising more immediate concerns, the transversal profile closer to the spillway evidenced that the previously observed erosion near the spillway was developing further upstream, exposing the spillway downstream cutoff wall. The erosion near the cutoff wall presented an average 4 m depth.

Underwater inspections with divers were carried out to assess what type of material covered the scoured zone. Special attention was given to the interface between the spillway downstream cutoff wall and the river bed. Visual inspections evidenced that most material in the scour hole was formed by sediments, the protective riprap and underneath filter layers having been damaged across most of the spillway width in the immediate vicinity of its downstream cutoff wall.

After 27 years of systematical observation of the riprap and assessment of need of corrective interventions, a decision was taken in 2011 to replace the damaged riprap. The correction measures involved:

Similarly to what was performed before the repair works, a program for systematic observation of riprap will be set up and implemented, taking as reference the situation evidenced in the most recent bathymetry detailed survey. This bathymetry was made upon the conclusion of the repair works downstream of the dam spillway in September 2013 (Figure 12). The extension of riprap on the right side of the river (left side of figure) resulted from a local additional reinforcement of riprap downstream of bay 3D (refer to Figure 4 for bay identification).

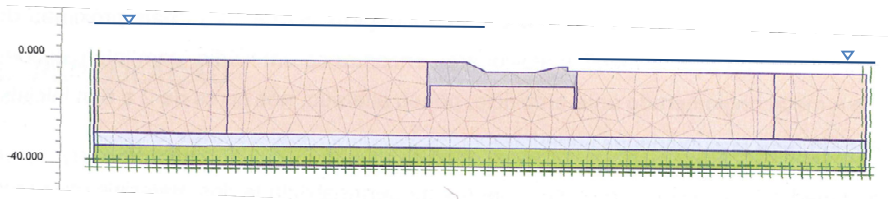
Figure 6. Stilling basins foundation 2D model - finite element mesh.

The geometry of the slab and concrete cutoff walls was reproduced in the finite element model. The river bed was modeled considering an alluvial layer 32.5 m thick, over a 4.0 m thick layer of slightly weathered and fractured rock on top of moderately weathered rock (Figure 6). This model, with some adjustments, was used in a more specific scenario regarding basins 1E and 3E, for which an upstream and a downstream constructive plastic curtains were placed for the basins construction. As the corrective solution found to address this specific problem was independent of the downstream riprap protection, its description is not considered in this paper.

The numerical modeling of the foundation stability provided helpful information regarding its safety and the effect of the erosion of bed material immediately downstream of the spillway cutoff wall. It evidenced that any further development of the erosion would result in the reduction of foundation safety comparing to the designed solution, namely if erosion would go below elevation (-8.00) near the downstream basins cutoff walls.
