# The failure of the Fonte Santa mine tailing dam (Northeast Portugal)

**ABSTRACT:** The Fonte Santa mine tailing dam situated in the Northeast of Portugal failed on the 27<sup>th</sup> November 2006 due to a combination of hazards, an extraordinary rainfall and an eventual clogging of the spillway. The dam was an earthfill embankment about 25 m high and with a crest length of roughly 35 m. After the overtopping of the crest, which originated the breaching process and consequent failure, the dam was completely washed away with a fraction of the mud retained in the reservoir. The present paper constitutes a preliminary report of the accident describing the dam breaching process and the morphodynamic changes on the downstream valley. The breach geometry is characterized and estimates of the water and mud releases are presented. The geomorphic changes in the valley are described, including deposition volumes of the dam material and eroded volumes from the riverbed.

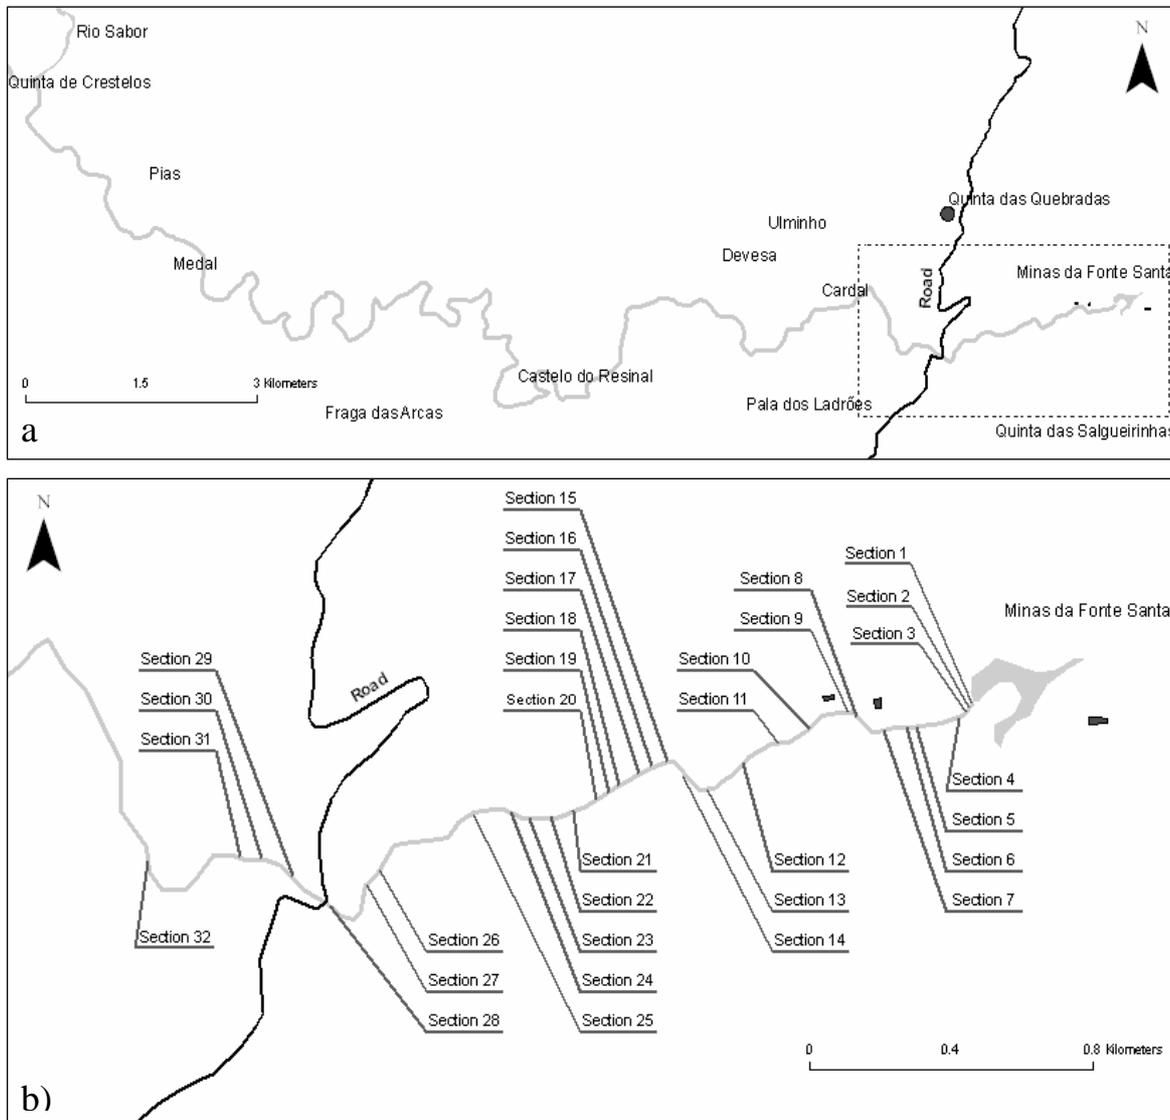
Figure 4. a) The valley of the creek Ribeiro da Ponte, between the dam section and the confluence with Sabor river (a major Portuguese river, one of the main tributaries of Douro river). Adjacent roads and towns are indicated; b) detail of the downstream valley with the sections where a detailed survey of the morphodynamic impact of the dam break event was made.

The detailed survey was realized between the dam position and the last section where morphodynamic changes were visible (erosion or deposition of the riverbed and banks), see Figure 4. The dispersion of the mud released from the reservoir however was observed until the creek outlet at the Sabor river (cf. Fig. 4), though with no significant impact on the river morphology.

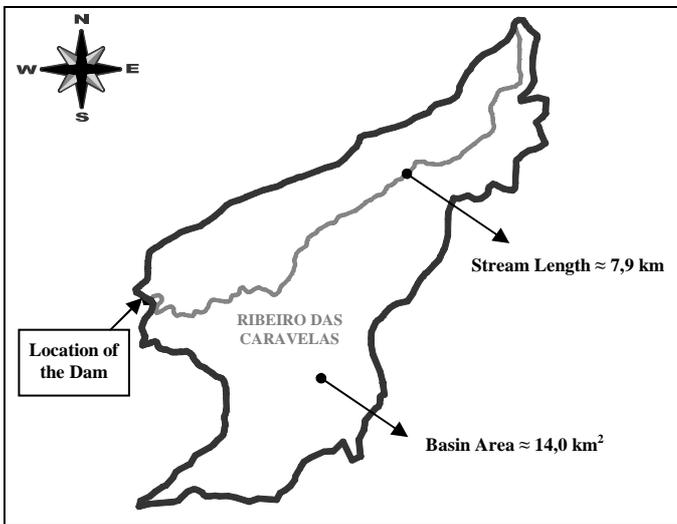
The dam of Fonte Santa creates a river basin of approximately 14,0 km<sup>2</sup> and its main watercourse is the Ribeiro das Caravelas (Fig. 5) which has about 7.9 km and can be qualified as torrential, attending to its longitudinal profile. The concentration time of this brook is about 3h and the basin area soil occupation is characterized by a curve number of 90, considering the most humid antecedent conditions (AMCIII). This parameter was obtained from the CN (AMCII) that was estimated in ARC-GIS with the Soil Hydrologic Characteristics Map that is available on [www.snirh.pt](http://www.snirh.pt).

Figure 5 – River basin determined at the section of the Fonte Santa dam.

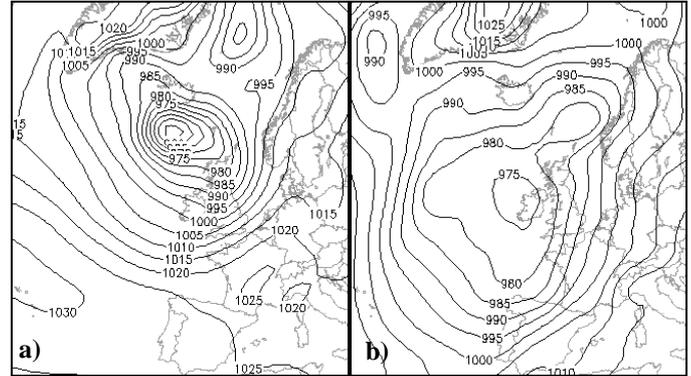
On 20<sup>th</sup> November, 2006 a large low-pressure system was centered in the Atlantic North near Iceland. From the 20<sup>th</sup> till the 24<sup>th</sup> of November this system moved towards the west coast of Ireland affecting the Portuguese territory as well. In the area of the Fonte Santa dam basin, a sea level pressure drop of approximately 25 mbar was observed between the days 20<sup>th</sup> and 24<sup>th</sup> of November (Fig. 6). After the 24<sup>th</sup> the system moved away from the Ireland west coast, causing a pressure ascent in all Portuguese territory. The 25 mbar pressure drop observed along those four days on the basin's area was the cause of the extreme precipitation occurred on the 24<sup>th</sup> of November.

Figure 6 – Low-pressure system formed in the Atlantic North on the days a) 20<sup>th</sup> of November and b) 24<sup>th</sup> of November.
