Main Spatial Defects of Illegal Residential Buildings: The Case of Alto da Cova da Moura District

The purpose of the paper is to describe the main spatial defects in illegal residential buildings. Three research questions are addressed: What are the main spatial defects of the dwellings? What are the main spatial defects in the relation between buildings? What is the impact of spatial defects to the minimum habitability conditions of dwellings?

The defects were identified during a survey of the buildings of the Alto da Cova da Moura District (Amadora, Portugal), carried out in 2008. This district is made-up of illegal constructions, covers an area of 16.5 ha and has approximately 5,000 inhabitants. During the survey 833 buildings and 1,884 units were inspected. The main results are: a) 65% of buildings have problems with windows; b) about 20% of buildings have spatial defects in common stairways; and c) more than 50% of dwellings have spatial defects.

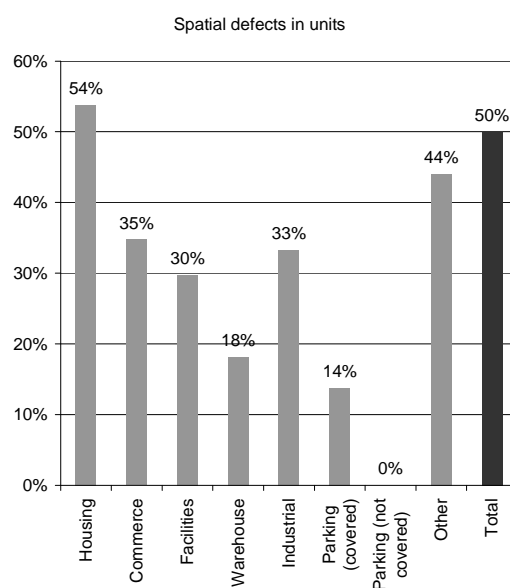
Figure 6. Spatial defects by type of use of units.

50% of the units had spatial defects (Fig. 6). This percentage increases to 54% for residential units. The main space defects in habitable rooms of residential units were: insufficient daylighting and ventilation, low ceiling height and cramped areas.

The insufficient daylighting and ventilation of rooms was found in about 70% of the units with spatial defects. This defect is due to rooms having small windows or no windows at all. Since many buildings only have one façade, many rooms inside the building only receive daylight through openings to other rooms.
