Valtorno-Mourão Dam. Reinforcement of the foundation grout due to problems detected during the first filling

Abstract

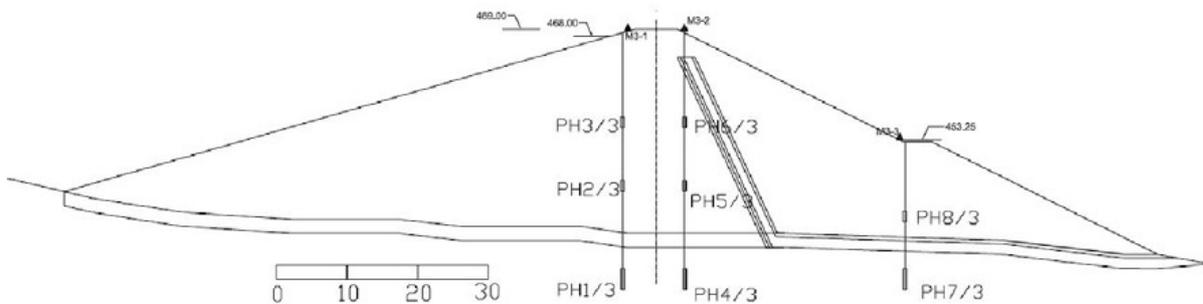
Figure 1: Cross-section (3-3) of Valtorno-Mourão dam

Some significant changes were also noticed at the pore water pressure in the foundation and in the dam. For example in profile 3-3, (Figure 1), the pore pressure in the foundation is shown in Figure 9. The first plot presents the head in piezometers 1, 4 and 7, all in the foundation. The second plot presents the relative hydraulic load defined as:
