## **Selected solutions for rehabilitation of wooden structures: some Portuguese case studies**

Artur O. Feio<sup>1,a</sup>, Daniel Félix<sup>2,b</sup>, Vítor M. Cunha<sup>3,c</sup> and José S. Machado<sup>4,d</sup>

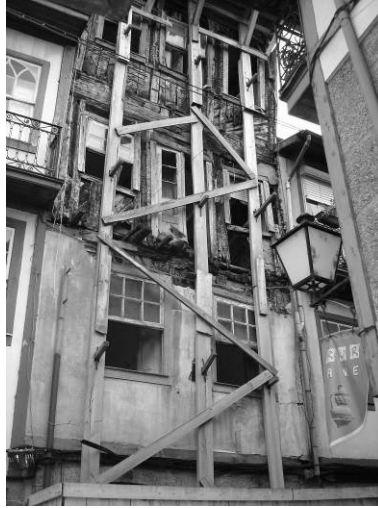
Figure 1. Rehabilitation in the historic Centre of Guimarães: UNESCO World Heritage Centre and European Capital of culture 2012.
