## DAMAGE ASSESSMENT AND DIAGNOSIS FORM

<b>Name of the building – Location</b> Salvas Chapel – Sines, Portugal
<b>Type of damage – decay pattern</b> <ol style="list-style-type: none"><li>1. Cracking, sanding and crumbling. Detachment of the paint layer and of the superficial coats.</li><li>2. Efflorescences and detachment of the paint layer.</li><li>3. Powdering</li><li>4. Moisture spots, water flow marks and biological development</li></ol>
<b>Materials concerned</b> <ol style="list-style-type: none"><li>1. Render</li><li>2. Plaster</li><li>3. Red ceramic tiles of the pavement</li><li>4. External façades of the church</li></ol>
<b>Tests performed</b> <ul style="list-style-type: none"><li>▪ Moisture and hygroscopic moisture content (HMC) profiles, at two exterior locations</li><li>▪ Ion chromatography on four superficial samples of render</li><li>▪ XRD characterization of efflorescences collected at the interior of the church</li></ul>

LNEC

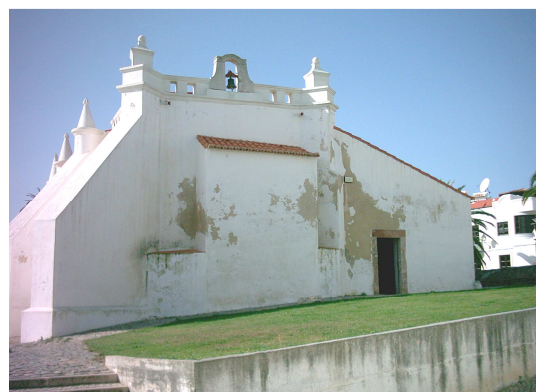
Fig. 6 –Salvas Chapel, NE (back) façade (2003-11-19)

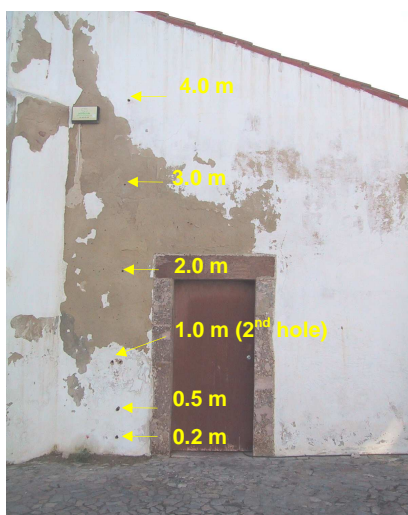
Fig.27– Location of sampling at the back façade

Table 1 – Main type of materials found at the back façade (visual observation of powder samples)

Height (m)	Depth (cm)								
	0-2	2-5	5-7.5	7.5-10	10-15	15-20	20-25	25-30	30-35
4.0	LM	LM	LM	S	S	LM + S	LM	S + LM	LM
3.0	LM	S	S	S	S	S	S + LM	LM	LM
2.0	-	LM	LM	LM	LM	-	?	LM	LM
1.0	LM	LM	LM	LM	S	S	S	S	S + LM
0.5	LM	B + LM	B + LM	B + LM	LM + B	LM + B	LM + B	LM + B	LM + B
0.2	LM	LM	LM	LM	LM	LM	LM	LM	-

LM – lime-mortar; S – stone; B - brick

Analysis of the moisture content profiles (general decrease of the moisture contents with height) points for capillary rise being the main source of moisture (although it is not clear the reason why, at the back façade, the moisture content at the height of 0.2 m is lower than at 0.5 m).

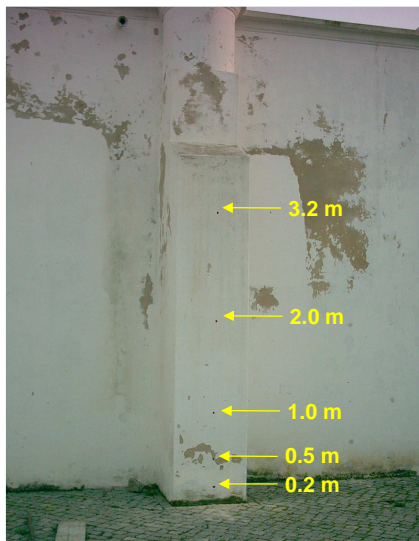
Fig.30 – Location of sampling at the lateral façade

Table 2 – Main type of materials apparently found at the lateral façade (visual observation of the powder)

Height (m)	Depth (cm)								
	0-2	2-5	5-7.5	7.5-10	10-15	15-20	20-25	25-30	30-35
3.2	LM	LM	LM	LM	LM	LM	LM	LM	LM
2.0	LM	LM	LM	LM	LM	LM	S	S + LM	S
1.0	LM	LM	LM	LM	LM	LM	LM	LM	LM
0.5	LM	LM	LM	LM	LM	LM	LM	S	S
0.2	LM	LM + B	LM	LM	LM	LM	LM + B	LM + B	-

LM – lime-mortar; S – stone; B – brick

At the buttress of the lateral façade, which has an adjacent drain, the salts contents, the moisture contents and the damage are low.
