FMEA of a tailings dam

Ricardo Neves Correia dos Santos ^a , Laura Maria Mello Saraiva Caldeira ^a & João Paulo Bilé Serra ^a

^a Laboratório Nacional de Engenharia Civil, Lisbon, Portugal

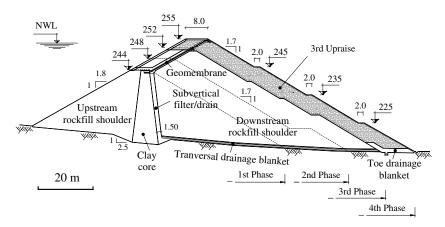
Figure 3. Sequential downstream heightening of the dam (Hidroprojecto 2002).

The most vulnerable component of the drainage system should be the drainage blanket, given its reduced section, when compared with the other components. Both the chimney filter and the downstream toe drain are implanted along the entire extent of the dam. Additionally, the last heightening has been mainly executed with rockfill materials (see Figure 3), providing extra drainage for possible blocking of the drainage system in this area.

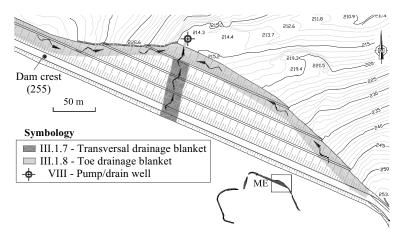
Figure 4. Internal drainage system and pumping well (Hidroprojecto 2002).

For seepage control of the dam body and foundation, an internal drainage system was adopted, composed of a chimney drain, a transversal drainage blanket, located at the valley bottom, and a peripheral downstream toe drain (Figure 4).

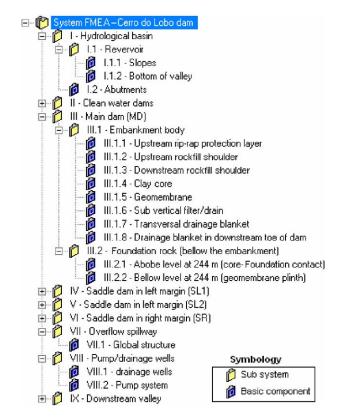
Figure 7. Cerro do Lobo dam system.

Figure 7 partially illustrates the hierarchical structure of the *FMEA* of the Cerro do Lobo complex system, with components and corresponding parent subsystems being introduced. The definition of the system structure began with the identification of the main subsystems, which are the major sets of relevant elements of the system.

Those were, in turn, divided successively into subsystems of a lower level, until the basic components were reached, e.g. *III.1* subsystem in Figure 7, as detailed below.

As an example (e.g. Table 2), for the main dam (III), two sub-systems of the next level were considered: the dam body (III.1) and the rock foundation (III.2). These subsystems were then divided into basic components. For the dam body, the following basic components were used: the upstream protection layer (III.1.1), the upstream and downstream shells (III.1.2 and III.1.3), the clayey core (III.1.4), the geomembrane (III.1.5), the chimney filter (III.1.6), the transversal drainage blanket (III.1.7) and the peripheral downstream toe drain (III.1.8).
