COMPREHENSIVE ASSESSMENT OF THE CAHORA BASSA DAM'S CONCRETE SWELLING PROCESS

António Lopes Batista^{1*}, Ezequiel Fernandes Carvalho², Ilídio Marcos Tembe²

¹Laboratório Nacional de Engenharia Civil (LNEC), Lisbon, PORTUGAL

²Hidroeléctrica de Cahora Bassa (HCB), Songo, MOZAMBIQUE

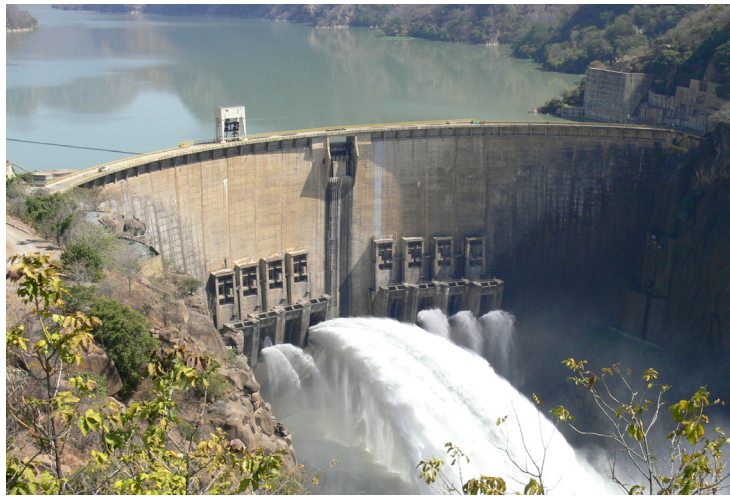
FIGURE 1: Downstream view of Cahora Bassa dam

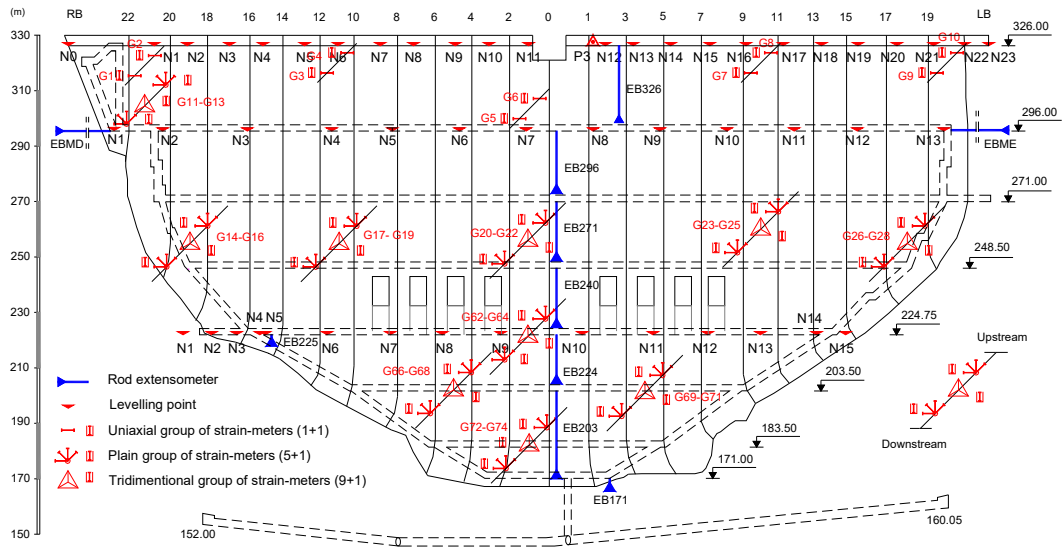
Figure 2 presents the dam's monitoring system for the observation of vertical displacements and concrete strains.

FIGURE 2: Dam's monitoring system for the observation of vertical displacements and concrete strains
