16th International Conference on Alkali-Aggregate Reaction in Concrete Lisboa | LNEC | Portugal | 31 May - 2 June 2022

Monitoring of ASR/ISR structural effects in Aguieira bridges

Luís Oliveira Santos⁽¹⁾, Min Xu⁽²⁾, António Santos Silva⁽³⁾

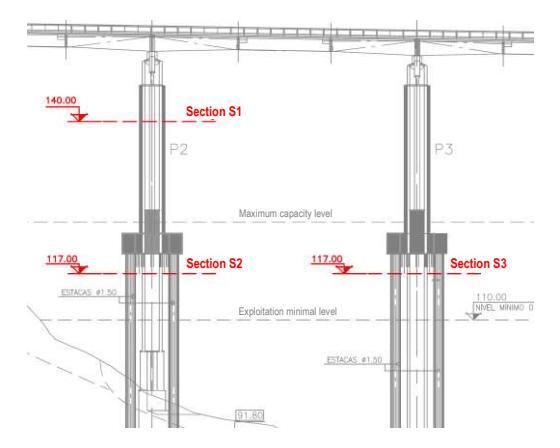
Figure 3.1: location of the instrumented sections at Criz II Bridge

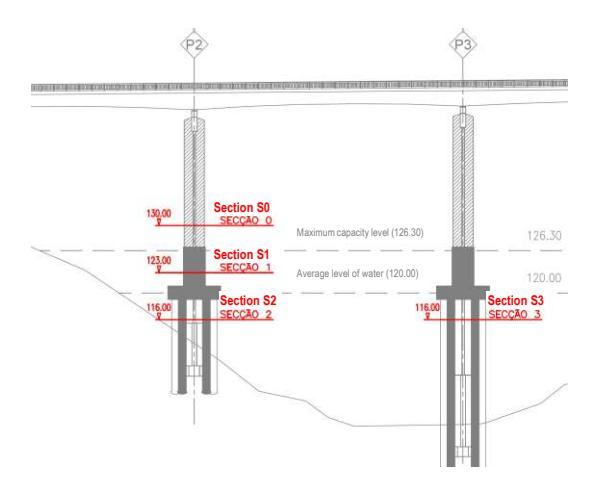
Figure 3.2: location of the instrumented sections at São João das Areias Bridge

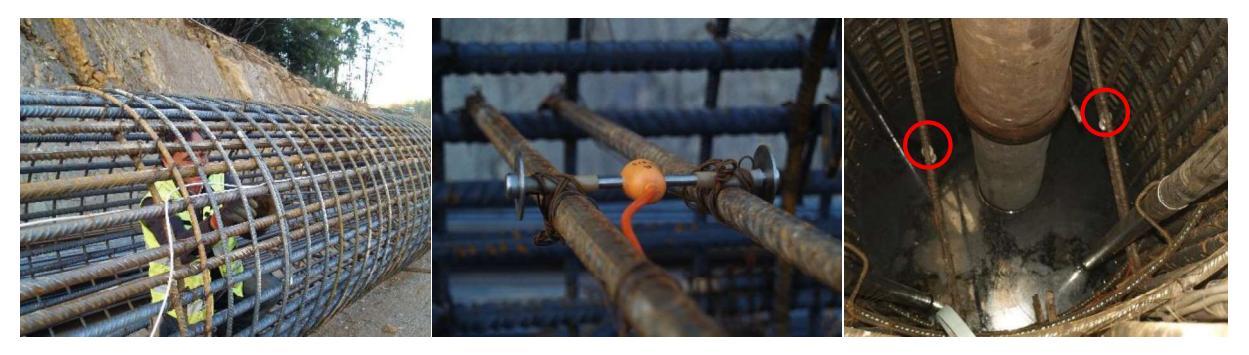
These strain gauges were installed when the reinforcement bars of the piles were still in the construction site (Figure 3.3). The strain gauges were fixed to two bars positioned for this purpose, which were welded to the main rebars of the piles (Figure 3.4). Then, the rebars were transported in a barge to the respective pier and installed inside the metallic jacket. Figure 3.5 shows a detail of a vibrating wire strain gauge during the installation of the reinforcement bars inside the metallic jacket.

Figure 3.3: Rebar instrumentation Figure 3.4: Strain gauge installed in the rebar of a pile

Figure 3.5: Strain gauges during concreting of a pile

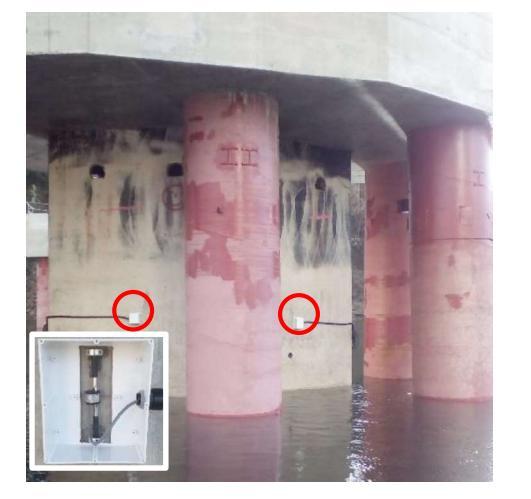
For the same purpose, the original shaft of the instrumented piers was also instrumented. In these piers, at the same level of the sensors installed in the piles, a vertical strain gauge was installed on each face of the original shaft (Figure 3.6). In addition, two horizontal strain gauge were mounted. Figure 3.7 presents the layout of the instrumented sections at the bottom of two piers of each bridge.

Figure 3.6: Strain gauges in an original pier

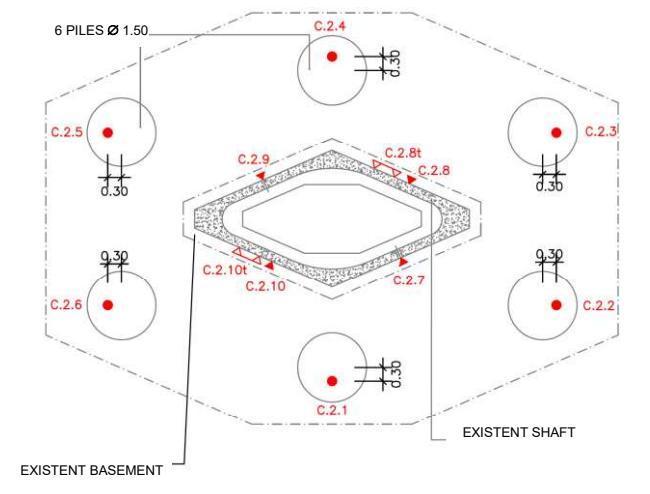
Figure 3.7: Layout of an instrumented section

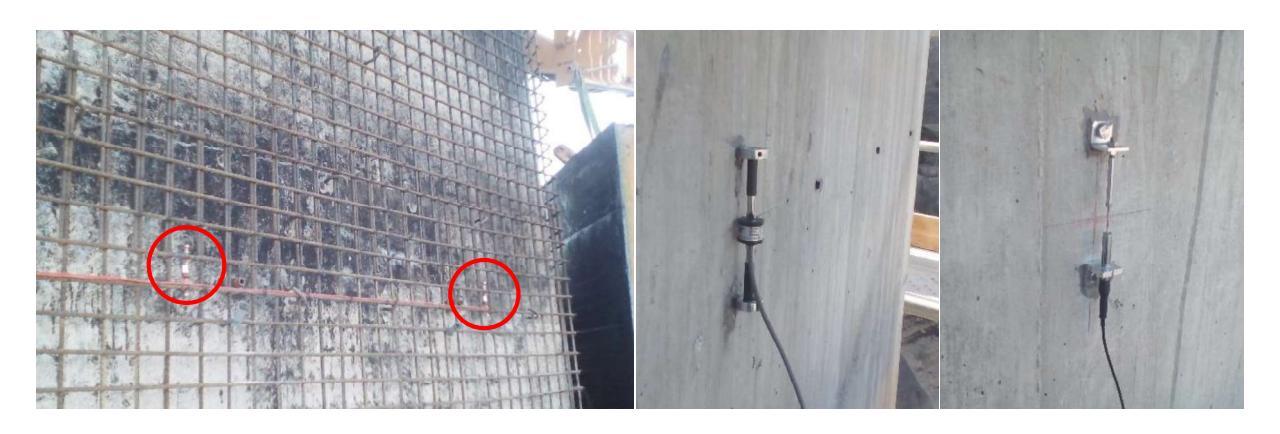
Finally, as a significant part of the piers of the São João das Areias Bridge was not jacketed, in a section close to the top of the pier P2 (section S0), two surface vibrating-wire strain gauges were installed (Figure 3.9), as well as two LVDT (Figure 3.10), in order to monitor the evolution of its deformation.

Figure 3.8: Strain gauges inside jacketing concrete

Figure 3.9: Strain gauge on the concrete surface

Figure 3.10: LVDT on the concrete surface

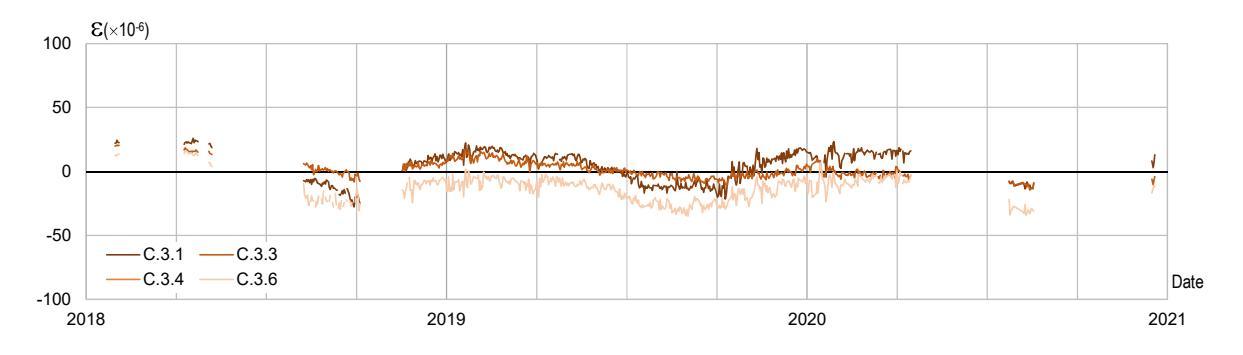
The strains measured in the piles of pier P3 of the Criz II Bridge are shown in Figure 4.1. The seasonal effects are clear in this figure, as a result of the significant temperature variations measured in the piles by the thermistors installed inside the strain gauges (Figure 4.2). The daily average air temperature is also shown in Figure 4.2.

Figure 4.1: Criz II Bridge: strains measured in the piles of the pier P3

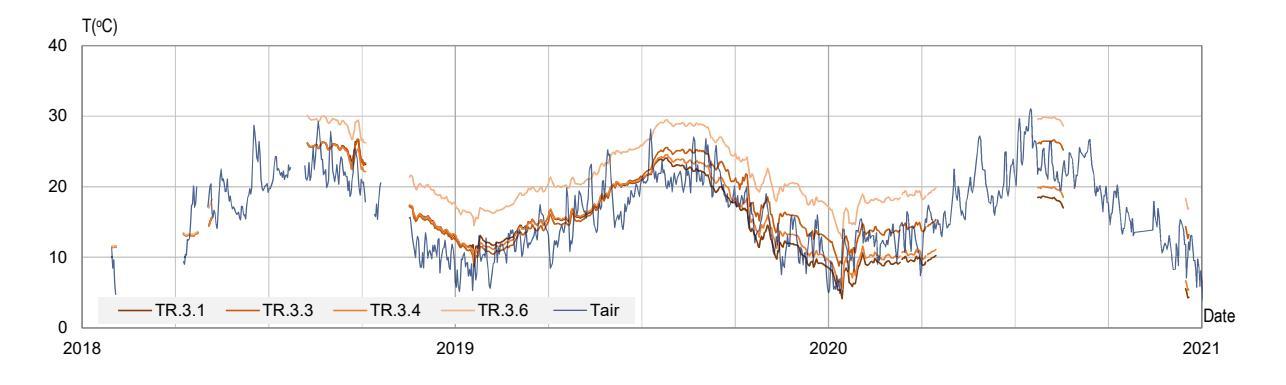
Figure 4.2: Criz II Bridge: temperatures measured in the piles of the pier P3

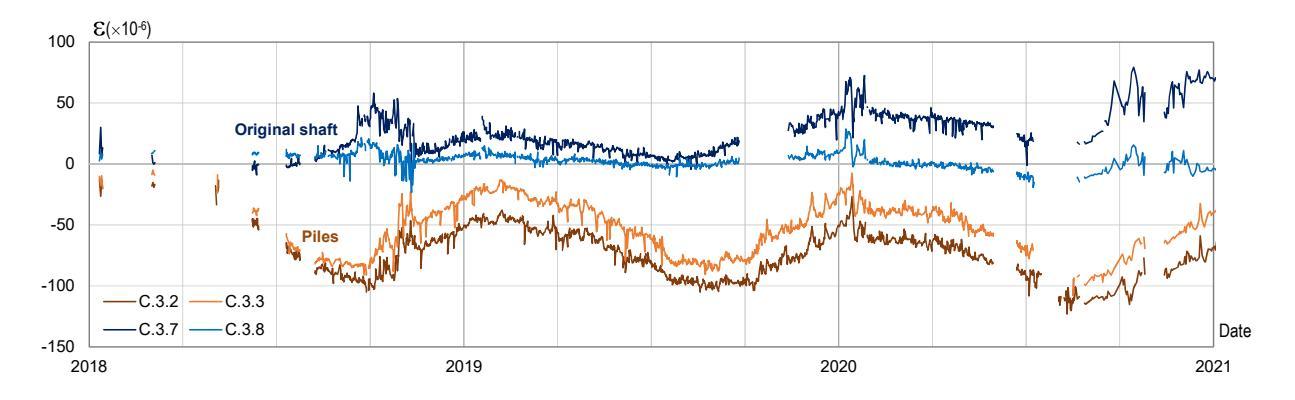
Among the experimental values obtained at the São João das Areias Bridge, Figure 4.3 shows the strains measured in the pier P3 piles, as well as in the respective original shafts. Also in these values, the effect of seasonality is clear. In fact, the variation of temperature measured by the thermistors integrated in the strain gauges is significant (Figure 4.4).

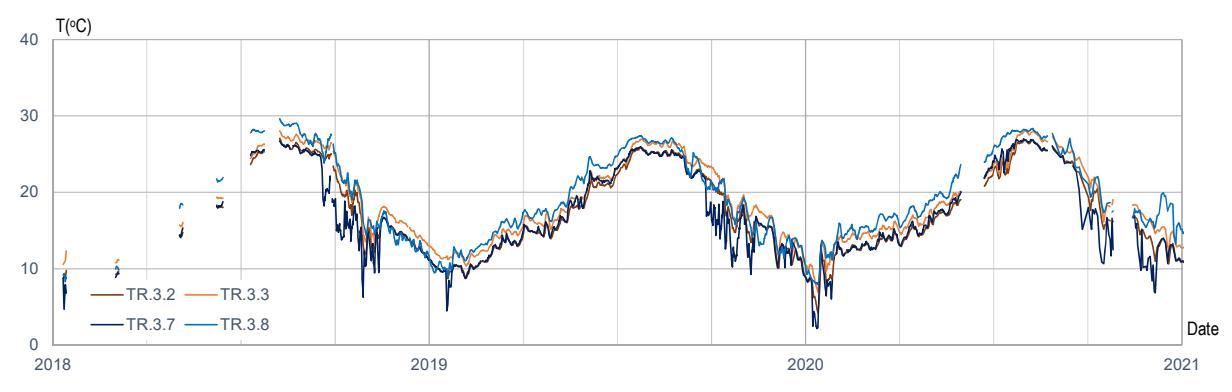
Figure 4.4: São João das Areias Bridge: temperature in the piles and in the original shaft of the pier P3
