PRELIMINARY IDENTIFICATION OF THE STRUCTURAL EFFECTS OF CONCRETE SWELLING IN CHICAMBA DAM (MOZAMBIQUE)

ABSTRACT

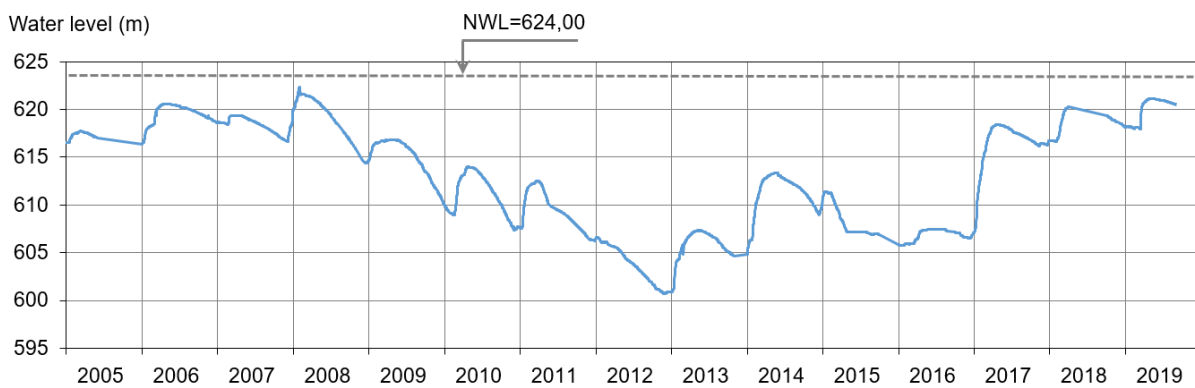
Fig. 3 – Evolution of the reservoir water level from the beginning of 2005 to August 2019

Figure 3 shows the evolution of the reservoir water level from the beginning of 2005 to August 2019. Between 2005 and 2008 the average water level in the reservoir was close to 618 m, showing the typical seasonal variations (rise in the rainy season, in the first semester, and fall in the dry period, in the second semester). After 2008, the average annual water level decreased gradually until 2012. In that year, in which the usual level rising during the rainy season did not occur, the reservoir reached the minimum level of the last 15 years (600.70 m on 12/06/2012). In 2013 and 2014 the level rose again, standing at around 610 m at the end of 2014. In 2015 the level decreased, having remained at elevations close to 607 m during the final part of 2015 and during 2016. In the beginning of 2017, the water level rose about 11 m, reaching the elevation 618.43 m in 19/04/2017. From there on the average annual level increased gradually. In early May 2019 the level reached 621.14 m, close to the maximum of the last 15 years, which occurred in early 2008 (622.35 m). From that date, the level gradually decreased, having been, at the end of August 2019, at 620.51 m.

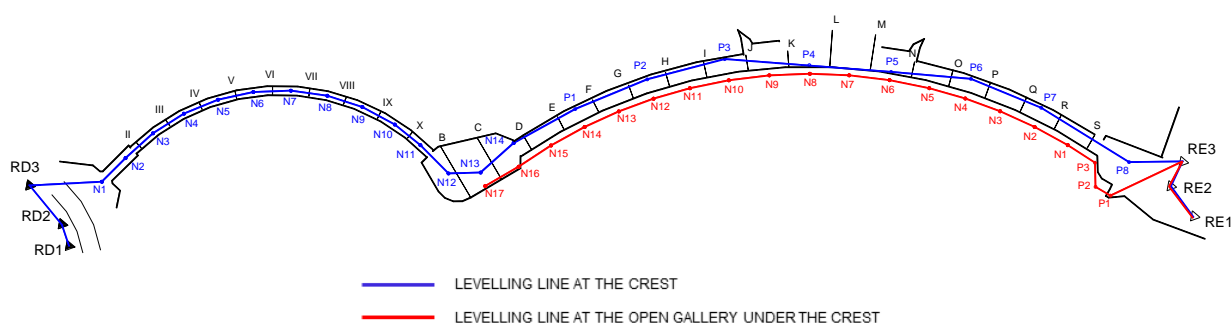
Fig. 7 – Plan of the two precision levelling lines installed on the open gallery under the crest of the main arch (elevation of 222.50 m) and on the crest of the secondary arch (elevation 225.00 m)

Fig. 7 shows the dam's plan with the location of the measuring points of the two precision levelling lines installed on the crest of the dam (elevation 225.00 m) and on the open gallery under the crest of the main arch (elevation of 222.50 m).

Fig. 8 and Fig. 9 present the vertical displacement along the levelling lines obtained on 11 surveys performed between 2010 and 2018. The obtained movements are consistent with seasonal thermal variations and with the existence of moderate expansions in the concrete.
