A CASE STUDY OF DESIGN, INSTALLATION AND LEAKAGE DETECTION SYSTEM OF A GEOMEMBRANE LINER

SUMMARY: A monolandfill (ash pond) for the ashes generated in the Sines thermoelectric power plant has been constructed, which has a geomembrane lining at its bottom to avoid impacts on the local groundwater. In order to verify the integrity of the geomembrane before the beginning of the ash disposal, a leakage detection system was installed. The paper describes the technical aspects related with the design and installation of the geomembrane liner, and presents the damage detection system used.

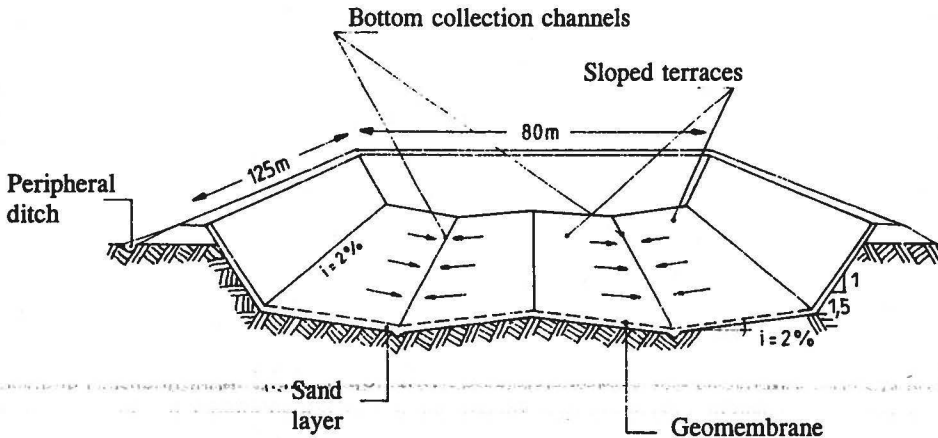
The construction of the cell started with the regularization and compaction of the bottom layer, with a final longitudinal slope of 2%. To avoid the accumulation of leachate, the bottom area was arranged into four parallel sloped longitudinal terraces, as shown in figure 1. The leachate that accumulates on the surface of the terraces will drain to one of the two leachate collection channels, as the cross slope of the terraces is also 2%.

Figure 1. General view of a cell

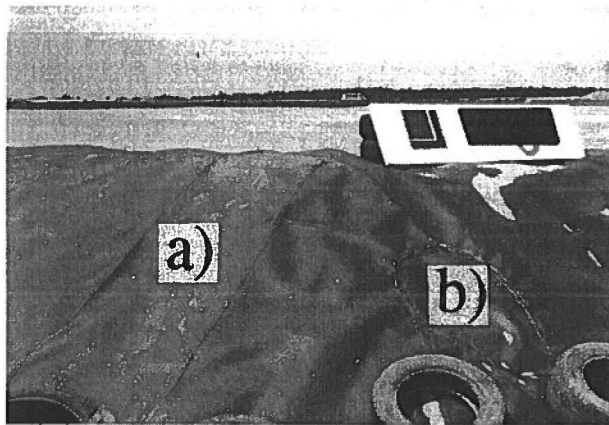
The geomembranes were predominantly welded with a double hot wedge, except for special points where, due to any occurring defect, the use of the extrusion technique became necessary (figure 2).

Figure 2. Geomembrane welding system: a) double hot wedge; b) extrusion

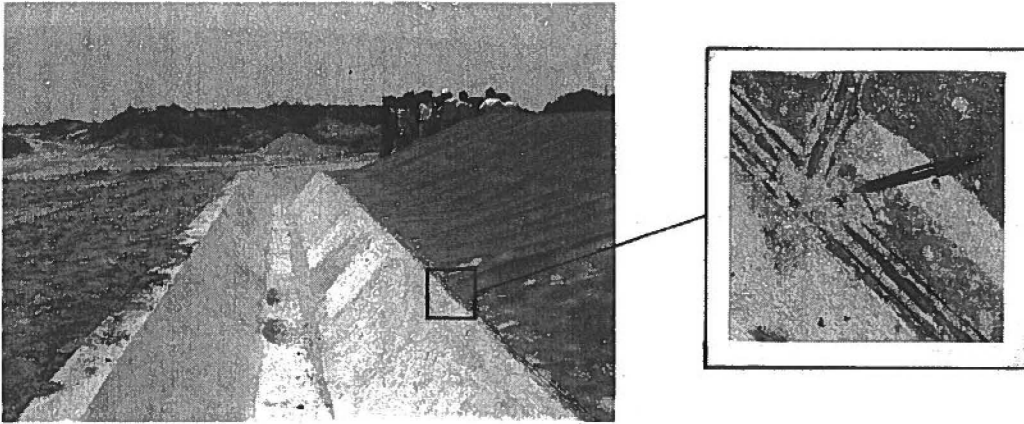
The terminal joint (geomembrane-concrete drainage ditch) was made with a high density polyethylene profile, which, on one side, was fitted into the drainage ditch and, on the other, welded to the geomembrane by extrusion. This technique offers an excellent resistance and ensures the imperviousness of the joint (figure 3).

Figure 3. Geomembrane-concrete drainage ditch connection

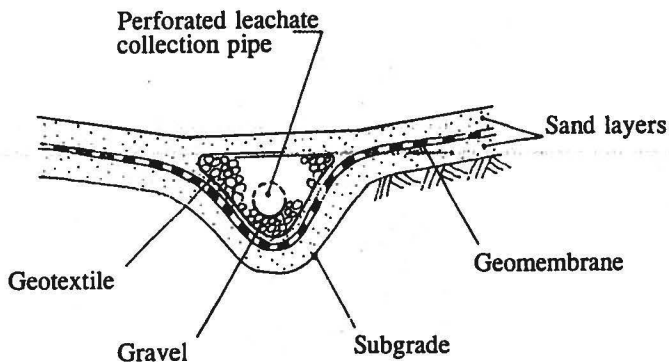
The drainage system comprises the peripheral ditch, to divert the surface water runoff, and two bottom collection channels (figure 4).

Figure 4. Bottom drainage system

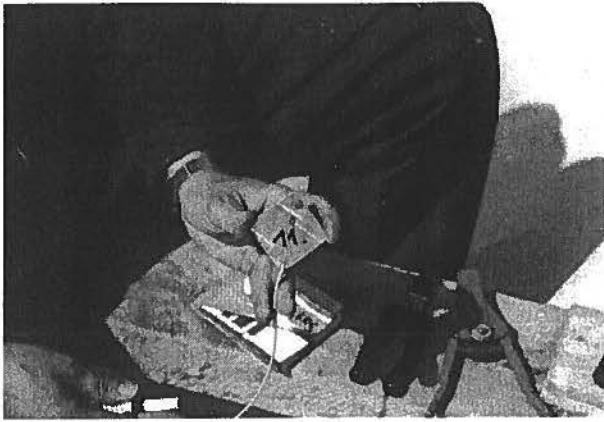
The electrical detection system consists in a network of sensors (figure 5), placed under the geomembrane. All sensors are connected with the central unit (figure 6), via cables, which are also installed under the geomembrane. An electrical source is applied above the liner, and the sensors measure the electrical field generated by this source (figure 7). An interpretative software analyses the data from the central unit, producing an equipotential diagram, any abnormality showing up as peaks on a contour line display.

Figure 5. Sensor

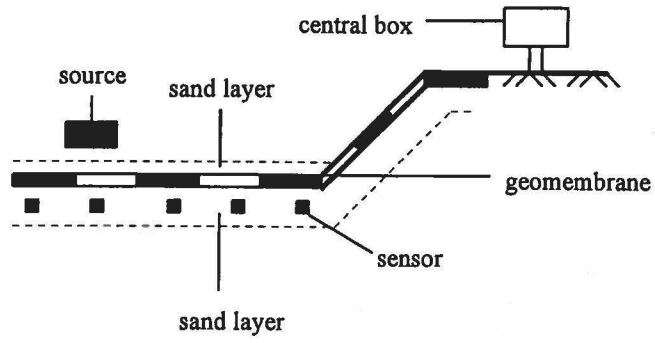
After completion of the installation of the geomembrane and the protective layer (20 cm sand), an electrical current was applied. The sensors beneath the geomembrane measured the potential coming from the source. The current density of the field depends on the integrity of the geomembrane. The measured data were treated by the software, and a three-dimensional map was draw (figure 8). The analysis of the results gave a precise information on the position of the damages present in geomembrane.

Figure 7. Damage detection system
