CONSTRUCTION AND FIRST FILLING OF PINHÃO CONCRETE FACE ROCKFILL DAM

João Marcelino¹, Manuel Moras², Sotero Ribeiro²

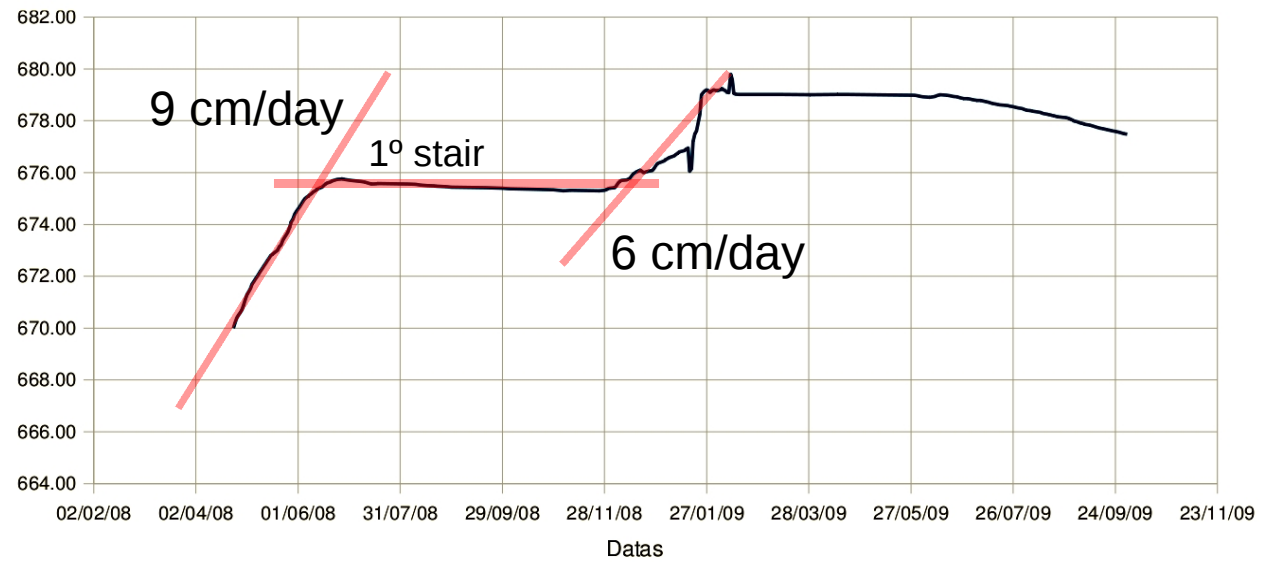
Water level (m)

Máximo=	679.8	em	10/02/09	Média=	676.61
Mínimo=	670	em	24/04/08	Desvio Padrão=	2.26

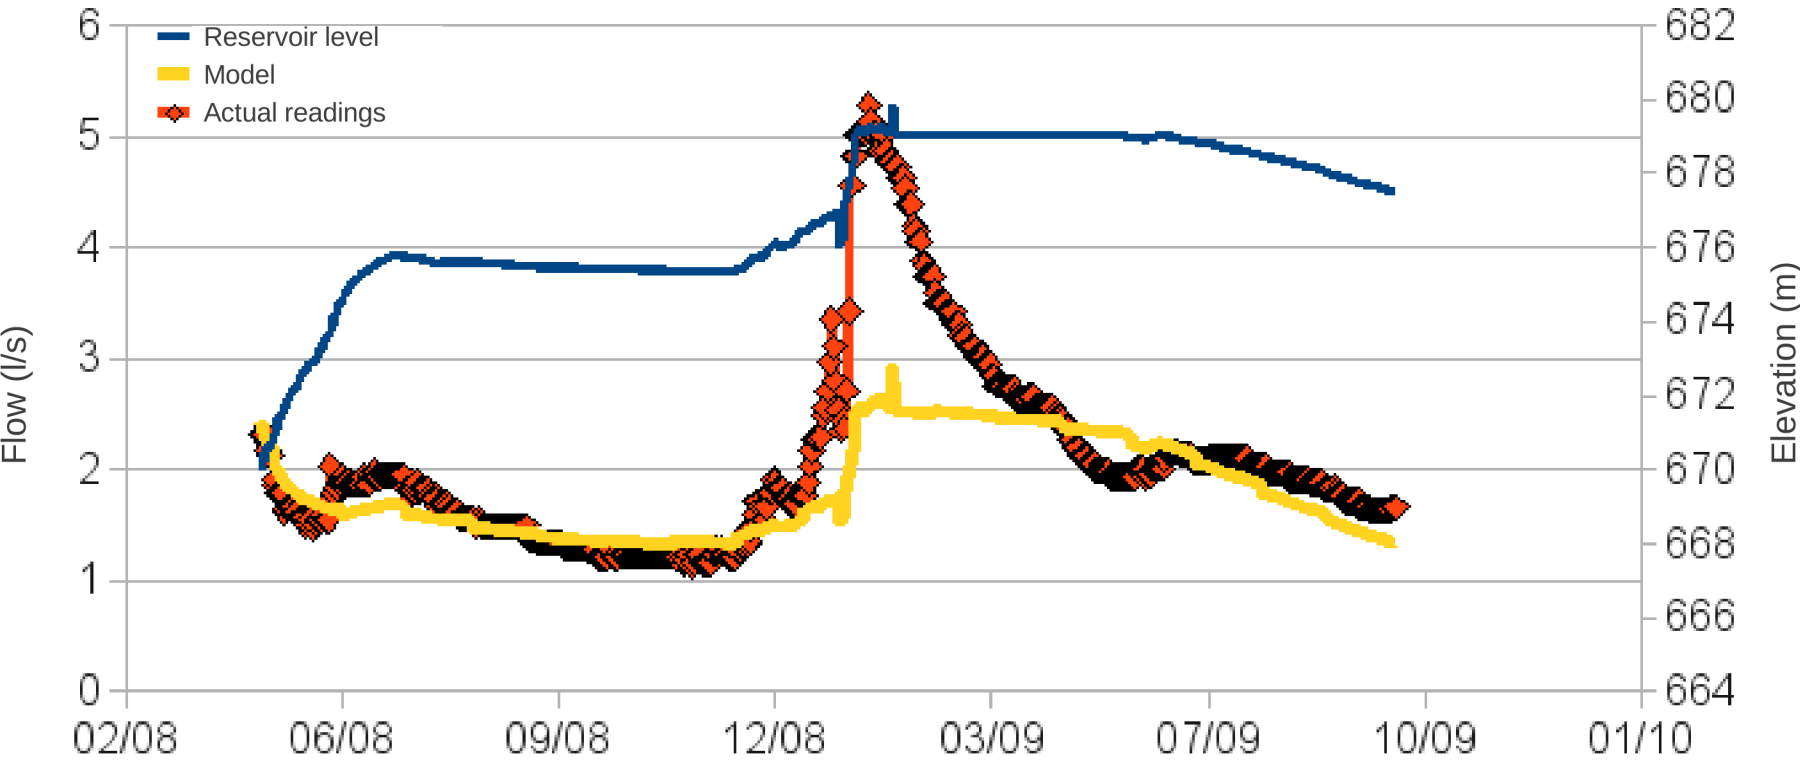
$$Flow(l/s) = 2,149 - 0.00133 N + 0.3046 f(M) - 0,3537 (wl - 670) + 0.0451 (wl - 670)^2$$

Model → 98 m³/day
Actual measurements → 118 m³/day
