ANALYSIS AND INTERPRETATION OF THE STRUCTURAL BEHAVIOUR OF ALQUEVA DAM DURING THE FIRST FILLING OF THE RESERVOIR

Abstract. *This paper presents the most relevant monitoring data and the interpretation of the structural behaviour of Alqueva dam during the first filling of the reservoir, which took place between February 2002 and January 2010.*

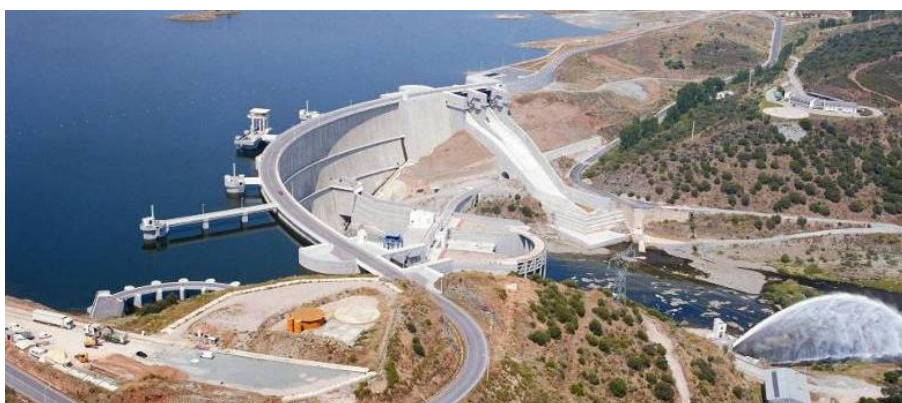
Figure 1: Alqueva dam

Alqueva dam is a 96 m high double curvature thick arch dam, with two artificial abutments and a crest development of about 348 m, built on the Guadiana River. At the normal water level (el. 152 m), the reservoir is the largest artificial lake in Western Europe, with a total volume of 4150 hm³ and covering an area of about 250 km².

Alqueva dam (Fig.1) is the main structure of a multipurpose project, located in the Alentejo region (southern Portugal), whose main objectives are the creation of a strategic water reserve in a region which has been showing a trend to desertification, the water supply to the population and to irrigation and the production of electricity. This project, owned by a public enterprise (EDIA – Empresa de Desenvolvimento e Infra-Estruturas do Alqueva), involves numerous structures, mainly dams, irrigation channels and pumping stations, and is changing the region through the development of new industries and services, such as agriculture and tourism.

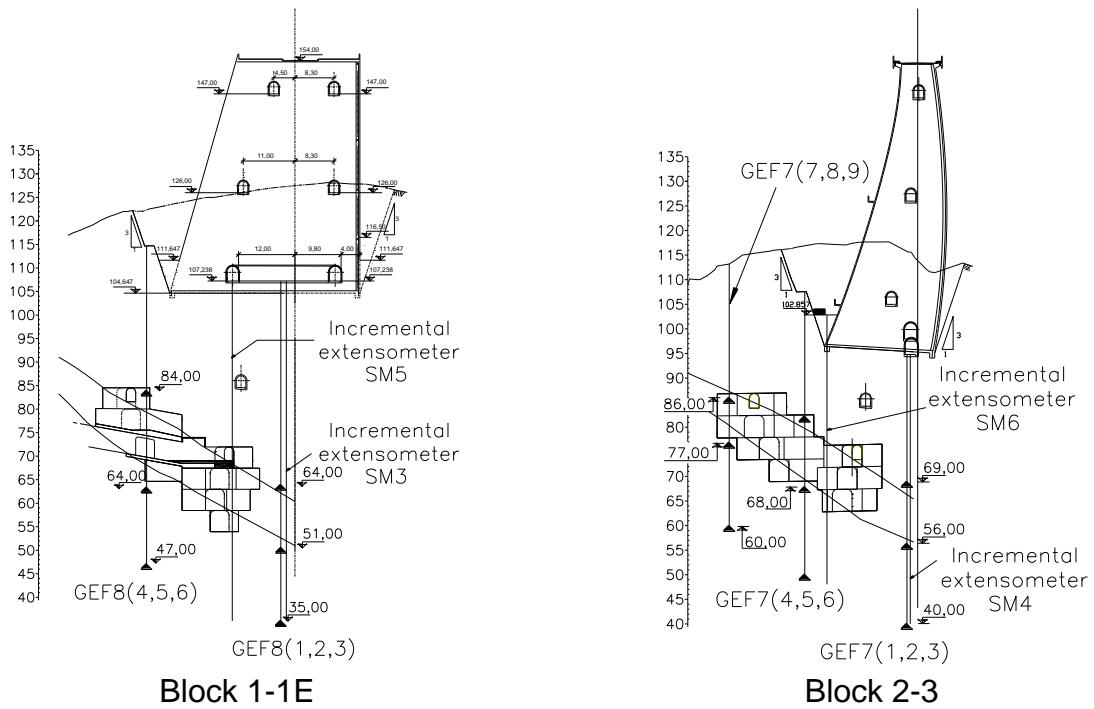
Figure 5: Monitoring devices in the zone of fault 22

The monitoring plan outlined prior to the dam construction already considered the monitoring of specific items related to the foundation behaviour in the zone around fault 22. However, during the construction works it was necessary to adjust the primary design, which required the development of a specific monitoring plan concerning the observation of the behaviour of this foundation region⁴. According to this plan, specific devices for measuring displacements and stresses in the concrete were placed in well-defined cross sections of blocks 2-3 and 1-1E (Figure 5).

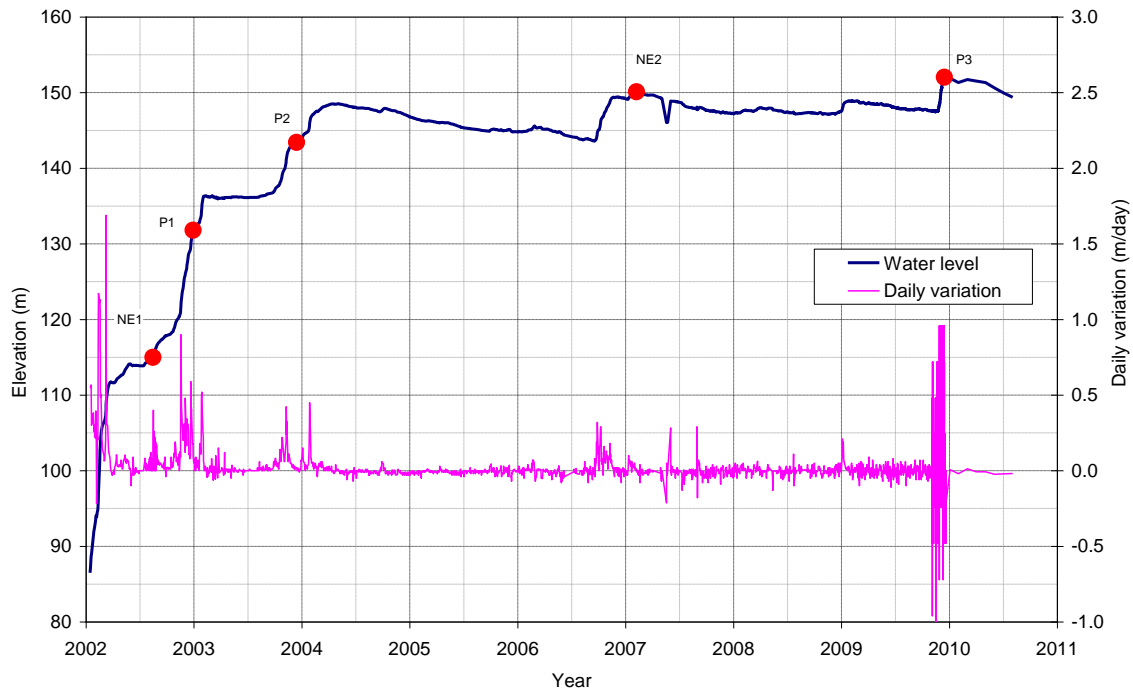
Figure 9: Time history of the water level in the reservoir

Until May 2002 the increase of the water level was conditioned by the works in the foundation and in the contraction joints (Figure 9). After the 2003/2004 winter the increase rate of the water level was smaller, due to the use of water for irrigation purposes. The water level only reached elevations 150 m and 152 m, corresponding to the last phases of the reservoir filling, in 2007 and 2010, respectively.

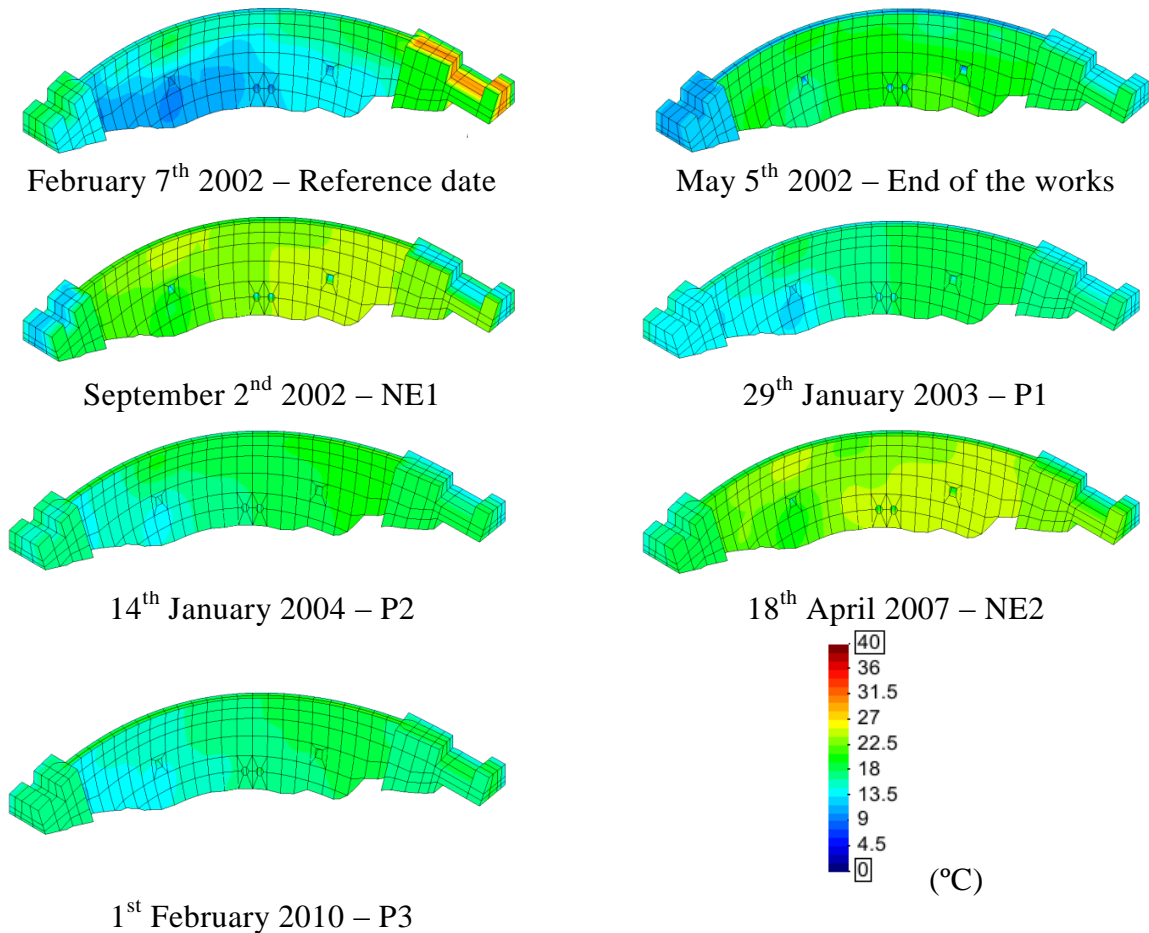
Figure 11: Calculated thermal field on different dates.

During the first months of the reservoir filling the concrete temperature variations were significantly affected by a forced cooling, carried out so as to allow a proper injection of the contraction joints (Figure 10). Thus, in May 2002, when this injection was concluded, the dam body was at an exceptional low temperature, of about 10 °C, and only in 2005 the temperature correspondent to the average annual temperature was reached. As the dam's body was cooled in several phases, it was necessary to take into account the variations of the real thermal field in the dam. Figure 11 shows the isothermals calculated in some key dates during the reservoir filling.

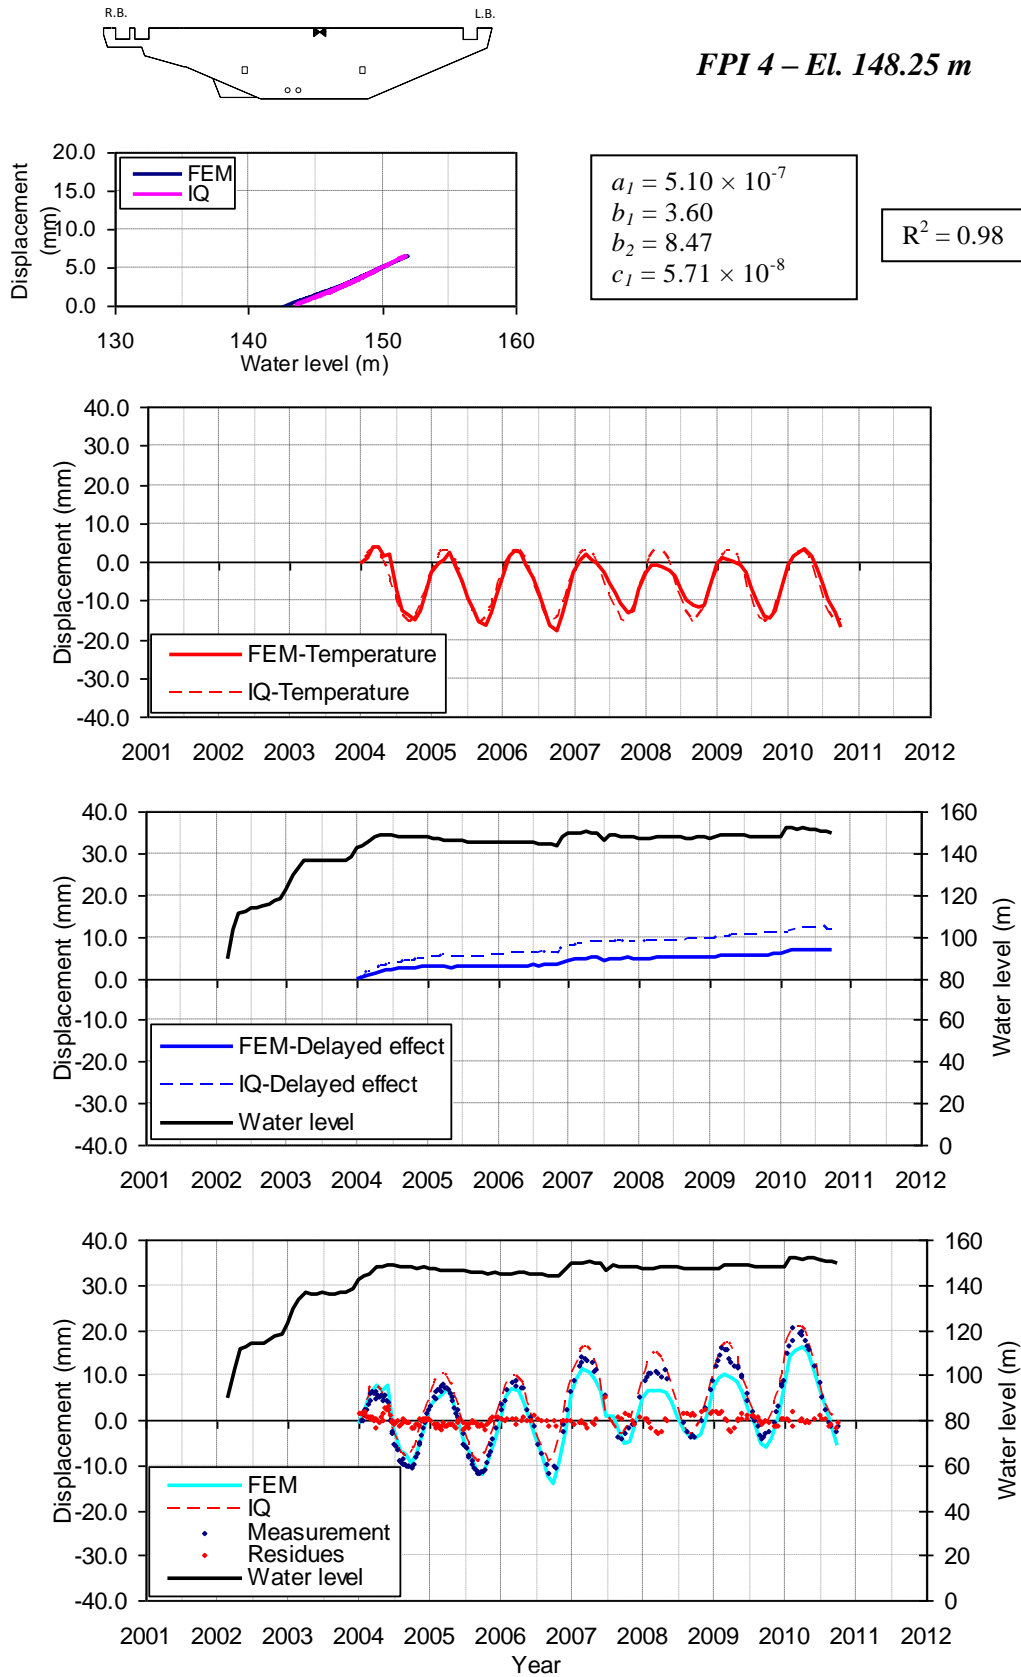
As an example, Figure 13 shows the comparison between the measured values and the results of both the quantitative analysis and the finite-element model for the radial displacements observed at the higher coordinometer base of plumb-line FPI4, at elevation 148.25 m, close to the central cantilever.

Figure 13: Comparison between observed radial displacements measured at FPI4 plumb-line (el. 148.25 m) and the results of both the quantitative analysis (IQ) and the FEM analysis (displacements towards downstream are positive).

The quantitative analysis results show that this model is a close representation of the observed displacements.

As shown, the hydrostatic effect estimated by the quantitative analysis is very close to the correspondent results of the finite element model.

In the quantitative analysis method, the thermal effects have the same sinusoidal evolution in all years during the analysed period. Thus, in years with environmental temperature variations very different from average temperatures in the period under analysis, the agreement results of the quantitative interpretation are not close to those calculated with the numerical model, which takes into account the observed temperature variations. This is what happens, for instance, in 2008 and 2009.

The time effect estimated by the quantitative analysis is more important than the correspondent results of the numerical model. Nevertheless, during almost all period, with the exception of 2008 and 2009, the observed displacements are close to those calculated with both the quantitative analysis and the numerical model. A reference must be made to the fact that the quantitative analysis considers only the measured displacements in each base, while the numerical model takes into account the structural behaviour of the dam/foundation set.

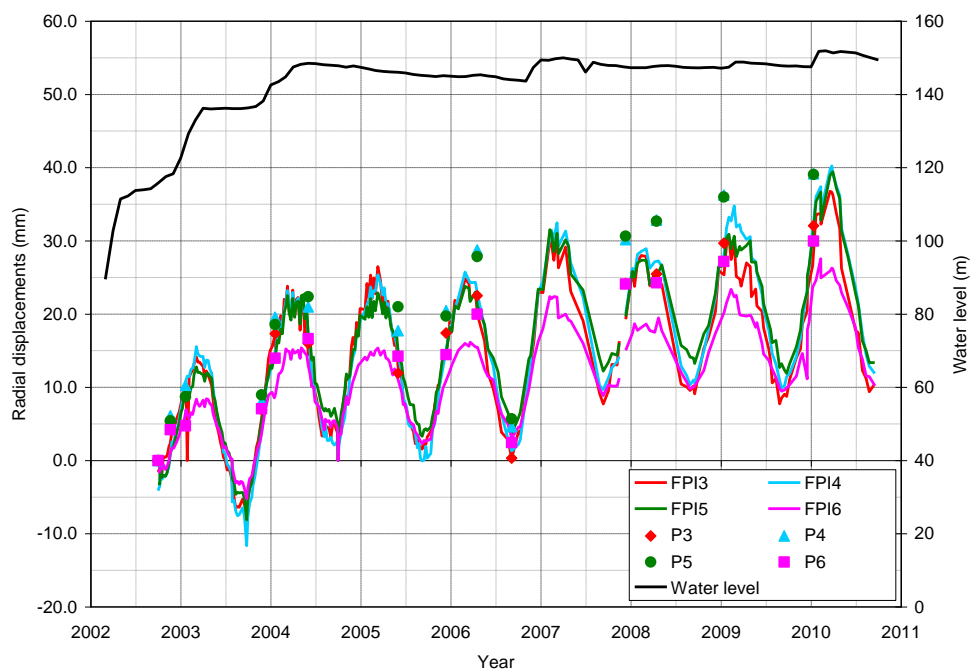
Using the displacements observed in all the bases of each plumb-line it is possible to extrapolate the displacements at the crest in that specific section. These displacements may then be compared with those measured by geodetic campaigns in the crest traverse. Figure 14 shows the good agreement between the displacements obtained by both methods in the higher blocks¹⁴.

Figure 14: Radial displacements at the crest obtained through the plumb-lines measurements and by geodetic methods (positive displacements towards downstream)

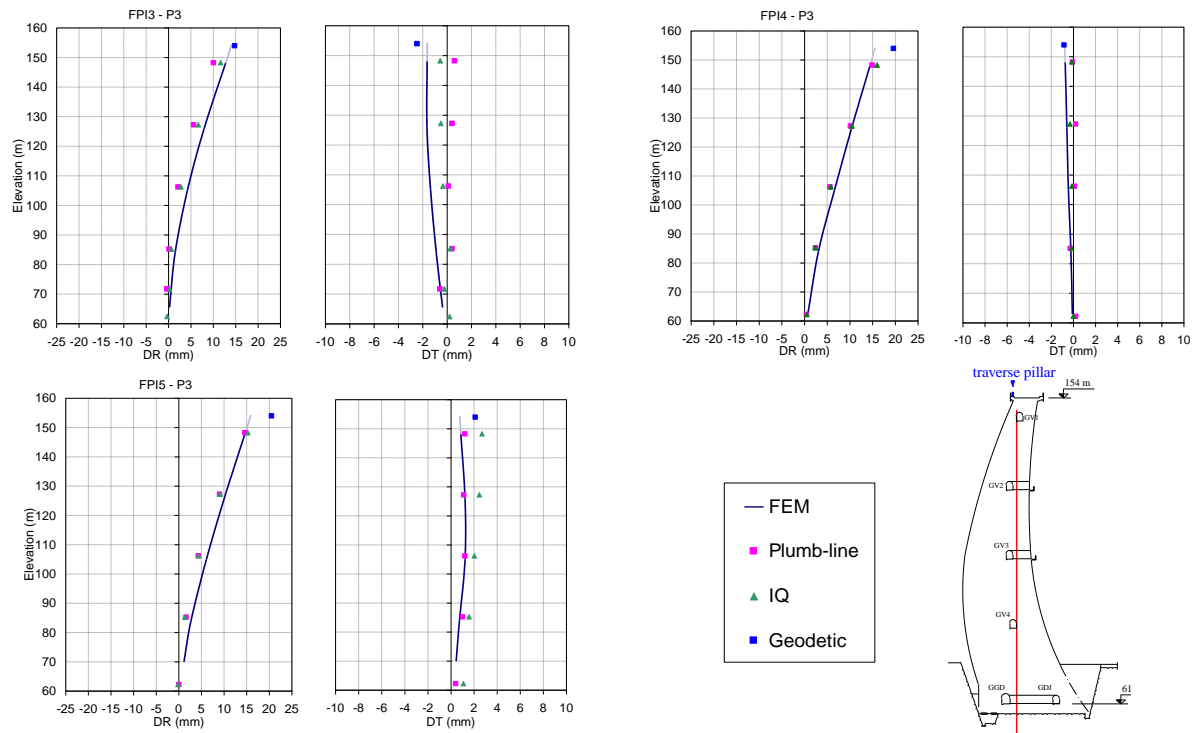
Figure 15 shows the comparison between the horizontal displacements measured in January 2010 ($H = 152.02$ m) at the central plumb-lines by the two methods and calculated by both the quantitative analysis and the numerical model at the same points.

Figure 15: Radial (DR) and tangential (DT) displacements in the central plumb-lines at P3 water level (2010-01-12; H = 152.02 m)

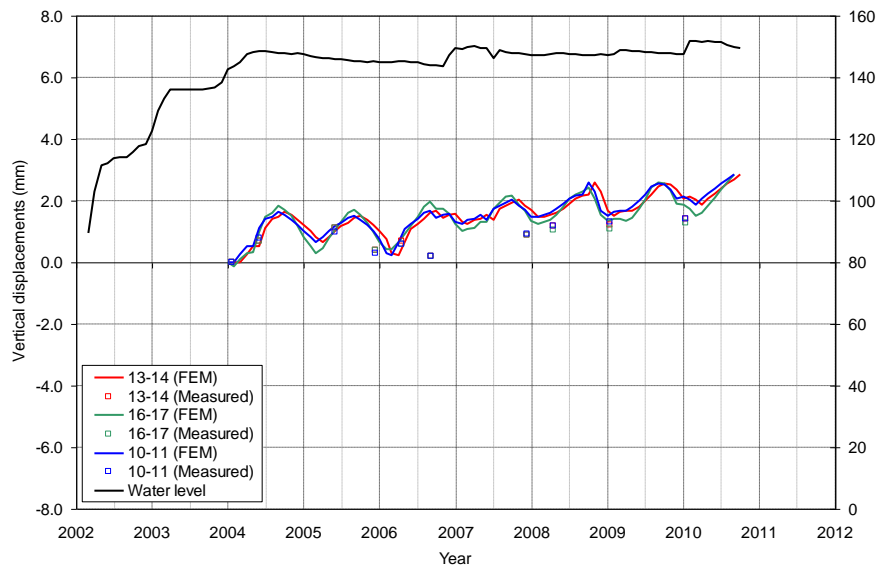
Figure 17: Vertical displacements on the GV3 gallery measured by geometric levelling and obtained from FEM analysis (positive values upwards).

Figure 17 shows a similar comparison between vertical displacements observed in some dam blocks through precision levellings along GV3 gallery and the correspondent values determined by the numerical model.
