## FAILURE BY OVERTOPPING OF EARTH DAMS. QUANTIFICATION OF THE DISCHARGE HYDROGRAPH

S. AMARAL<sup>(1)</sup>, R. JÓNATAS<sup>(2)</sup>, A. M. BENTO<sup>(3)</sup>, J. PALMA<sup>(4)</sup>, T. VISEU<sup>(5)</sup>,  
R. CARDOSO<sup>(6)</sup> & RUI M. L. FERREIRA<sup>(7)</sup>

Dam overtopping is one of the major causes for the failure of earth dams. The objectives of the present paper are the characterization of the breach evolution and the quantification of the breach hydrograph caused by dam overtopping. To meet these objectives an embankment dam laboratory model was led to fail by overtopping under hydraulic and geotechnical controlled conditions. The data presented concerns the hydrograph, calculated by indirect and direct methods. The key features of the hydrograph are discussed attending to the observed evolution of the failure event.

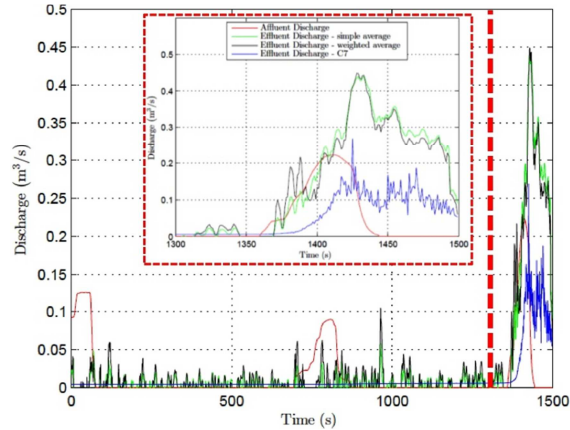
The breach outflow hydrograph in the first experiment was predicted by two indirect estimates, presented in Figure 12, namely from the spillway calibration curve (blue line in Figure 12) and the mass balance of the reservoir (black line in Figure 12). The spillway estimate is unreliable for discharges higher than the upper range of calibration (details in Bento, 2013, Jónatas, 2013).

Figure 12. First experiment. Indirect estimates of the breach outflow hydrograph

1. in the initial stage of the dam failure ( $t < 1380$  s):
  - 1.1 the breach outflow hydrograph estimated from the spillway provides a good estimate since the flow velocity inside the sand box is still relatively low and the effluent discharge is within the range of the spillway discharge rating curve (without extrapolation);

- 1.2 the breach outflow hydrograph obtained using balance of water mass within the reservoir (black and green lines in Figure 12) is not reliable since the noise amplitude of the estimate is higher than the estimated flow values;

2. from the moment the overtopping phenomenon becomes more pronounced ( $t > 1380$  s):
  - 2.1 the high agitation inside the sand box did not allowed reliable data levels acquisition; additionally, the water heights above the spillway crest were out of the range of the spillway rating curve and therefore, the spillway estimate was no longer reliable;

- 2.2 although there is still noise present in the breach outflow estimate, its amplitude is approximately constant and much lower than the estimated flow values; therefore, at this stage, this is the reliable estimate;

3. the inertia of the flow inside the facility cannot be neglected, as it can be verified by the approximately 15 seconds lag between the increase of the affluent and the effluent discharge;

4. a quite similar behavior of the breach hydrographs estimated using balance of water mass within the reservoir was observed using an equal or a weighted contribution of all the probes used in the data acquisition of the water levels inside the reservoir;

5. a peak outflow discharge of approximately 450 l/s was observed.

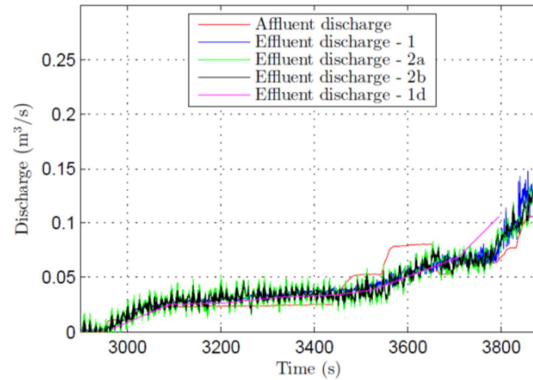
Figure 15 shows that there is a good agreement between direct and indirect estimates in the domain where it was possible to determine the former.

Figure 15. Second experiment. Comparison between the indirect and direct estimates of the breach outflow hydrograph

The direct estimation of the breach effluent discharge was not possible to perform until the instant of the peak discharge mainly due to: 1) the lack of sufficient styrofoam beads in the flow to allow the determination of the velocity with the LSPIV algorithm; and 2) the difficulty to accurately define the upstream parabolic shape of the breach (Figure 12).
