Second International
Dam World Conference
PORTUGAL • LISBON • LNEC • April 21-24, 2015

DOWNSTREAM VALLEY HAZARD CLASSIFICATION OF ITABIRA MUNICIPALITY DAMS

This paper presents the downstream valley hazard classification of five dams located in Itabira Municipality, in the context of the new Brazilian dam safety law.

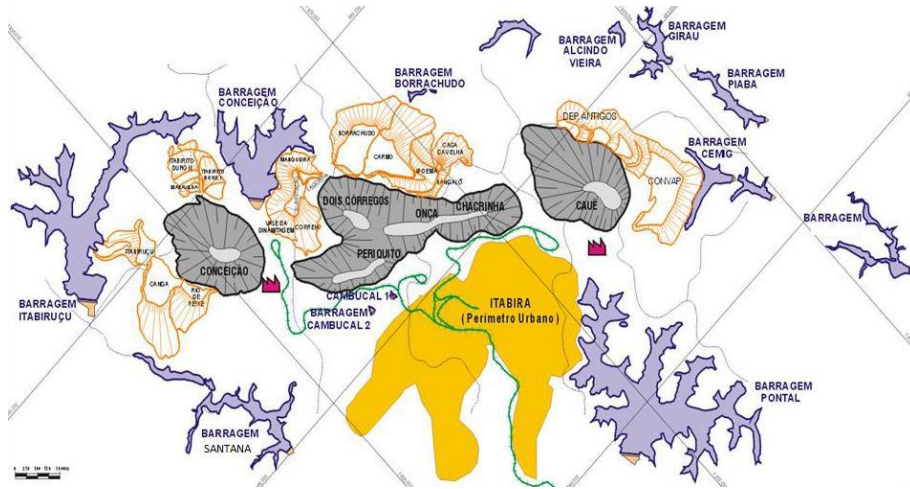
districts where there are basic heavy industries, a campus university, and growing urbanization as shown in Figure 2.

Figure 2 – Geographical growth conditioning – Source: Vale S.A.
