IP - 2

Helena CRUZ¹

SUSTAINABLE USE OF TIMBER IN CONSTRUCTION – SPECIFICATION, DETAILING, MAINTENANCE AND REPAIR FOR EXTENDED LIFE

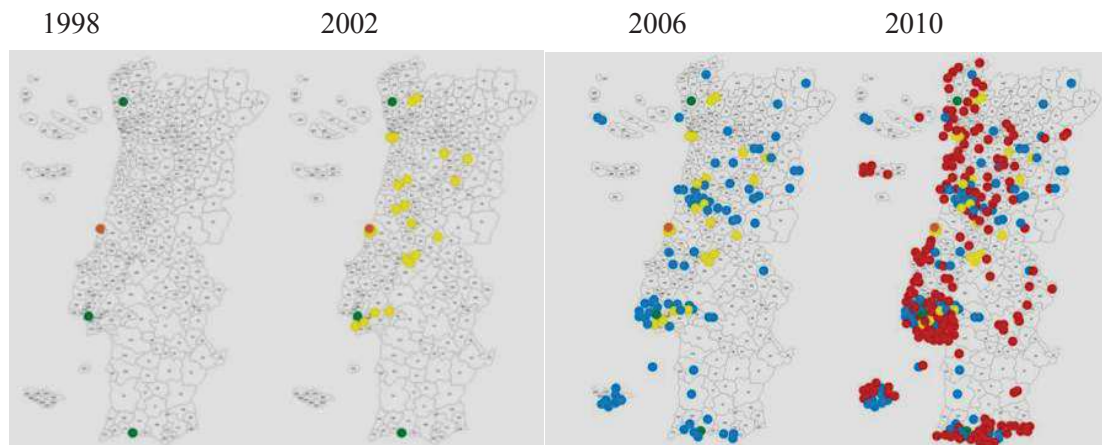
Figure 1. Glued laminated timber structures in Portugal (Negrão, 2011)

Glued laminated timber became very popular in Portugal (Figure 1) for the new public buildings like sports and concert halls, shopping centers and swimming pools. A small number of refurbishment works have also been done using this material (mostly in the form of straight floor beams).

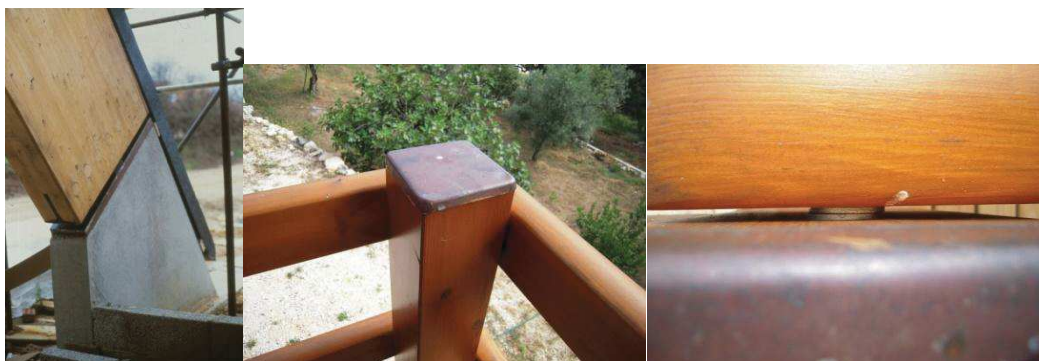
Figure 2. Timber resting on a concrete column to avoid contact with ground water; metal cap of the column end-grain surface; washers to space contact surfaces (top view)

End grain surfaces must be carefully protected from direct rain in outdoor uses as this is the preference entering way of water in timber. The use of metal caps (Figure 2), preservative treated timber layer or sacrificial (to be replaced when needed) timber layer, are several ways of doing it. Detailing should include ventilation gaps and dripping-pans, to prevent water retention. Repeated application of sealants or water repellents on the end grain surfaces may limit water exchanges with the exterior environment, thus limiting moisture variations.

Contact surfaces between timber elements are prone to water adsorption and uptake by capillarity, especially severe in large contact surfaces. In places subjected to the accumulation of dust and rubbish a gap larger than 5mm between adjoining surfaces is recommended; otherwise, a gap about 2mm is sufficient. Metal washers or similar simple devices may be used for that purpose (Figure 2). Horizontal contact surfaces may be more difficult to protect, requiring for instance the use of dripping-pans to drive water away, water repellent paints to reduce absorption), and in certain cases preservative treatment may be advisable to locally increase the durability.
