Towards a mobile monitoring tool for coastal structures inspection: The Ericeira rubble-mound breakwater test case

Rui CAPITÃO¹, Alexandre MAIA², Rute LEMOS¹, Armanda RODRIGUES²,
Conceição FORTES¹

Abstract

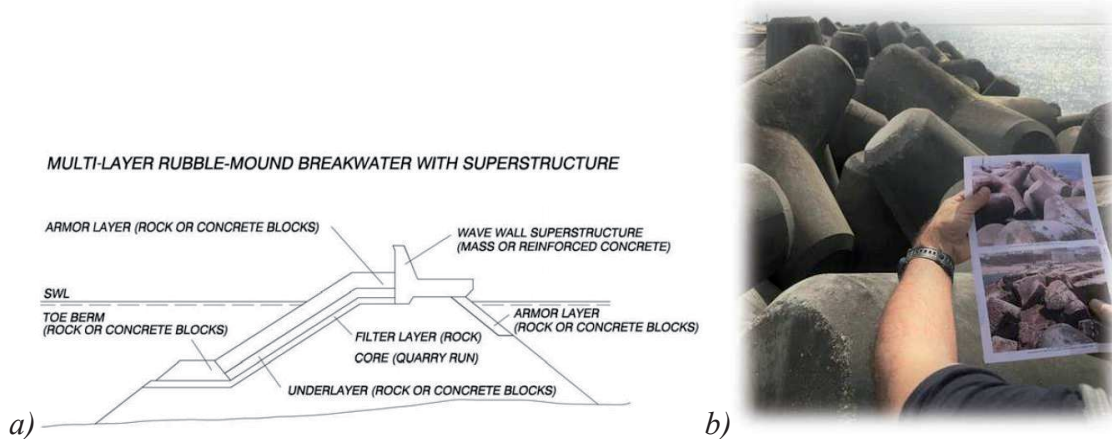
Fig. 1: a) A typical RMB with superstructure; b) Visual inspection (comparison of photos) in a point of section B of Ericeira's breakwater.

armour units. Its main function is to dissipate wave energy and/or to reflect wave energy back into the sea. Usually, rubble mound breakwaters consist of a core of fine material covered by an armour layer, made with stone or concrete blocks, together with filter layers as to avoid that fine material could be washed out through the armour layer (*Fig. 1a*).

Therefore, periodically, the structures are subjected to visual inspection, performed by the LNEC team, (*Fig. 1b*). In general, the structure is inspected yearly but additional inspections may be performed, especially after occurrence of notable storms. The data collected in each of those inspections refer to the current condition of the structure, namely its main components such as the armour layer, the superstructure and the inner filters.

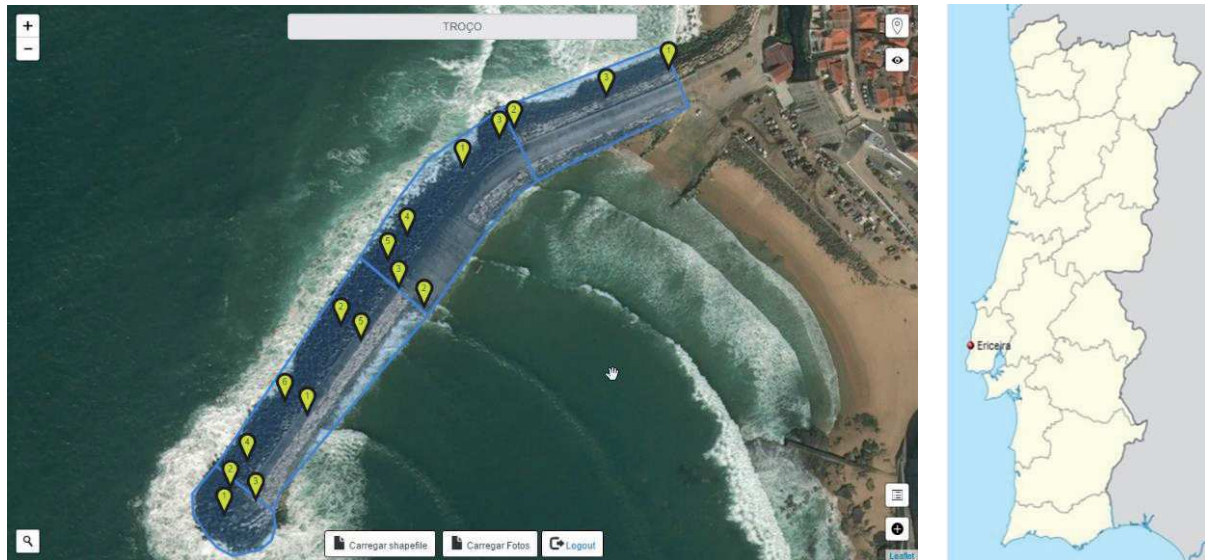
Fig. 2: Map showing sections and observational points of RMB of Ericeira used for the inspection campaign of 20th of April 2017.

Fig. 2 shows the 4 sections (A, B, C and D, from the root to the head of breakwater) and a total of 17 observational points of the RMB of Ericeira used for the inspection campaign of 20th of April 2017. Sections were introduced for the first time using pre-defined shapefiles on the WebGIS platform, before the first inspection. For subsequent inspections, sections' inspection

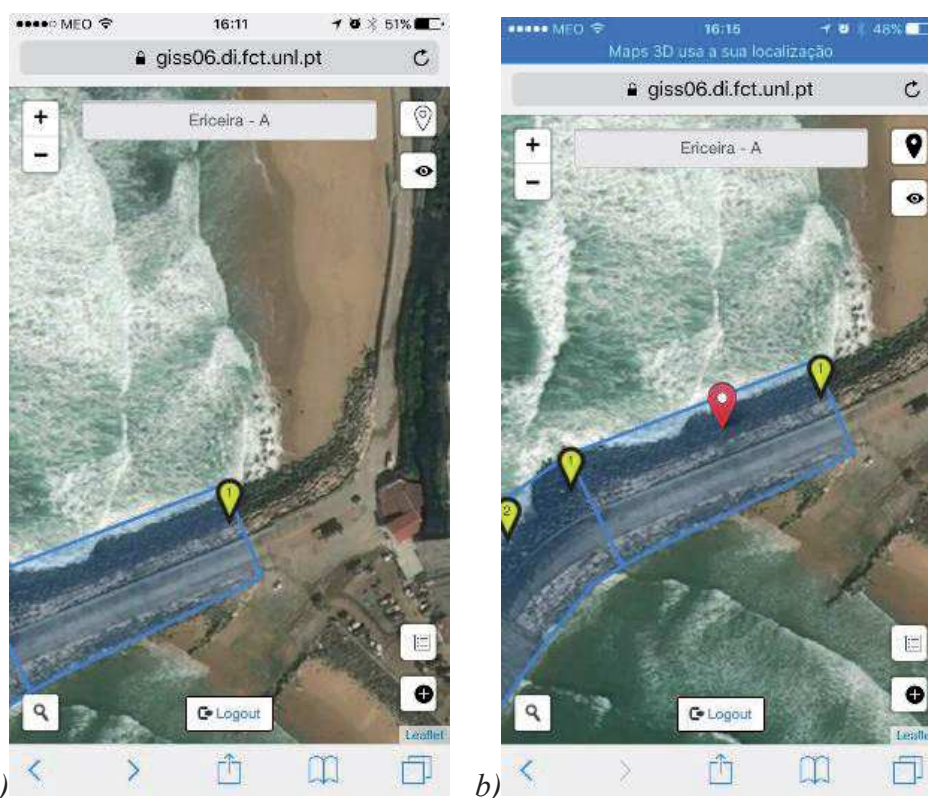
Fig. 3: a) Existing observational point (1, in yellow); and b) A new point (unnamed yet, in red), both in section A of RMB of Ericeira.

In Fig. 3, below, as an example taken on the 20th of April 2017 with a mobile phone (iOS 10.3.1, using Safari browser), one can see a point already pinpointed in section A of RMB of Ericeira (Fig. 3a) and the setup of a new point (red marker) on the same section (Fig. 3b).

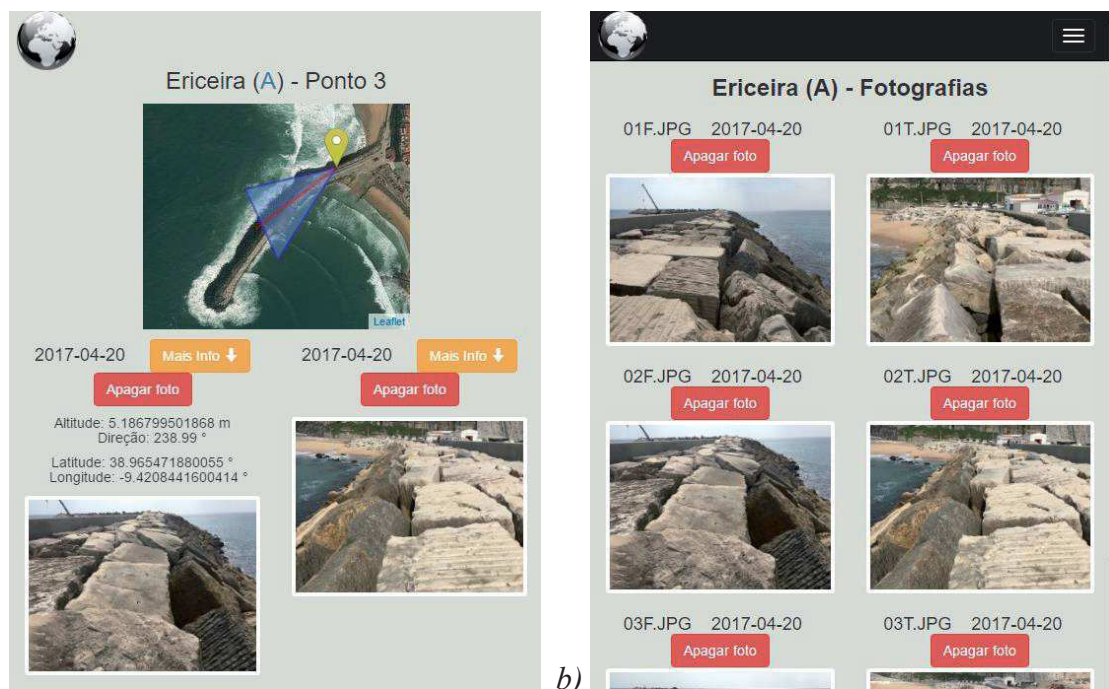
Fig. 4: a) Photos from point 03, section A; and b) All photos from section A (only points 01 and 02 are shown in figure), of RMB of Ericeira.

On the photos' page, the user has the chance to check the photos' metadata, with the help of a map, where the orientation of capture is displayed (Fig. 4a). With this feature, the user can capture photos using a particular camera instead of the mobile device camera. In this figure, note that the direction of the photo is indicated on the top image. On the left image on the bottom, one can observe the Exif data associated to that photo, namely the geographical coordinates, altitude and the direction of the captured photo.

One can access all photos and videos pertaining to each section of the RMB, that is, for all its points (Fig. 4b). In this figure, filenames include a "F" if they refer to the "front" of the RMB and "T" if they present the back, when referring to the direction of the photo.

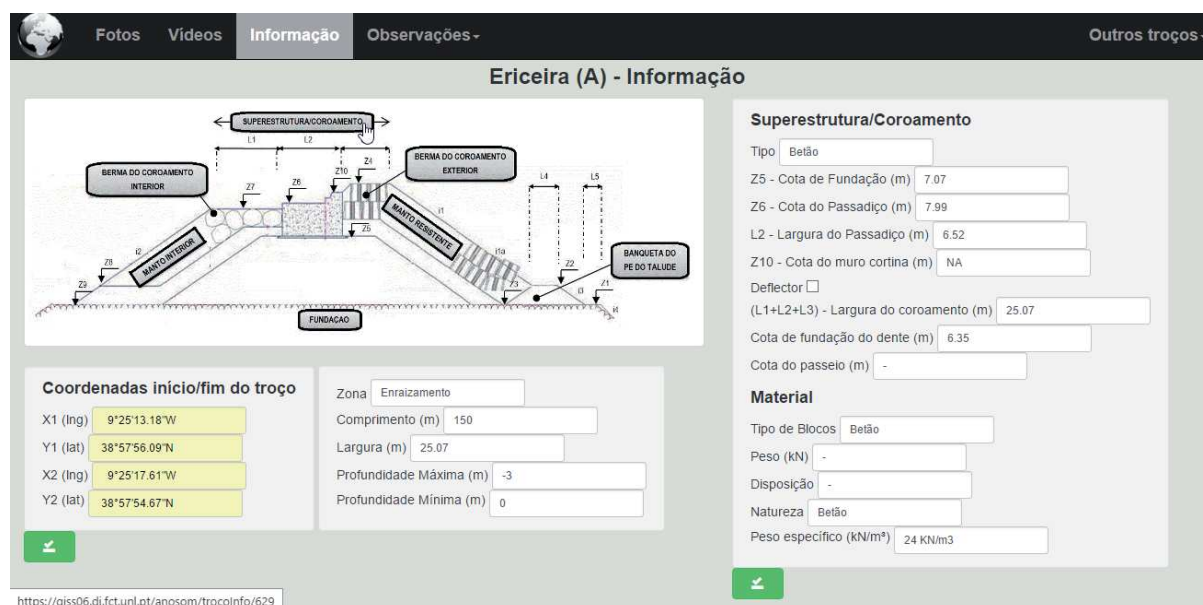
Fig. 5: The interactive interface includes clickable drawings and alphanumeric information of the elements of the section (in this case, section A of RMB of Ericeira).

Each structure's section has very specific characteristics, as shown in Fig. 5, such as its length and width, information about the superstructure/crown, the armour layer, the outer crest berm, the inner crest berm, and so on. This information essentially relates to the slope of the outer armour layer, the width, the values of the maximum and minimum dimensions and their materials (the type of blocks, the weight, the layout, etc.). To facilitate information viewing and analysis, the section interface page includes an interactive drawing of a breakwater, enabling viewing of a particular part of the information by clicking on the structure's relevant part.
