# Fernandina Wall of Lisbon: Mineralogical and Chemical Characterization of Rammed Earth and Masonry Mortars

**Abstract:** This paper aims to provide information on rammed earth and masonry mortars of the Fernandina defensive Wall of Lisbon, Portugal, which was built in the second half of the 14th century. No previous information exists concerning the materials and construction techniques used in this defensive structure, which is essential to increase knowledge and to define requirements for a reliable conservation. An experimental campaign was carried out on samples extracted in nine different sections of this structure, which were analyzed by X-ray diffraction, thermogravimetry and wet chemical analysis. Calcitic lime was employed as a binder in the stone masonry bedding mortars and was also identified in the rammed earth samples. The results obtained allowed us to verify the use of different binders and aggregates, with heterogeneous binder/aggregate ratios, in different sections of the Wall. To reduce time for lime preparation and to achieve a durable lime matrix, most probably quicklime was used and hydrated together with the moistened earth to produce rammed earth and mason

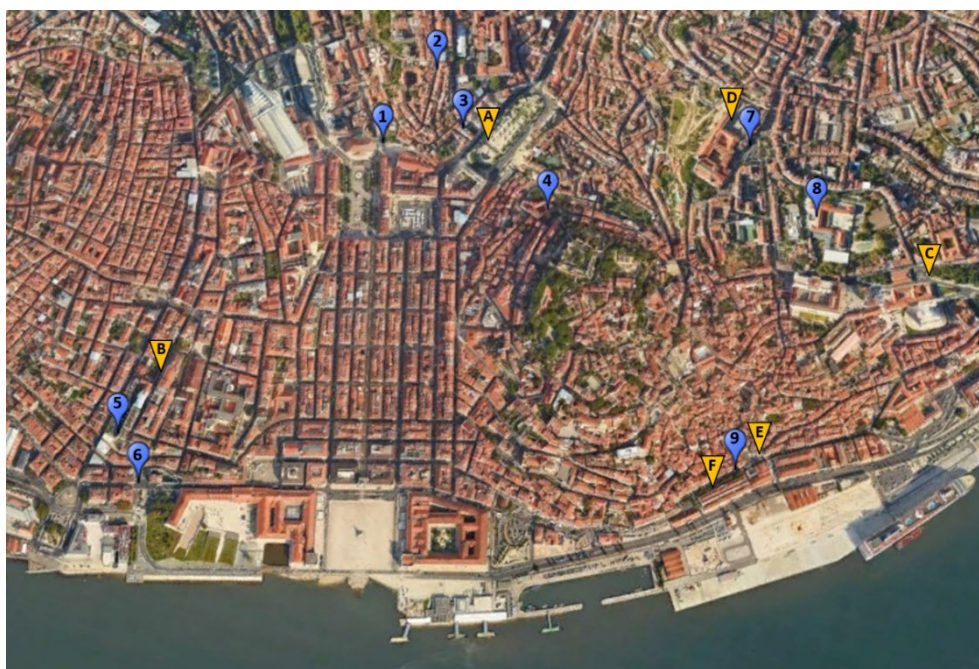
**Figure 2.** Aerial mapping showing the locations where interventions were carried out (identified by capital letters) and of the section's location on the Wall (identified by numbers). Notation: A—*Jogo da Péla* tower; B—*António Maria Cardoso* street; C—*São Vicente de Fora* parish; D—*Graça* parish; E—*Chafariz de Dentro* square; F—*Terreiro do Trigo* street; 1—Independency Palace; 2—*Calçada de Santana*; 3—*Calçada do Jogo da Péla*; 4—Rose Palace; 5—*Bragança* Terraces complex; 6—*Corpo Santo* Hotel; 7—*Gil Vicente* school; 8—*Graça* square; 9—*Terreiro do Trigo* street.

To the authors' knowledge, the interventions that were documented were carried out in the last 20 years. The first documented intervention took place in 1998, to the Western section of the Fernandina Wall, namely in the *Jogo da Péla* tower (Figure 2), near the *Martim Moniz* square. It was carried out by geologist Rui Brito in the context of his dissertation, in straight collaboration with the Lisbon City Council. It was intended to provide information on plastering and jointing mortars used between stone masonry blocks, as well as on the rocky substrate at the site of the tower. Laboratory tests revealed that the original mortars were mainly composed of air lime (CaCO<sub>3</sub>) and silica sand. Based on a macroscopic examination, the stones used for the masonry were classified into four different types: two sandstones, one fine-grained and the other very fine-grained, and marl and shell limestones [17].

The 2014 intervention on *António Maria Cardoso* street, in the historic center of Lisbon (Figure 2), focused on identifying the conservation state of the Western section of the Wall. Recommendations were made in order to preserve and restore the original characteristics of the walled structure. Inside one building, rammed earth main walls were identified in a reasonable state of preservation, including the concavities of the wooden needles inherent to its construction. Extending outside the building, one of the sections of the Wall presented a severe state of degradation, mainly owing to the impact of atmospheric agents. Air lime mortar and small pieces of bricks were, respectively, used to fill the existing smaller and larger gaps. After filling these gaps, the walls were rendered with two layers of natural hydraulic lime (NHL) mortar, the first layer with a proportion of 1:3 (NHL: sand) in mass, and the second of 1:4. In addition, the cement mortar render found in the interior of the building was removed and replaced with NHL mortars [18].

The tower of *Jogo da Péla*, placed in the sidewalk with the same name, is located near *Martim Moniz* square, an important landmark of Lisbon located between *Arco da Graça* street and *Calçada do Jogo da Péla* (Figure 2). It is one of the better-preserved elements of the Wall, found in the Western section. Nowadays, it holds no visible continuity with other sections, either to the west or to the east. This tower, made with limestone masonry and air lime mortar, is the only completely isolated example that still preserves some of its original features (Figure 3c).

The *Terraços de Bragança* residential and commercial complex, located on Alecrim street (Figure 2), is composed of eight five-story buildings. Designed by the renowned Portuguese architect Siza Vieira, its construction began in 2003. During the construction works, a section of the Fernandina Wall was discovered and remains one of the most representative existing examples of the Western fluvial section of the Wall made in limestone masonry and RE (Figure 4a).

During the rehabilitation works on the buildings numbered 6 to 26 on *Terreiro do Trigo* street (Figure 2), several traces of the Fernandina Wall in rubble stone masonry were found, namely main walls, one tower and one small entrance. These buildings are located along the Eastern section of the Wall, close to Tagus River.

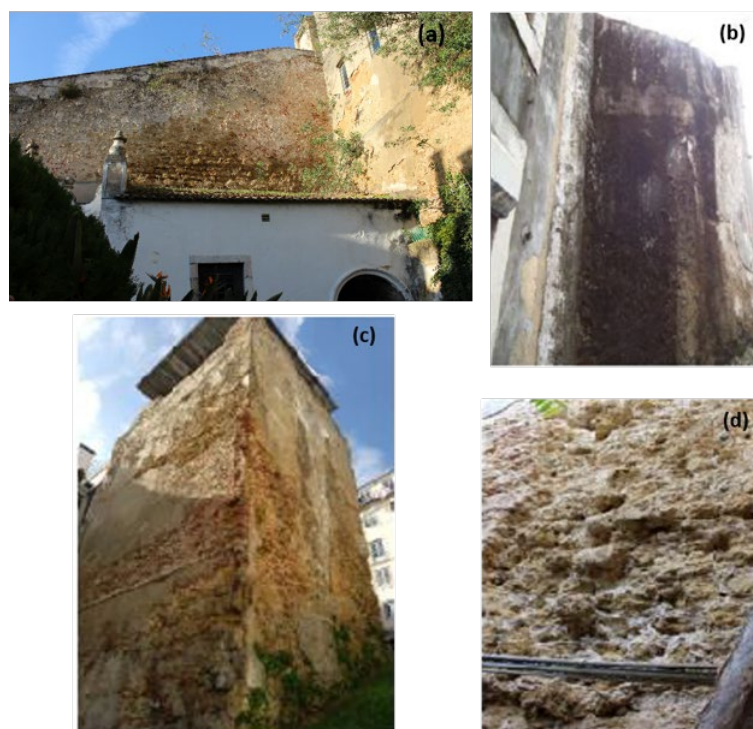
**Figure 3.** Case studies in Wall Western section: Independency Palace (a), *Calçada de Santana* (b), *Jogo da Péla* (c) and Rose Palace (d).

This may explain the degradation of the surface of the southern exposed Wall (Figure 3a), which lacks protective render and joint mortars. The various interventions carried out to this section, including the inclusion of the staircase and repair works using, eventually, inappropriate mortars, may also have contributed to the deteriorated conservation state of this original Wall section.

The turret in limestone masonry, with an implementation area of 5.5 m × 9.0 m and a height of 11 m (Figure 3b) [23], contains, at its top, a 36 m<sup>2</sup> terrace with walls facing east and west. In the past, elements such as chicken coops and flower beds diminished the authenticity of the structure. As previously mentioned, the *Fernandina* turrets were as high as the walls, i.e., about 8 m tall. The fact that the *Santana* turret is taller suggests that an extension was added at a later date.

A section of the Fernandina Wall in rubble stone masonry is present in the palace gardens (Figure 3d). Archaeological works being carried out in the palace exposed the foundations of the structure and discovered a tunnel dug inside the wall.

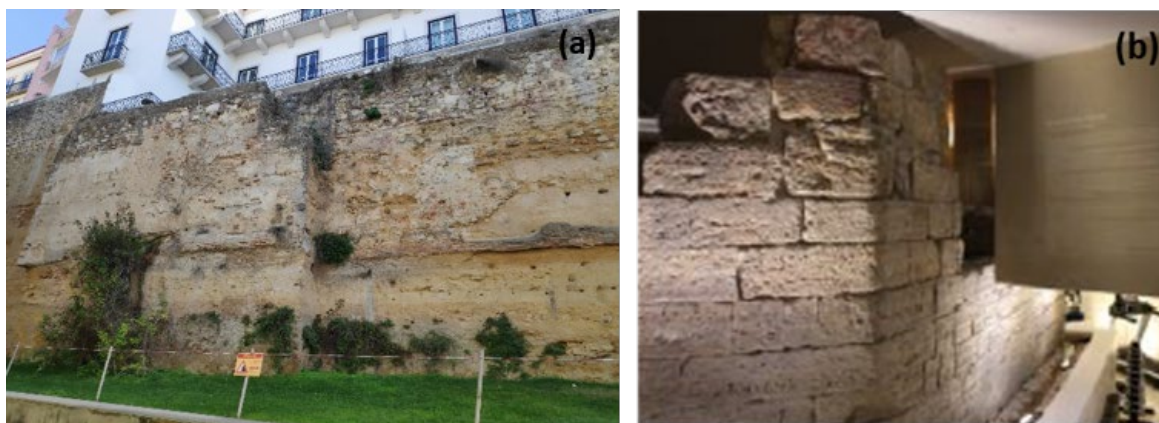
**Figure 4.** Case studies in Wall Western fluvial section: *Terraços de Bragança* Complex (a) and *Corpo Santo* Hotel (b).

construction, a large number of archaeological remains, structures of the Fernandina Wall and surrounding structures were identified (Figure 4b) [26]. The most impressive is the *João Bretão* tower, built with limestone ashlar masonry. The concern with the preservation of Portuguese historical heritage by *Corpo Santo* Hotel has already been recognized with the achievement of several international awards.

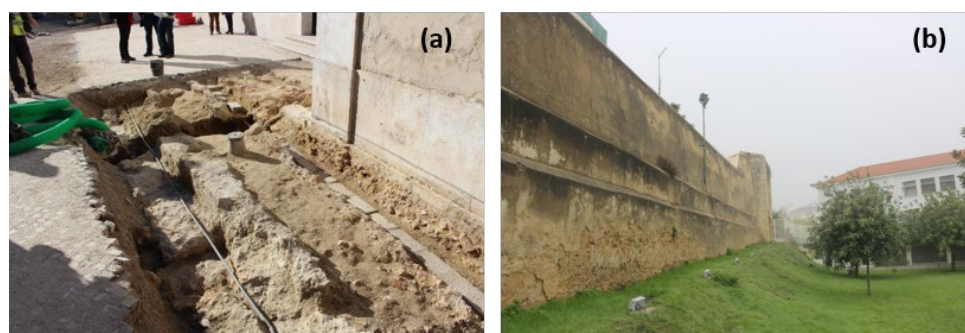
**Figure 5.** Case studies in Eastern section: *Graça* square (a) and *Gil Vicente* school (b).

Located in the neighborhood of *Graça*, the square is one of the most visited touristic sites in the city of Lisbon. The square was outside the boundaries of the Old Moorish Wall; however, with the construction of the Fernandina Wall, it became part of the city and, thus, became protected. Remnants of the walled structure in RE are visible in the fire station, located close to the square, and in the square itself (Figure 5a).

The *Gil Vicente* School is located in *Graça* parish, one of the traditional neighborhoods of Lisbon, as previously mentioned. On the school north limit area, there is a 50 m long sector of the Eastern section of the Wall, well preserved and relatively protected (Figure 5b).
