**THE INTERNATIONAL RESEARCH GROUP ON WOOD PROTECTION**

**Test methodology and assessment**

**Introduction of the COST FP 1303 Cooperative Performance Test**

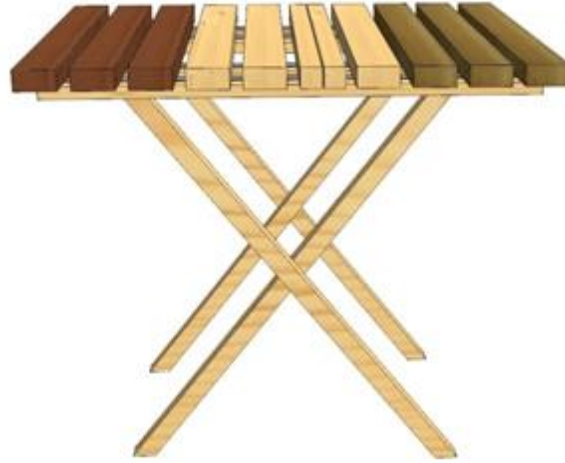
Fig. 1. Performance folding table.

A folding table with boards made from three different materials, *i.e.* Norway spruce, English oak and thermally modified Norway spruce (Table 1) served as easy shippable and ready-to-use test object (Fig. 1). The boards were fixed with partly stainless and partly ordinary steel screws. The table was available in three different versions:

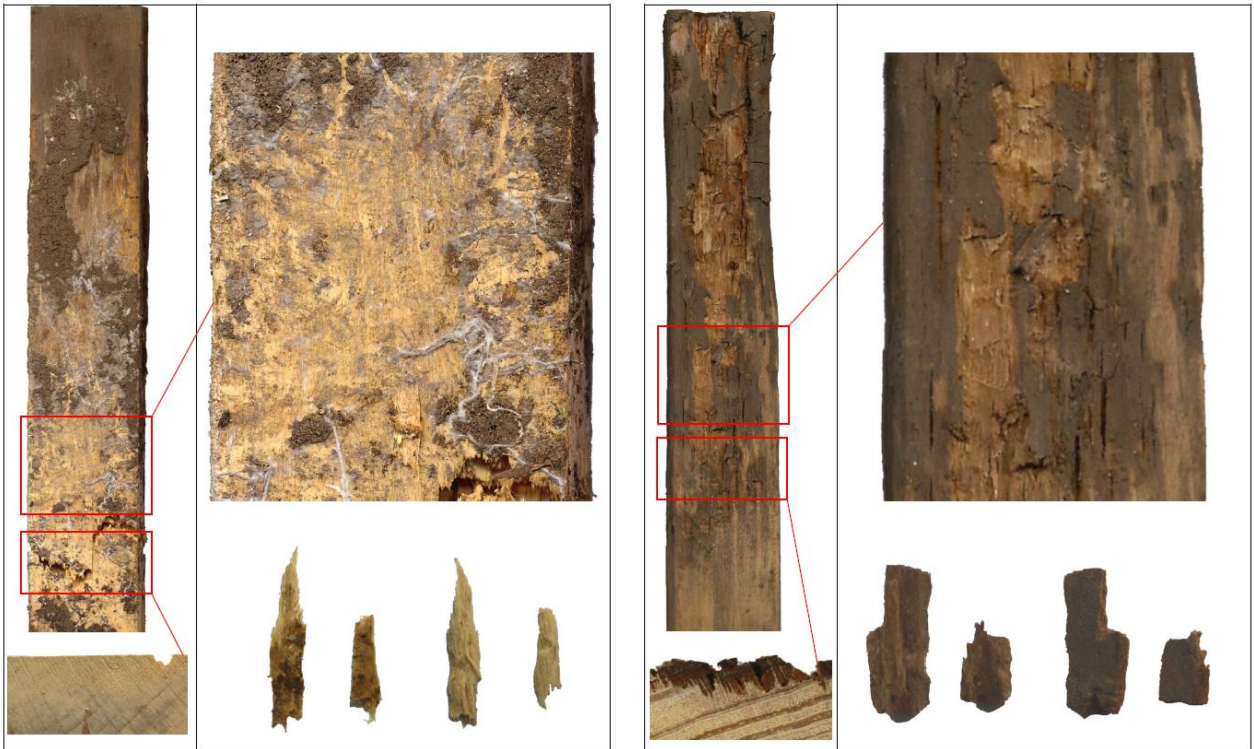
Fig. 2: Left: Beech. Failure after 0.5 years exposure. Visual inspection showed typical signs of white rot: whitish discoloration, long-fibred splinter, fibred fracture. Right: Southern yellow pine. Failure after 0.5 years exposure. Visual inspection showed typical signs of brown rot: brownish discoloration, brittle/cubical splinter, cross-checking texture

Additionally, on the basis of visible characteristics the type of decay should be identified. Information how to distinguish the main decay types (brown rot, white rot, soft rot and tunnelling bacteria) can be found in CEN/TS 15083-2 (2005) – Annex D. Typical examples of the main decay types are shown in Fig. 2 and Fig. 3.

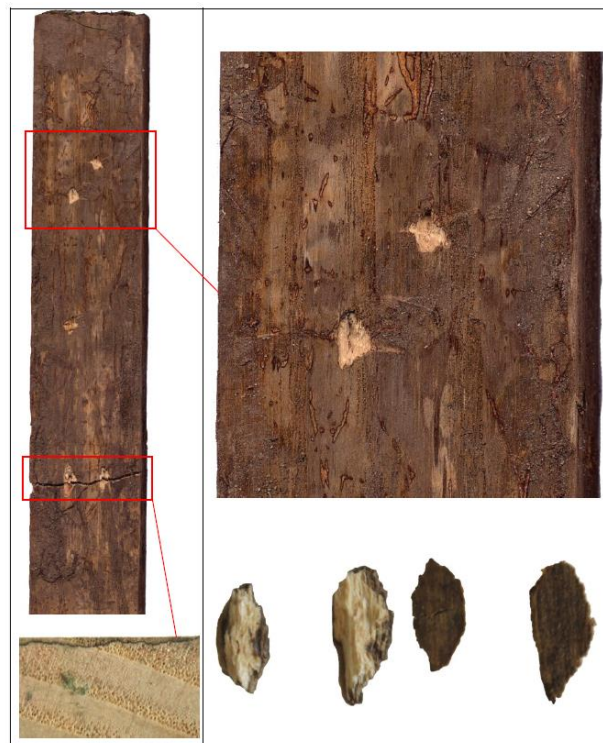
Fig. 3: European ash. Failure after 0.5 years exposure. Visual inspection showed typical signs of soft rot: shell-shaped splinter, attack on the outer wood shell, clean fracture.

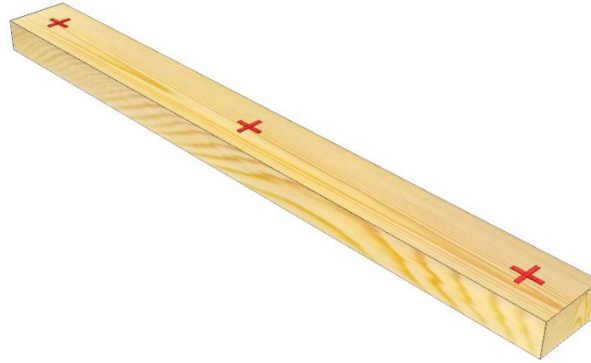
Fig. 4. Positions for measuring L\*a\*b\* colour values.

Colour measurements were recorded at three points on the upper surface of each specimen with a colorimeter. The measuring points were marked on each specimen through cross lines. The positions were centrally between the long sides of the specimens and 30 mm from the end-grain and in the middle of the specimen as shown in Fig. 4.

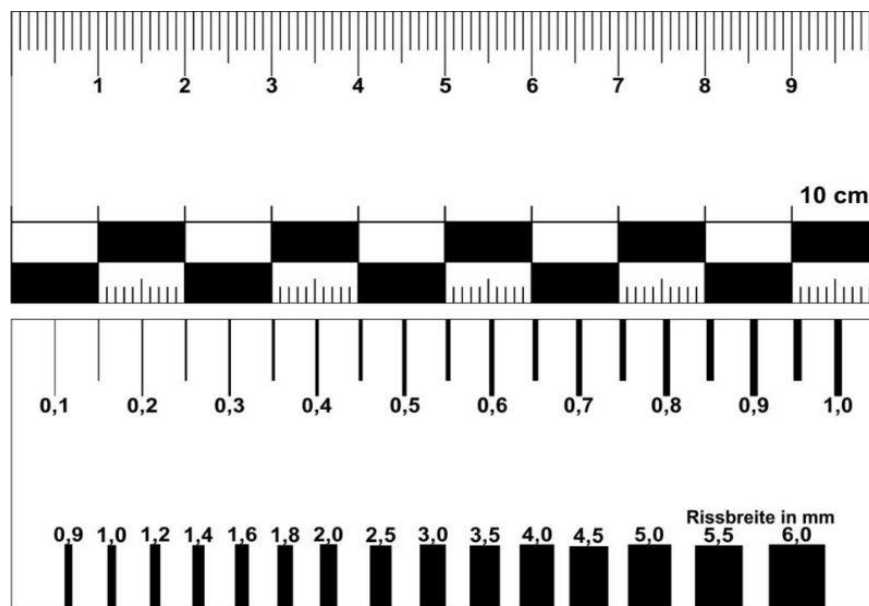
Fig. 5. Crack measuring gauge.

The length of cracks can be easily determined using a ruler. For measuring the crack width a crack measuring gauge (Fig. 5) was used. The maximum width of each single crack (longer than 5 mm) was recorded to determine the mean maximum crack width. The sides and the lower surface of the specimens will not be considered. Specimens were inspected regarding the formation of cracks before exposure (initial state) and then every 3 months.

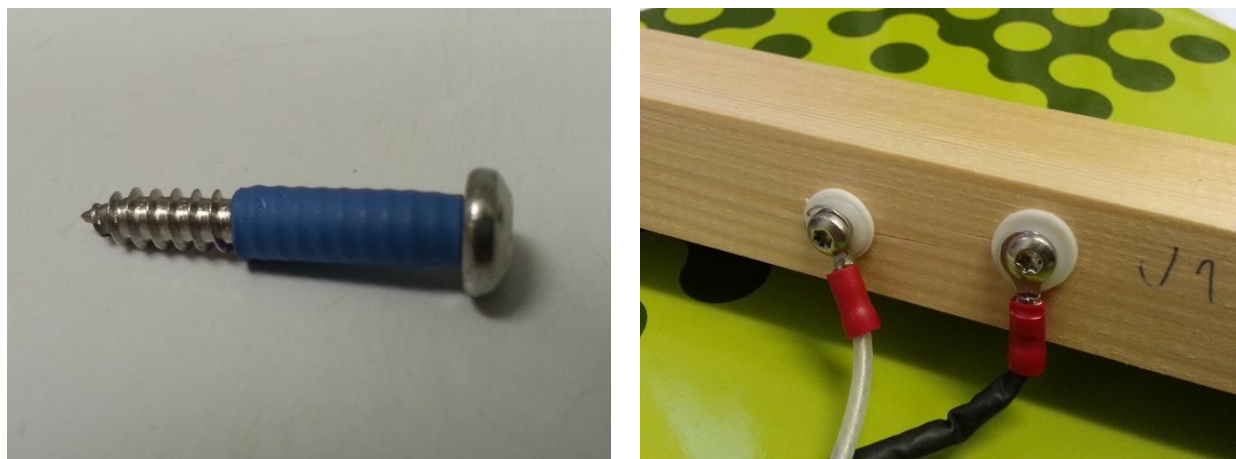
Fig. 6. Isolated fasteners (left) used for fixing electrodes on wood specimens (right).

Version A of the performance table was equipped with moisture content sensors, a Thermofox datalogger and a connected gigamodule (Scantronik Mugrauer GmbH, Zorneding, Germany) for electrical resistance measurements and recordings. Data loggers were connected with the test specimens. Electrodes were fixed to the wood with insulated fasteners as shown in Fig. 6. Therefore, the moisture content was recorded only in the central part of the specimen

There were eight electrodes mounted to the wood; first three in the Norway spruce, second three in thermally modified spruce, and the last two in English oak. Temperature was measured and recorded in the least dense (thermally modified Norway spruce) and the densest material only (English oak).
