Characterization of Portuguese Historical Gypsum Mortars: a Comparison between Two Case Studies

Abstract. The use of gypsum plaster for interior covering of walls and ceilings in the Portuguese architecture was particularly expressive in the period between the XVIII and the XX century. However, information about this important heritage is almost inexistent, which is leading to a fast loss of important patrimony. In this paper, the results of the characterization of gypsum plaster samples belonging to two buildings from the same historical period (end of the XIX century and beginning of the XX), situated in distant geographical regions of Portugal are presented and discussed. XRD, TGA-DTA, optical microscopy and SEM-EDS observations were used for the chemical and microstructural characterization. Some physical and mechanical properties, such as capillary absorption, dynamic elasticity modulus and compressive strength were also determined and a relationship between the characteristics observed in the samples and the technology associated to their use and application on site, as well as the possible existence of regional influences on all these aspects, are discussed.

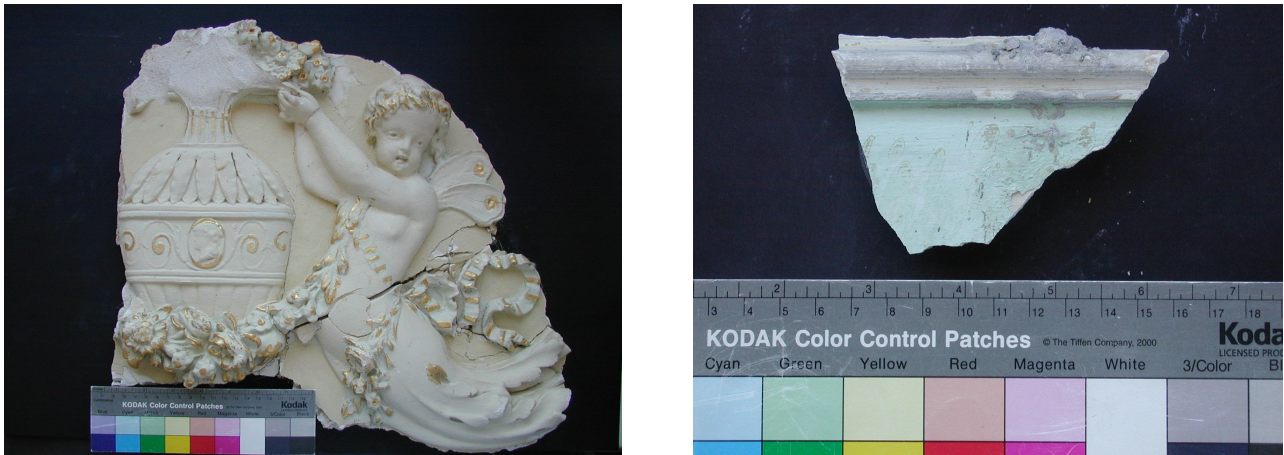
Fig. 1. Photographs of samples A (left) and I (right).

Sampling. The collection of the samples can be divided in two categories: those obtained directly on site by the authors (destructive procedure), mainly referring to smooth plaster surfaces, and those obtained indirectly, as they had been detached before due to the occurrence of different anomalies in the building (only in Estoi Palace). The last ones belong mainly to the decorative plaster program. The identification and description of the samples are summarized in Table 1. Fig. 1 shows two of the studied samples.
