# Article Adhesion of Historic Tile Fragments in Outdoor Architectural Settings

Abstract: Azulejos are part of Portugal's most important cultural heritage. However, a large part of this heritage is at risk due to lack of or improper conservation treatments. There are, however, not many studies dedicated to the procedures and materials used in their conservation to guide the choices of conservators/restorers. Through this work, the performances of the adhesives commonly used in *azulejo* conservation are studied considering the extreme conditions they may experience when in an outdoor environment. Three types of adhesives were studied: acrylics, epoxies, and cellulose nitrates. The adhesives were evaluated for their workability and characterized by FTIR, DMA, and bending tests to obtain information on their adhesion effectiveness and compatibility with the *azulejo* ceramic substrate before and after artificial and natural ageing. When subjected to mechanical loads, the high strength and stiffness of the epoxy resins could lead to the development of new fractures in the previously undamaged ceramic matrix, making them less suitable for the adhesion of historic tile fragments. Cellu

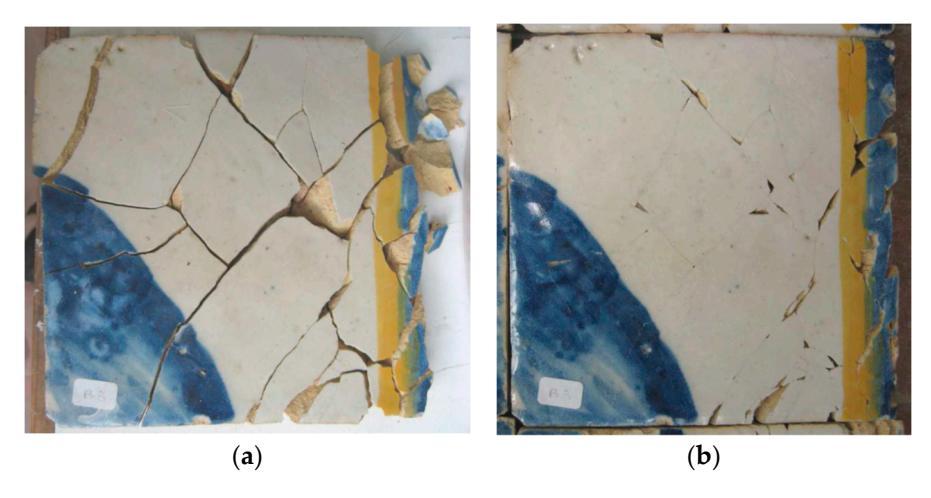
**Figure 1.** Tile fragment adhesion. (**a**) Fragmented tile and (**b**) tile after fragment adhesion treatment. Images by L. Esteves.

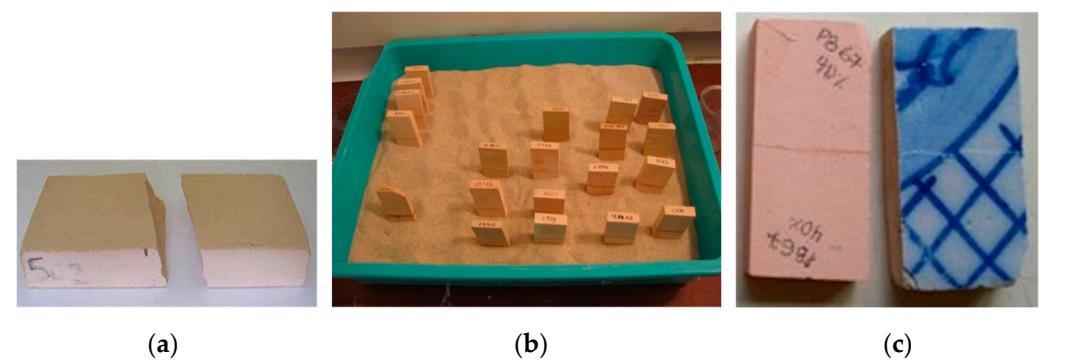
**Figure 2.** Sample fragments in different adhesion stages: (**a**) fragmented, (**b**) curing in a sandbox, and (**c**) bonded.

fragments were allowed to cure for at least 2 weeks at 21  $\pm$  1 °C and 50  $\pm$  5% RH in a sandbox (Figure 2).

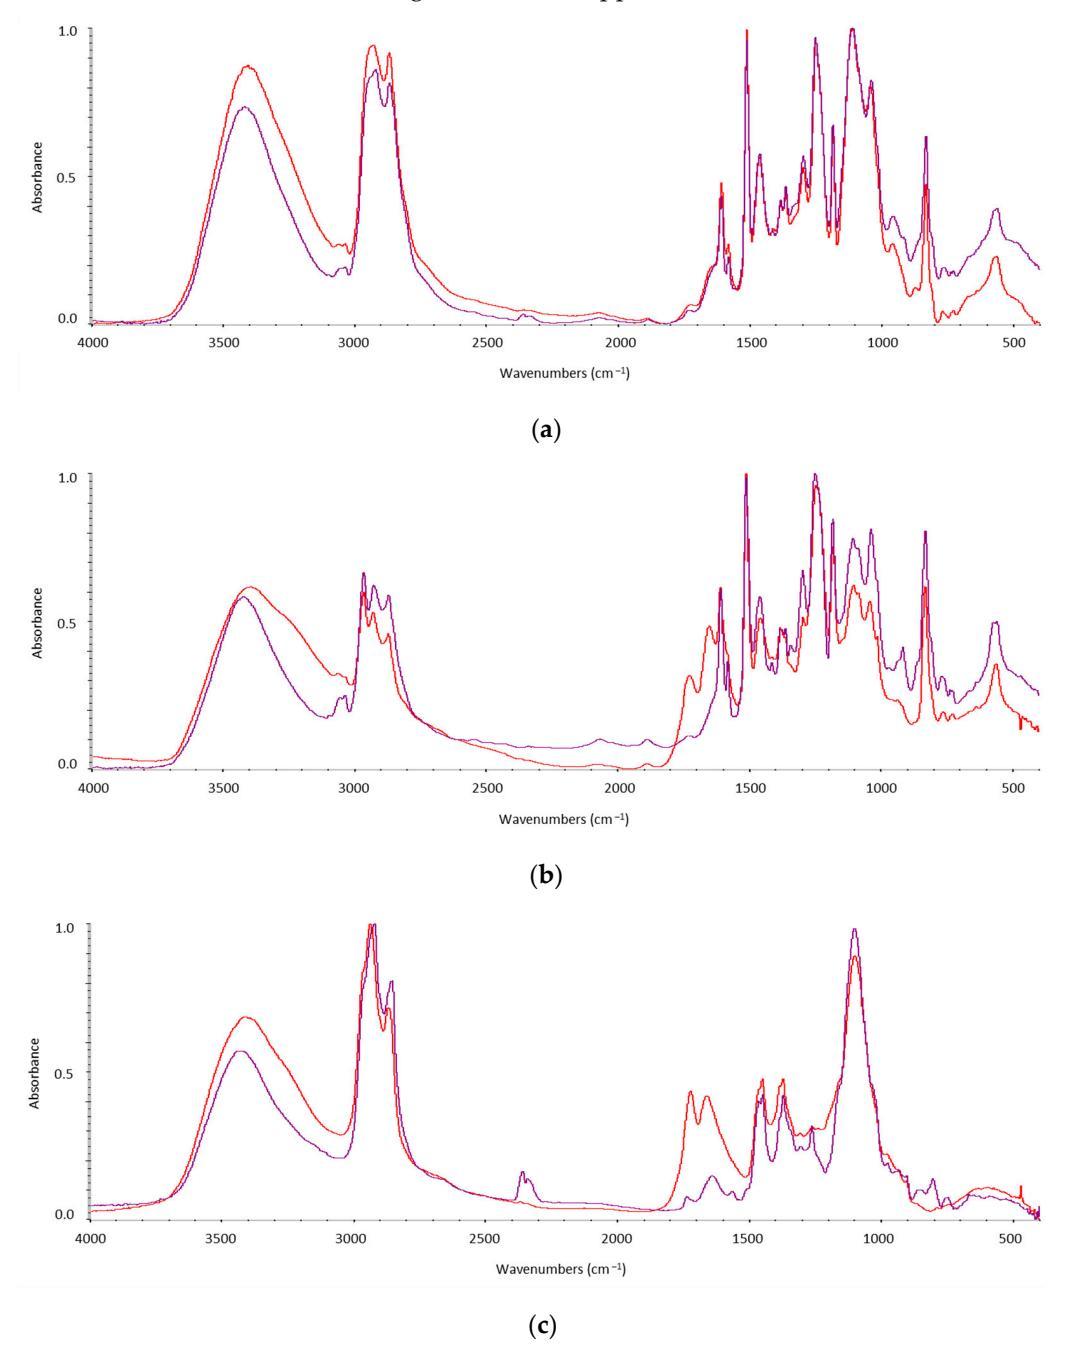
**Figure 3.** FTIR spectra of the epoxy resins before (purple) and after (red) ageing in the climatic chamber: (**a**) Araldite<sup>®</sup> 2020; (**b**) Fynebond<sup>®</sup>; and (**c**) Hxtal Nyl<sup>®</sup> 1.

The epoxy resins studied were composed of a first component based on the aromatic bisphenol A diglycidyl ether (DGEBA) for Fynebond® and Araldite®, and the aliphatic diglycidyl ether of hydrogenated bisphenol-A (HDGEBA) for Hxtal Nyl<sup>®</sup> 1; and a second component based on different hardeners for each adhesive. The FTIR analysis shows the characteristic bands of the epoxy resins, where the 915  $\rm cm^{-1}$  band is attributed to the unreacted C–O deformation of the epoxide ring [40,41]. In the FTIR spectra, the presence of the bands at 1380 cm<sup>-1</sup> and 1360 cm<sup>-1</sup> may be noted, which corresponds to the C-H<sub>3</sub> bending of the gem-dimethyl group characteristic of bisphenol A. The higher aromatic natures of the Fynebond<sup>®</sup> and Araldite<sup>®</sup> 2020 resins are evidenced by the presence of the bands at 1610 cm<sup>-1</sup> and 1510 cm<sup>-1</sup>, attributed to the C=C stretching of the aromatic nucleus [42,43]. In these resins, we also observed the presence of the band at 830  $cm^{-1}$ , characteristic of the C–H out-of-plane bending vibration on the para-disubstituted aromatic ring [42,44]. After ageing, all epoxy resins showed evidence of post-cure, with the disappearance of the oxirane ring characteristic band (at 915 cm<sup>-1</sup>) [42]. In Fynebond<sup>®</sup> and Hxtal Nyl<sup>®</sup> 1, the appearances of the bands at 1725  $cm^{-1}$  and 1660  $cm^{-1}$ , due to the formation of the carbonyl bonds, are indicative of the photo-oxidative degradation of the polymers due to the ageing process [41,43,44].

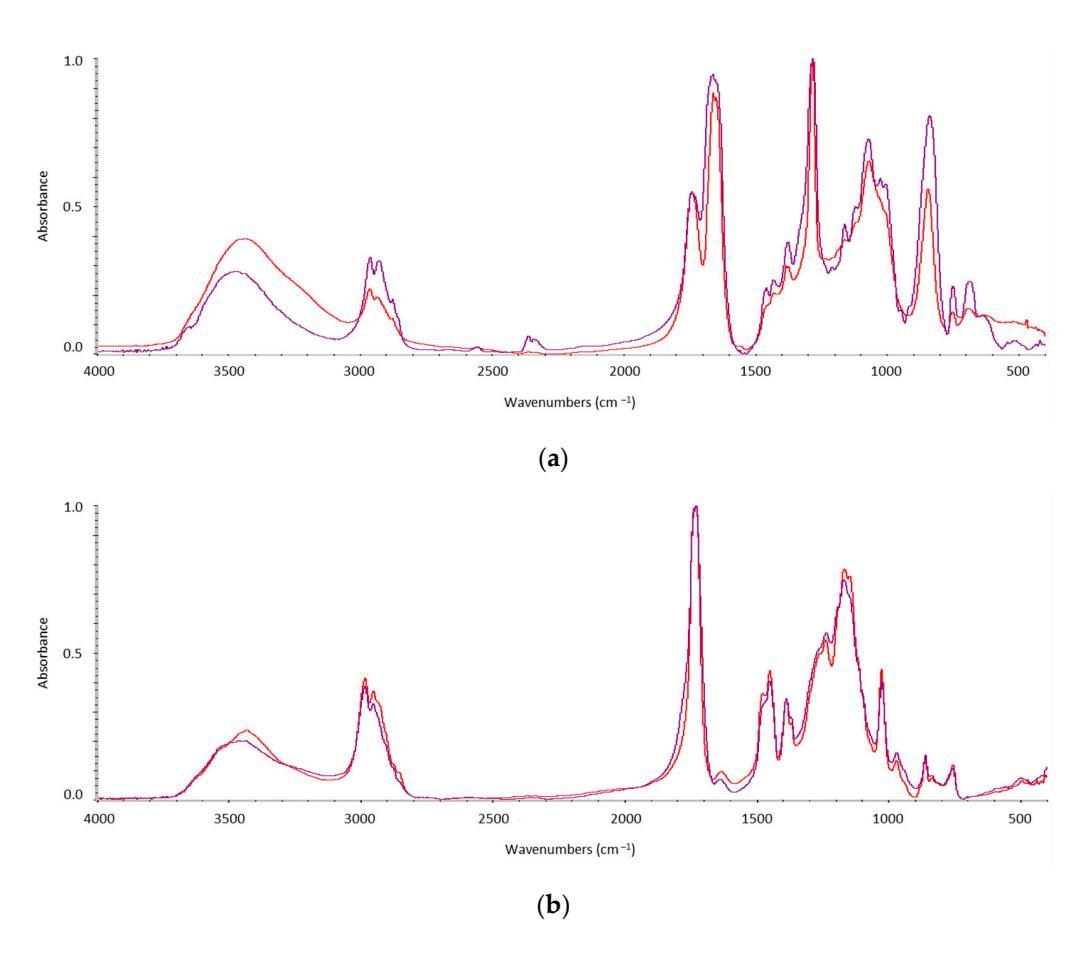
**Figure 4.** FTIR spectra of example cellulose nitrate and acrylic resins before (purple) and after (red) ageing in the climatic chamber: (**a**) UHU<sup>®</sup> Hart and (**b**) Paraloid<sup>®</sup> B72. For all the resin FTIR spectra, see Appendix A.

All FTIR spectra of the cellulose nitrates (Figure 4, Appendix A) exhibited the typical absorption bands at  $1650 \text{ cm}^{-1}$  due to the asymmetric stretching of the NO<sub>2</sub> groups, and around 1280 cm<sup>-1</sup> and 840 cm<sup>-1</sup>, which were attributed to NO<sub>2</sub> and the beta-anomeric linkage in cellulose, respectively [42,45,46]. The degradation of cellulose nitrate polymers has been reported in previous studies [43,45,47,48]. When comparing the spectra registered before and after ageing, it is possible to notice some variations in the intensities and shapes of the characteristic bands, namely, the decrease in the NO<sub>2</sub> asymmetric stretching band at

The acrylic resins studied are methacrylate homopolymers or copolymers: Paraloid<sup>®</sup> B72 (PEMA/PMA) is a poly-(ethyl methacrylate) poly-(methyl acrylate) copolymer; Paraloid<sup>®</sup> B44 (PMMA/PEA) is a poly-(methyl methacrylate) and ethyl acrylate; and Paraloid<sup>®</sup> B67 (PiBMA) is a poly-(isobutyl methacrylate) [49]. In all the acrylic resins, their characteristic bands can be observed, namely, the bands corresponding to the carbonyl absorption around 1730 cm<sup>-1</sup> and the bands between 1270 and 1150 cm<sup>-1</sup> characteristic of C–O–C stretching of an ester group [42,46]. The FTIR spectra of the three acrylic adhesives are similar before and after ageing, suggesting that the acrylic resins do not undergo chemical changes during the ageing process.

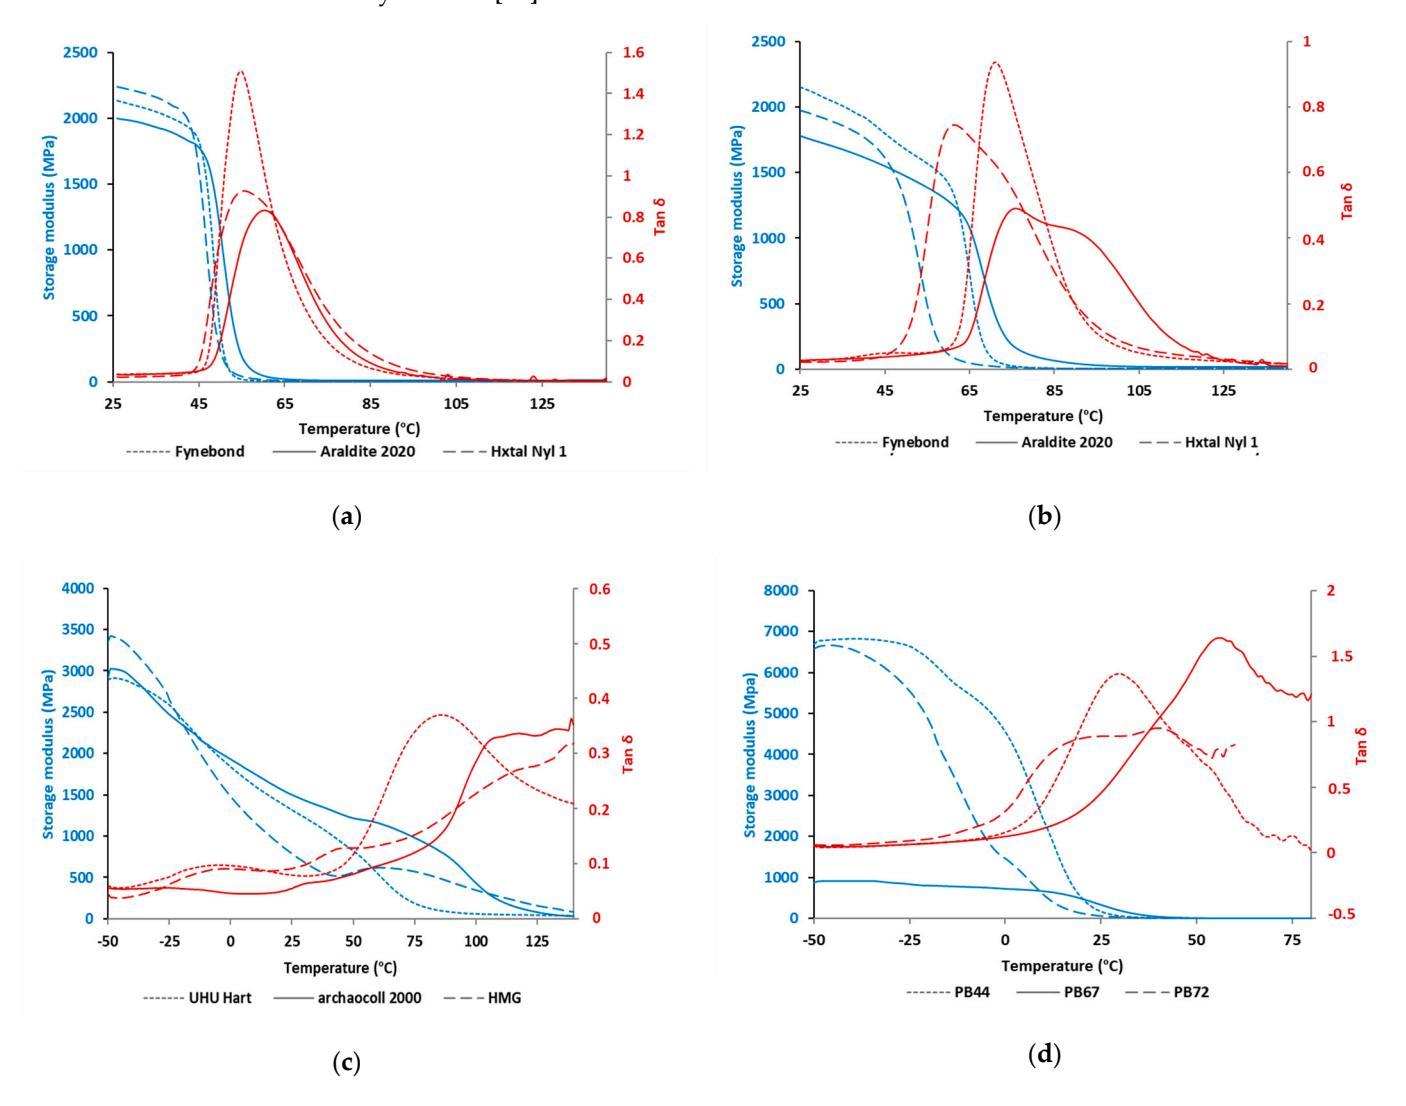
**Figure 5.** DMA of the selected resins: (a) epoxies after curing, (b) epoxies after 500 h of artificial ageing in climatic chamber, (c) cellulose nitrates after curing, and (d) acrylics after curing. Blue: Storage Modulus; Red: Tan  $\delta$ .

After curing at room temperature, all three epoxies presented a vitreous state and high rigidity (Figure 5a). The epoxies presented a well-defined  $T_g$  range, measured from the onset to the final point of the storage modulus curves (E'), namely, 43.8–49.3 °C for Hxtal Nyl<sup>®</sup> 1, 45.9–50.3 °C for Fynebond<sup>®</sup>, and 47.5–54.8 °C for Araldite<sup>®</sup> 2020. The results for Hxtal Nyl<sup>®</sup> 1 and Araldite<sup>®</sup> 2020 are consistent with those that have been reported from DSC measurements (47.4 °C and 49.8 °C for Hala Nyl<sup>®</sup> 1 and Araldite<sup>®</sup> 2020, respectively) [54]. However, Araldite<sup>®</sup> 2020 showed a lower  $T_g$  range compared to the manufacturer's reported value of approximately 39.5 °C [55]. The difference between the measured and literature values can be explained by the fact that  $T_g$  is not a first order transition, and its measurement is highly dependent on the experiment method, time scale, presence of solvents, sample age, and history [56].

After artificial ageing, the three epoxy resins exhibit a shift in the  $T_g$  range to higher values (47.9–57.5 °C for Hxtal Nyl<sup>®</sup> 1, 59.7–67.7 °C for Fynebond<sup>®</sup>, and 63.0–73.6 °C for Araldite<sup>®</sup> 2020) which is particularly evident in the E' curves of Fynebond<sup>®</sup> and Araldite<sup>®</sup> 2020. This phenomenon is common when room-temperature-cured epoxy resins are later exposed to higher temperatures (as happened here, with the exposure in a climatic chamber) because they continue to polymerize and cure. As a result of this change, the resins retain their stiffness at higher temperatures, and the glass transition temperature range is shifted to higher values. For Araldite<sup>®</sup> 2020 and Hxtal Nyl<sup>®</sup> 1, the tan  $\delta$  curve (a dimensionless parameter that represents the ratio of the loss modulus to the storage modulus, which measures the energy dissipation or the damping characteristics of the material) also shows an enlarged peak base and an inflection on the descending branch. This effect has previously been described as being due to the presence of different components, regions with different

Cellulose nitrates before ageing (Figure 5c) do not depict a well-defined onset or final points in the storage modulus curves (E'), and therefore, also the glass transition temperature range. All three cellulose nitrate adhesives are characterized by high stiffness at very low temperatures (-50 °C) but are softer than the epoxies at ambient temperatures. They exhibit a viscous–elastic behaviour up to temperatures around 70–100 °C, when the storage modulus decays. After artificial ageing in the climatic chamber, the cellulose nitrate resins presented alterations (they became extremely fragile and broke during the mounting on the instrument) that precluded a DMA analysis.

Thermoplastic acrylic resins also have a less pronounced glass transition temperature range than the epoxy resins. Compared to the cellulose nitrate resins, Paraloid<sup>®</sup> B72 and Paraloid<sup>®</sup> B44 show much higher stiffness values at -50 °C but also the fastest decrease in the storage modulus with temperature increase. Paraloid<sup>®</sup> B67 shows a distinct behaviour, with very low stiffness values and little influence of the temperature on the storage modulus up to about 25 °C. From temperatures around -40, -15, and 15 °C for Paraloid<sup>®</sup> B72, Paraloid<sup>®</sup> B44, and Paraloid<sup>®</sup> B67, respectively, the resins showed a viscoelastic behaviour up to around 25–35 °C, after which the viscous behaviour of all the resins prevailed. The

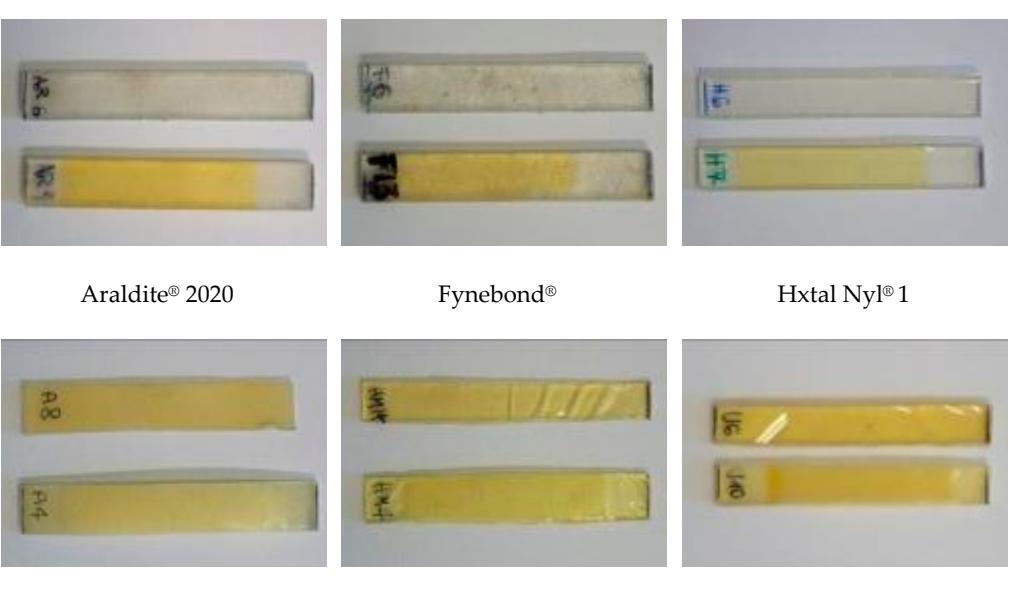
**Figure 6.** Comparison of samples before (top of each image) and after (bottom) 500 h artificial ageing in the climatic chamber.

Figure 6 shows the samples before and after artificial ageing in the Xenon radiation chamber, depicting the yellowing of the test specimens resulting from the exposure to the ageing test. It was observed that the three cellulose nitrates already presented a yellowish colour since their preparation, while only a slight increase in colour occurred after the ageing. All the epoxies were transparent after curing and yellowed after ageing, where the aliphatic Hxtal Nyl<sup>®</sup> 1 appeared to be the least affected by this factor. Acrylics (Paraloid<sup>®</sup> B72, B44, and B67) were not particularly affected by the yellowing, but there was a change in their shape which occurred due to softening caused by the temperature (55 °C) reached in the climatic chamber (Figure 7).

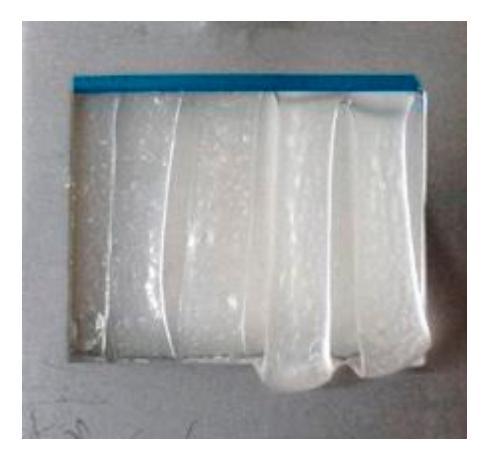
Figure 7. Example of Paraloid<sup>®</sup> B72 softening after 500 h in the Xenon climatic chamber.

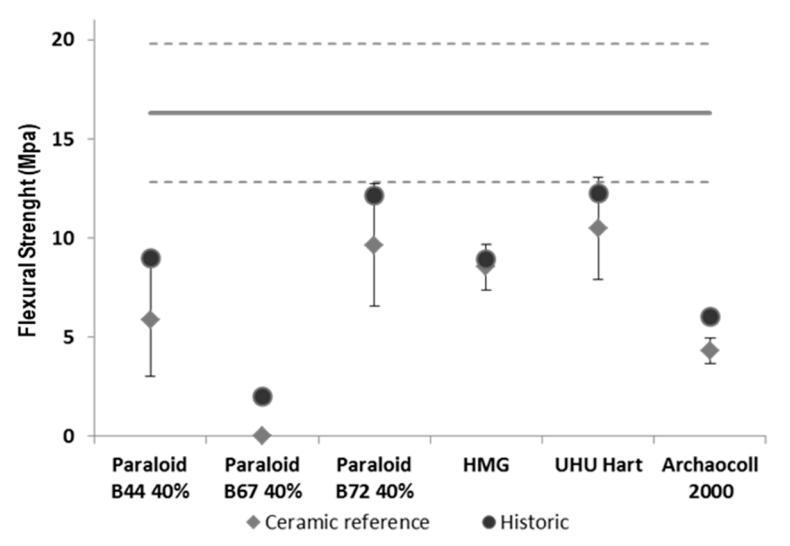
**Figure 8.** Flexural strength through bending tests after curing. The solid and dashed grey lines mark the average flexural strength and standard deviation of the ceramic reference matrix.

Figure 8 presents the results obtained from the flexural strength test samples. These were tested in a three-point bending setup. When the rupture of the sample occurs in the bonded joint or in its close vicinity, the flexural strength measurement gives an indication of the resin adhesive strength.

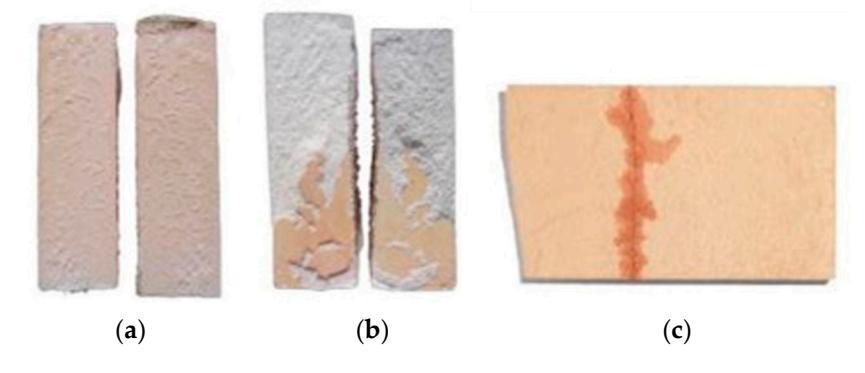
**Figure 9.** Depiction of the failure mode types of the bonded ceramic fragments through bending tests. (a) failure in the adhesive, (b) mixed adhesive–ceramic failure, and (c) ceramic failure.

The results obtained after curing showed that the epoxies did not fail in the bonded joint but failed in the ceramic matrix (Figure 9c), showing that the adhesive's strength was higher than the ceramic matrix flexural strength. This means that mechanical stress applied to the tile panel would probably create new fracture surfaces in previously undamaged areas. The results obtained therefore indicate that under mechanical stresses, such as movements in the building structure, epoxy bonding could cause further damage to the historic tiles. Methods for reducing the epoxy bond strength and/or improving its reversibility by, for instance, firstly applying a different adhesive coat layer, could potentially mitigate these issues [33].

The type of failure observed is proportional to the flexural bond strength obtained (Figure 9), where the adhesives with a low strength (Paraloid<sup>®</sup> B67, Paraloid<sup>®</sup> B44, HMG<sup>®</sup>, and Archaocoll<sup>®</sup>) result in adhesive failures, those with a medium strength (Paraloid<sup>®</sup> B72 and UHU<sup>®</sup> hart) show adhesive–ceramic failure, and those with high strength, such as the epoxies, produce fractures in the ceramic body and not in the bond layer.

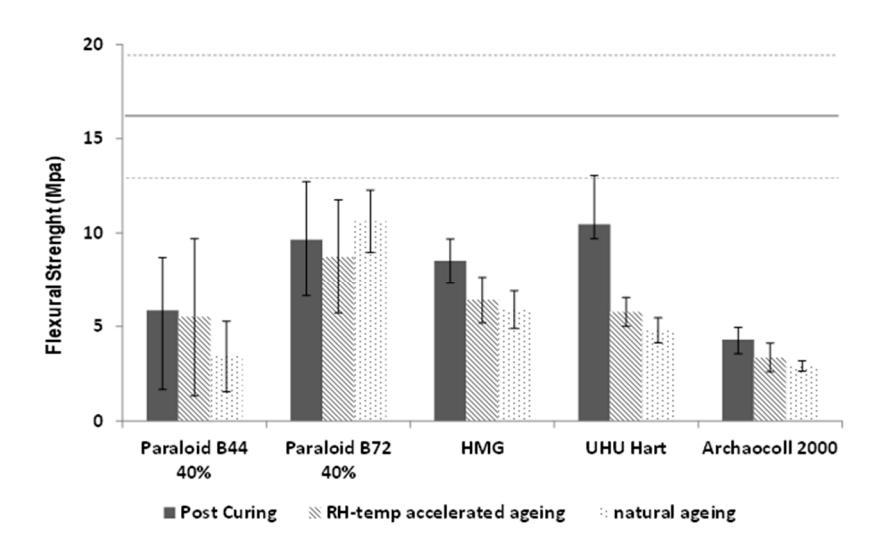
**Figure 10.** Results of bending tests before and after artificial and natural ageing. The solid and dashed grey lines mark the average flexural strength and standard deviation of the ceramic reference matrix.

After artificial ageing (Figure 10) in the climatic chamber with variations in the temperature and relative humidity, all the Paraloid<sup>®</sup> B67 samples presented with adhesive failure and did not allow the bending test to be performed. The bond strength observed after ageing revealed a small decrease for Paraloid<sup>®</sup> B44 and maintenance or even improvement for Paraloid<sup>®</sup> B72. A higher loss in effectiveness is observed for the cellulose nitrates. After ageing, Paraloid<sup>®</sup> B72 continues to impart some degree of strength to the joint, where the mixed adhesive–ceramic failure after the test remains. These breakages do not create new fracture surfaces but correspond to fragments of ceramic in the vicinity of the joint that remain attached to the opposite side (Figure 9b). After ageing, the cellulose nitrates mainly showed adhesive failures.

After natural ageing, the results of artificial ageing generally confirmed a high loss in the efficacy of the cellulose nitrates, a decreased performance of Paraloid<sup>®</sup> B44, and an apparent improvement in the performance of Paraloid<sup>®</sup> B72 (Figure 10).

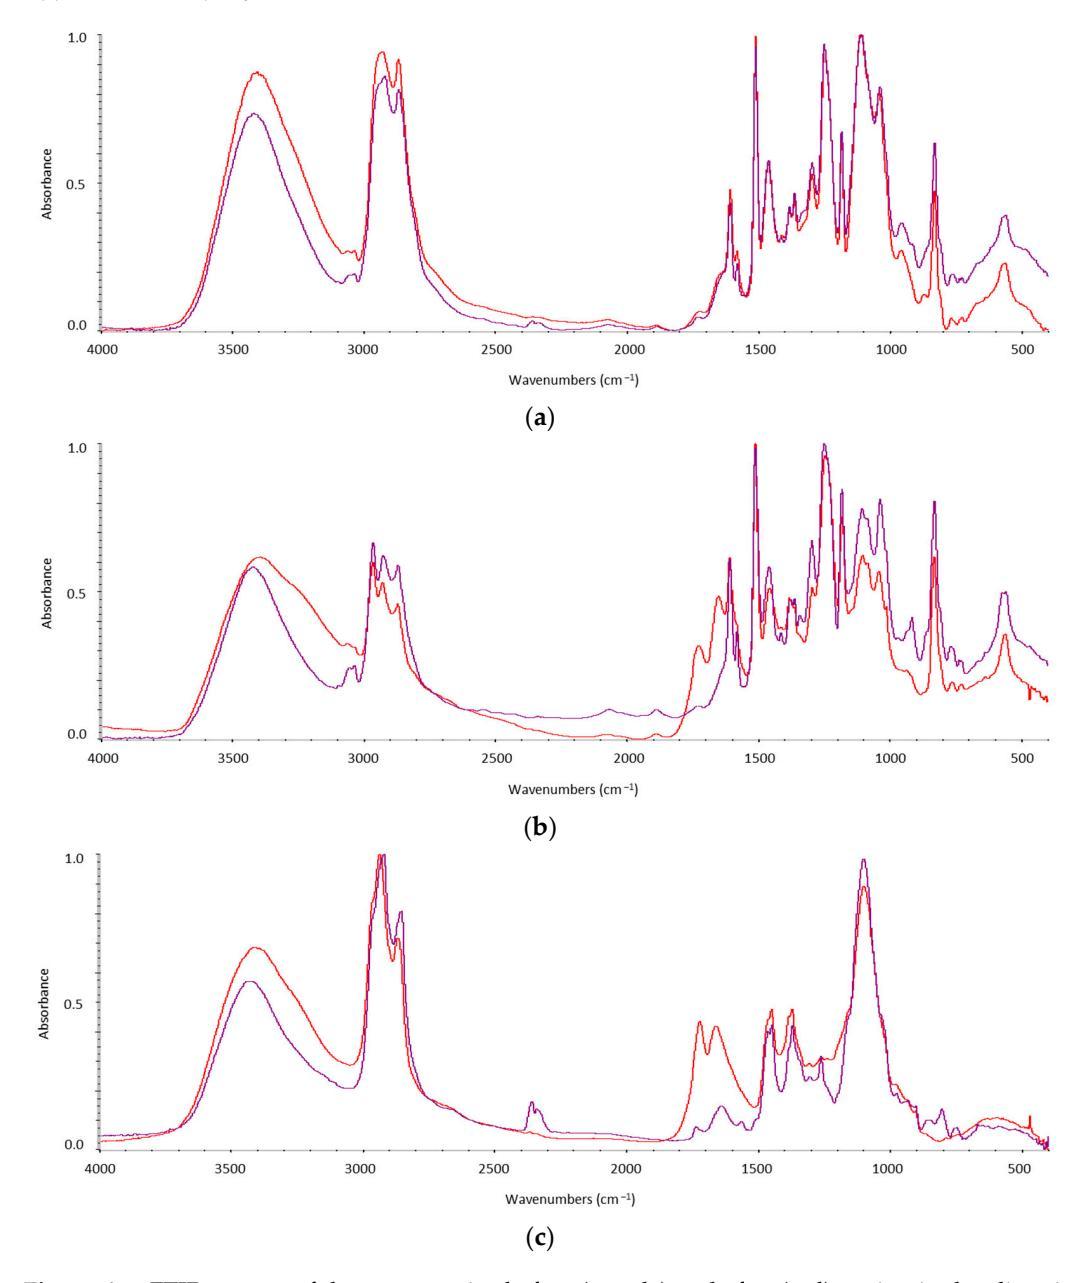
**Figure A1.** FTIR spectra of the epoxy resins before (purple) and after (red) ageing in the climatic chamber: (**a**) Araldite 2020; (**b**) Fynebond; and (**c**) Hxtal Nyl<sup>®</sup> 1.

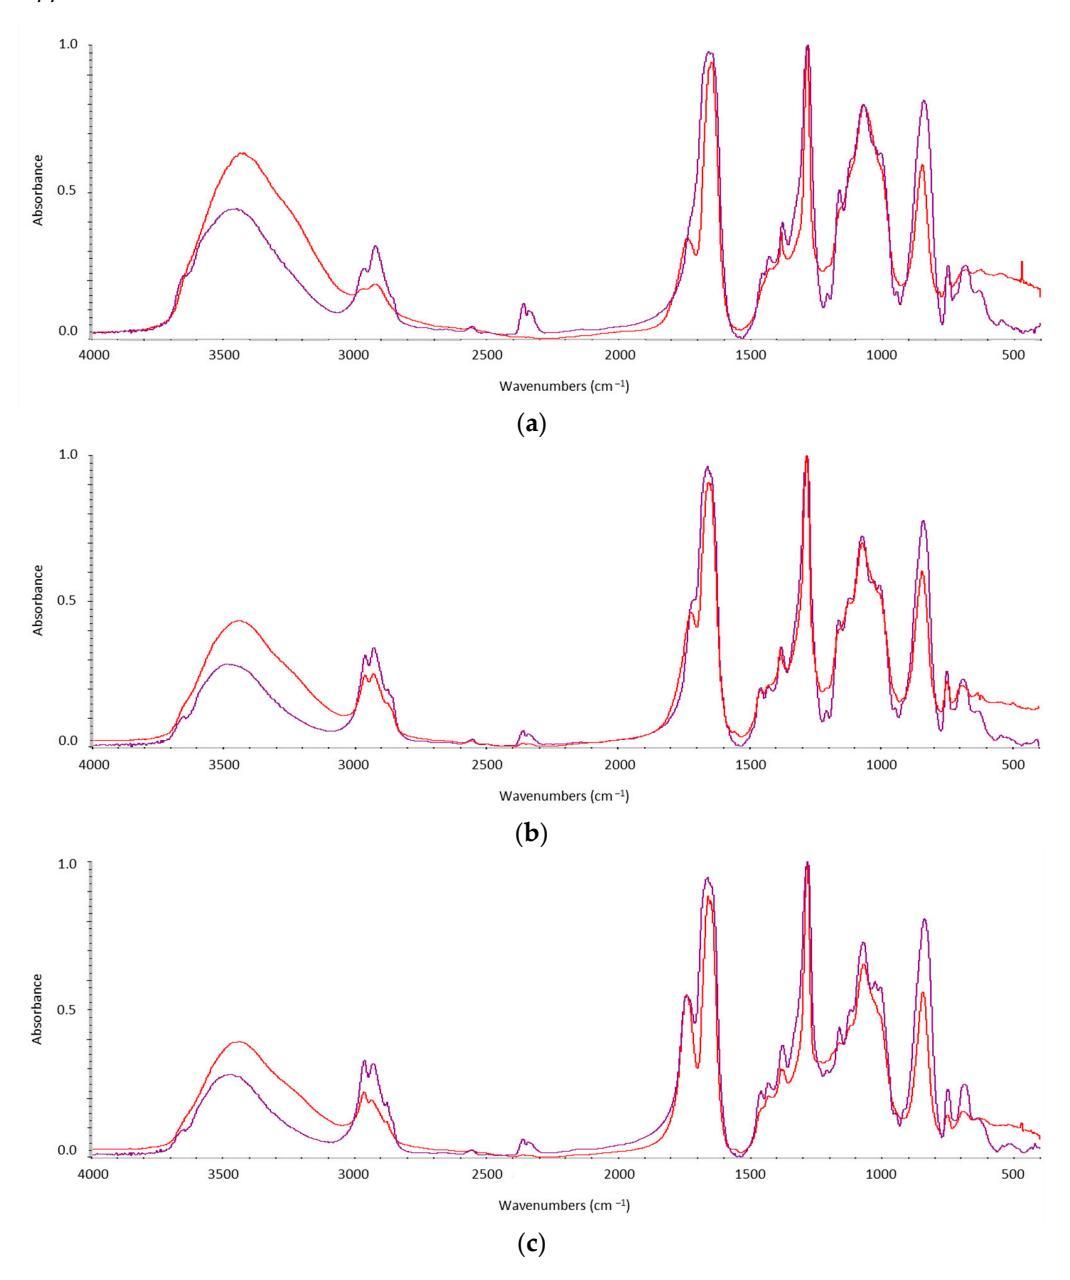
**Figure A2.** FTIR spectra of the cellulose nitrate resins before (purple) and after (red) ageing in the climatic chamber: (**a**) Archaocoll<sup>®</sup> 2000; (**b**) HMG<sup>®</sup>; and (**c**) UHU<sup>®</sup> Hart.

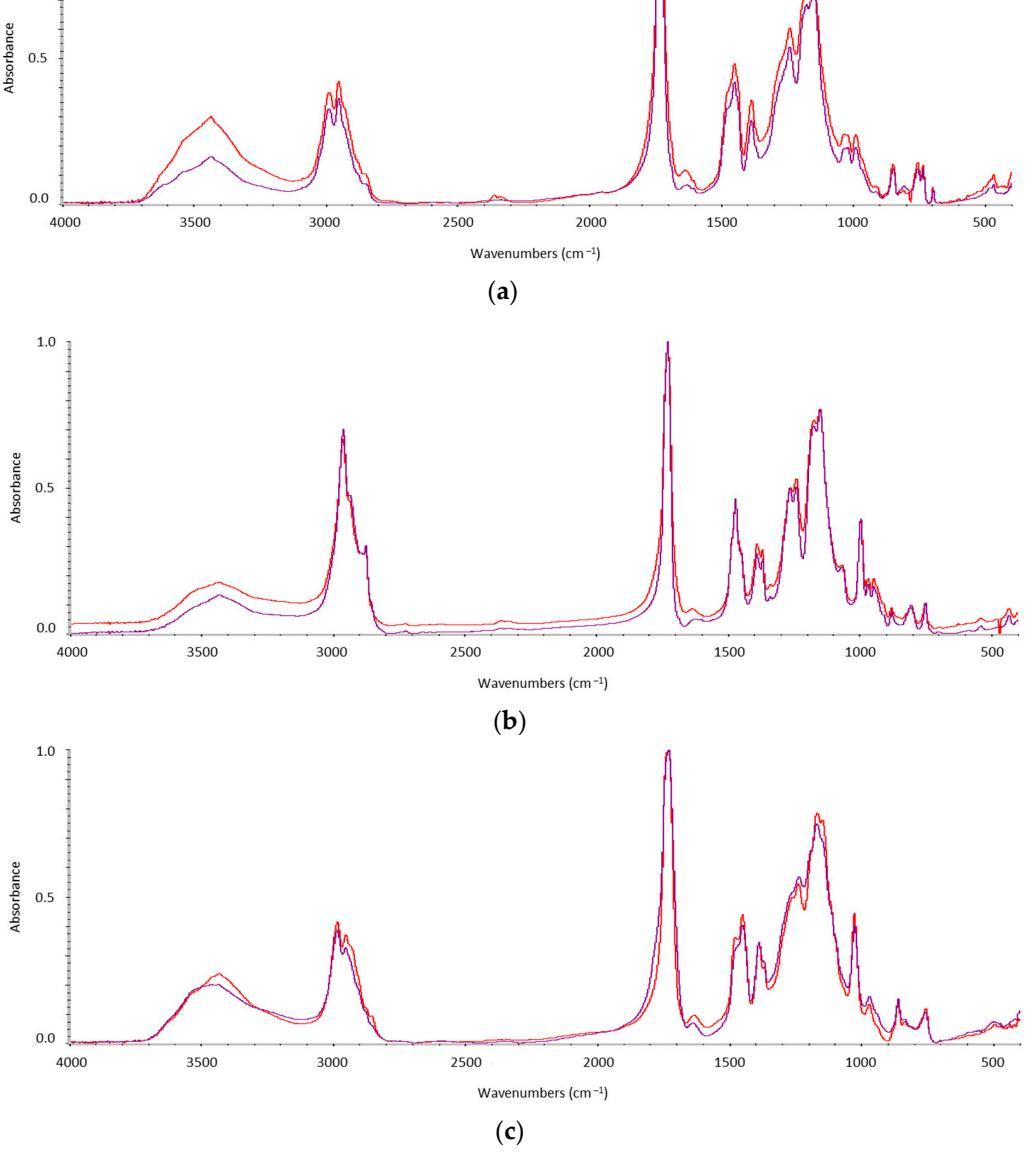
**Figure A3.** FTIR spectra of the acrylic resins before (purple) and after (red) ageing in the climatic chamber: (**a**) Paraloid<sup>®</sup> B44; (**b**) Paraloid<sup>®</sup> B67; and (**c**) Paraloid<sup>®</sup> B72.
