An estimation of the damage of scale models of breakwaters using the time of flight method

Rute Lemos¹ | Conceição Fortes¹ | Gabriel Silva¹ | Liliana Pinheiro¹

¹ LNEC – Laboratório Nacional de Engenharia Civil, Portugal rlemos@lnec.pt, jfortes@lnec.pt, lgs@lnec.pt, lpinheiro@lnec.pt

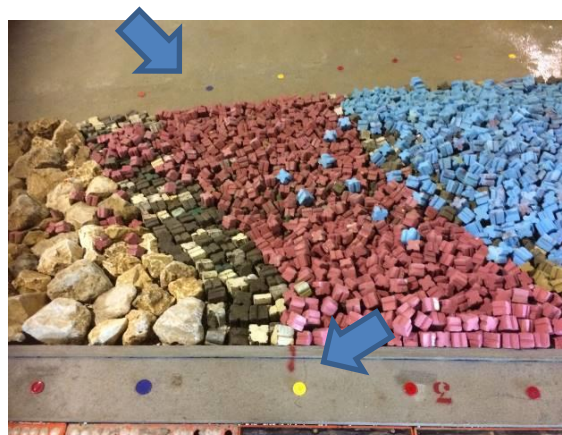
Fig. 3 | Ground Control Points used to georeference the clouds of points

A topographic survey of the model was conducted to obtain the coordinates of points to be used as ground control points (GCP) to geo-reference the clouds of points resulting from each model survey. Those points (Fig. 3), located on the model crest and also on the tank's concrete floor, were obtained by using a total station.

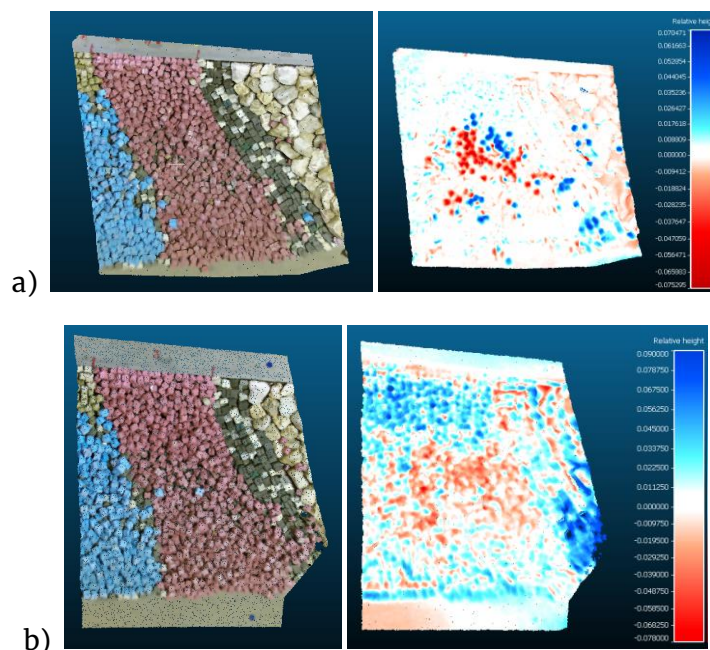
Fig. 4 | End of test series 1 (a) and 2 (b). Model survey and difference maps

Fig. 4 to 6 present the three-dimensional surveys and the difference maps between surveys conducted at the beginning and at the end of each test series for the three wave directions associated with both water levels.

For test series 1 to 4, the entire surveyed area was used in order to compute the eroded volume, since most of the movements correspond to displaced units (blocks with movements greater than their nominal diameter). On the other hand, for tests 5 and 6, with less removed units, but with many movements, a localized damage analysis was necessary, by cropping the most damaged area to be analyzed (Fig. 6).

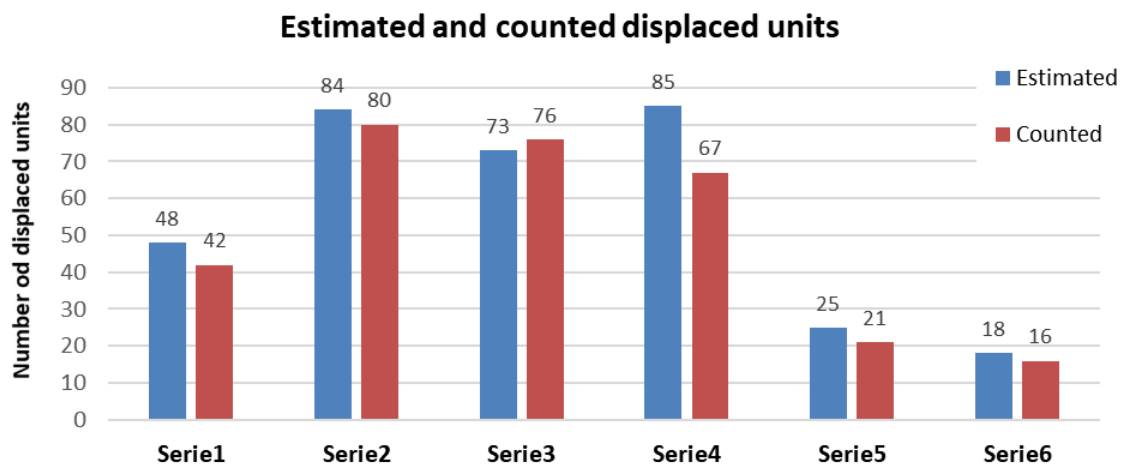
Fig. 7 | Estimated and counted displaced units at the end of test series 1 to 6

Fig. 7 illustrates the counted and estimated number of armor units based upon the eroded volume.

In a general way, damage estimation using the global eroded volume slightly overestimated the number of displaced units, as small movements between armour units can be wrongly computed as erosion.

Estimated and counted displaced armor units were quite convergent, except for test series 4, where the differences between counted and estimated displaced units was of 18 units. This difference was probably caused by movements at the toe of the structure which were accounted as displacements.
