GEO12-FW-017 - Integrity of HDPE Geomembranes: Effect of Weather Exposure on the Mechanical Properties of Seams

M. Barroso, Laboratório Nacional de Engenharia Civil, I.P. (LNEC), Lisbon, Portugal
M.G. Lopes, Instituto Superior de Engenharia de Lisboa (ISEL), Lisbon, Portugal
R. Dores, Empresa Geral de Fomento, S.A. (EGF), Lisbon, Portugal
L. Coimbra, Laboratório Nacional de Engenharia Civil, I.P. (LNEC), Lisbon, Portugal

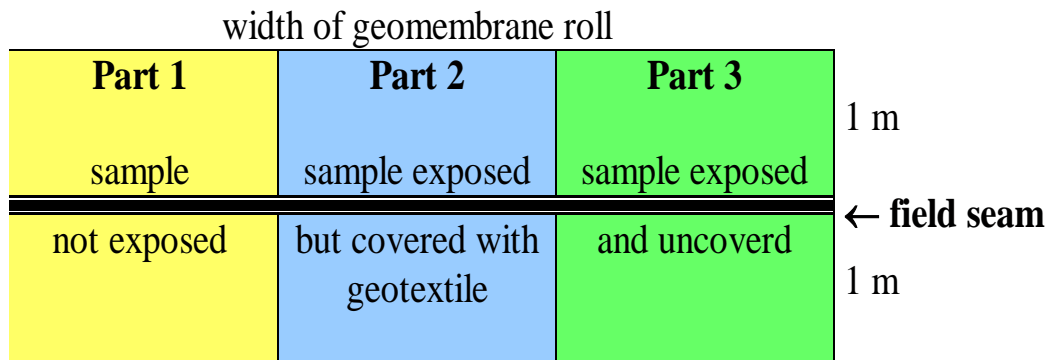
Figure 2. Scheme of welded geomembrane by field seam

As illustrated in Figure 2, samples were divided in three parts: part 1, unexposed; part 2, exposed to weather conditions with a geotextile over it; and part 3, fully exposed.

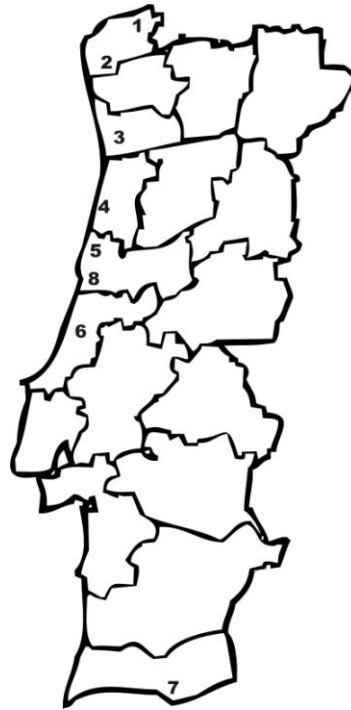
Figure 4. Location of seamed geomembrane samples at landfill sites in Portugal.

Figure 4 shows the location of seamed geomembrane samples at landfill sites in Portugal.

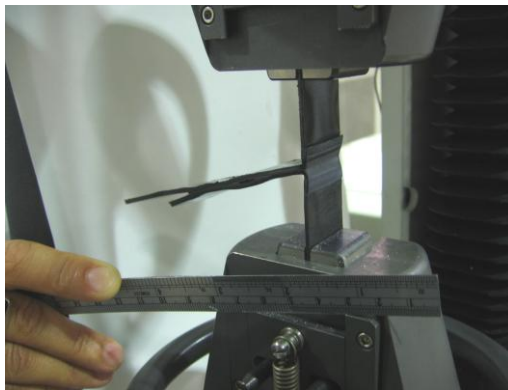
Figure 5. Peel test for seamed geomembranes

In brief, in each type of test, five specimens (150 mm×25 mm) were pulled out as shown in Figures 5 and 6 for peel and shear test, respectively. The seam is located centrally and perpendicular to length. Tests were carried out at an elongation rate of 50 mm/min. In peel test, both dual hot wedge seam were tested from outside towards the air channel.

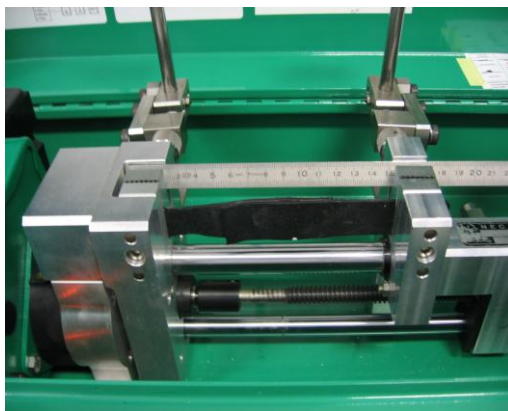
Figure 6. Shear test for seamed geomembranes

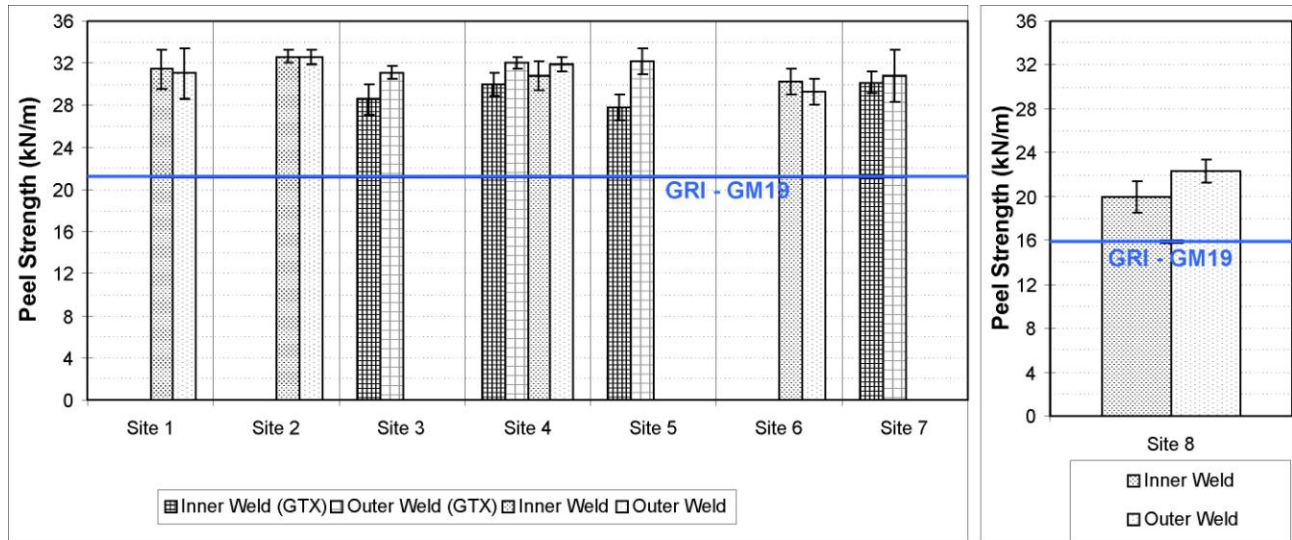
Figure 7. Peel strength for welded geomembranes

Regarding peel strength, Figure 7 presents the results obtained in this study for the 10-year aged seams, as well as the GRI-GM 19 required minimum value (solid line superimposed in figure). The values obtained experimentally contain the error bars corresponding to the uncertainty of measurement, calculated according to GUM (2008).

The Figure 7 shows that all 10-year aged seams exceed the GRI-GM 19 Seam Specification by a wide margin, both in inner and outer welds. For 2.0 mm geomembranes, the smallest value of peel strength was 27.8 kN/m (sample exposed at site 5), which is 6.6 kN/m above minimum recommended. A smaller difference (4.1 kN/m) was found for 1.5 mm geomembrane (sample exposed at site 8), even though well above the current specification value.

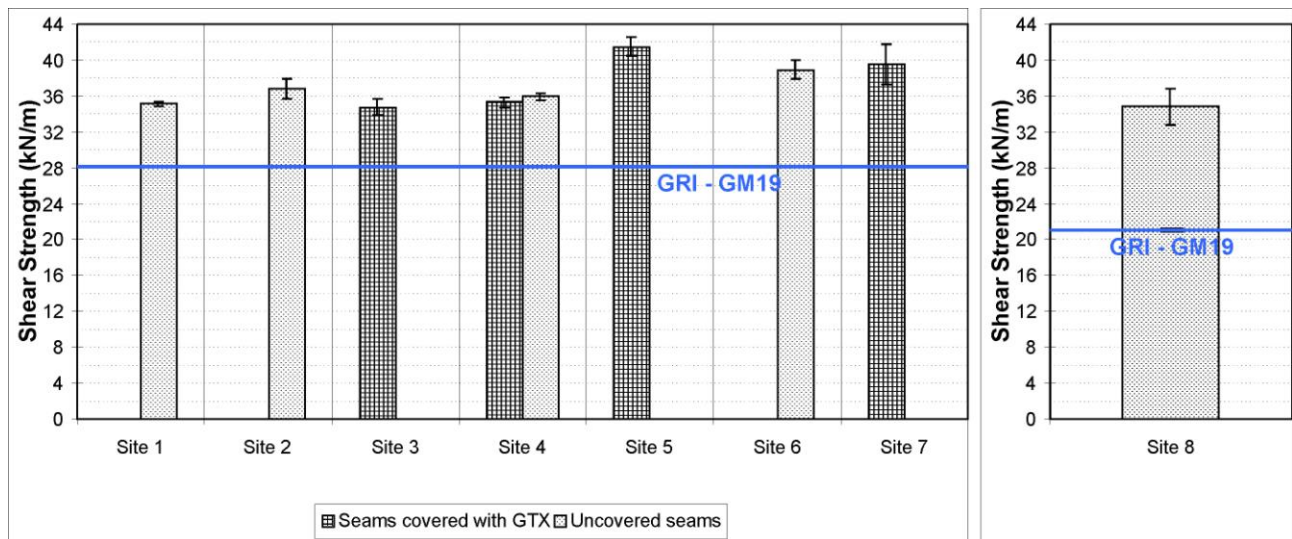
Figure 8. Shear strength for welded geomembranes

The shear strength obtained for the 10-year aged seams are plotted together with the GRI-GM 19 Seam Specification in Figure 8. As can be seen, all tested seams exhibit higher strength than the current specification value. The smallest strength obtained was 34.8 kN/m, for sample exposed at site 3, which is 6.8 kN/m above minimum suggested.

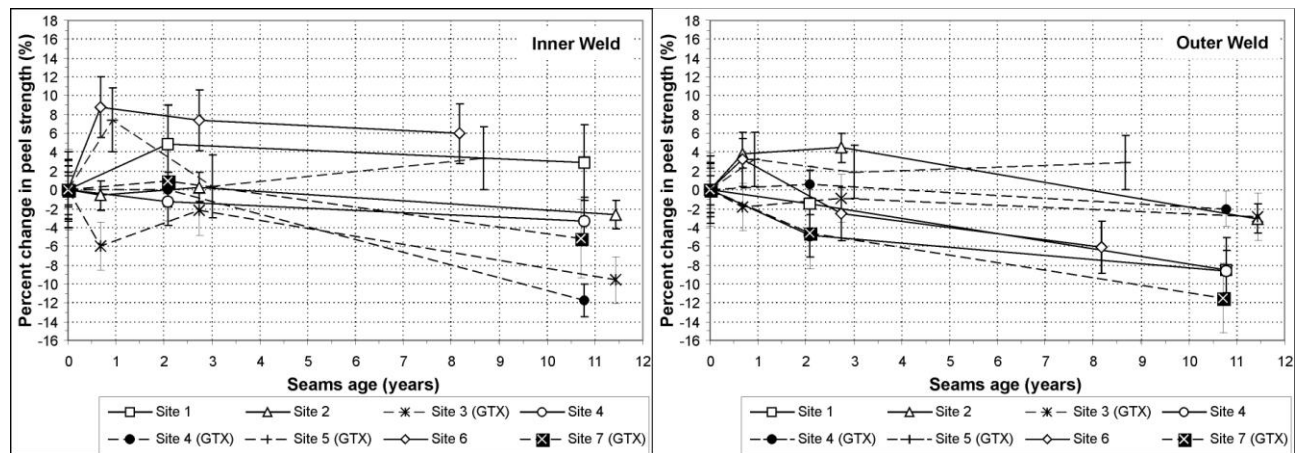
Figure 9. Peel strength as a function of seams age

Figure 9 depicts the change in peel strength, as a percentage, for each sample tested as a function of seam age.

It can be observed that, by taking into account the uncertainties associated to the measurements, the differences in peel strength over time can be considered as minor, both for inner and outer welds. Nonetheless, despite the scattering in data, it is possible to observe that the peel strength of the seams slightly increases in the first two years, except for seams exposed at site 3, in the case of the inner weld, and seams exposed at sites 4 and 7, in the case of the outer weld. This might be due to the increase in polymer crystallinity. Indeed, similar trend was reported by Rowe et al. (2009) for tensile properties of geomembrane sheets exposed in air. After a two year weather exposure, the peel strength tends to decrease, probably as result of the oxidation of the geomembrane due to UV light.

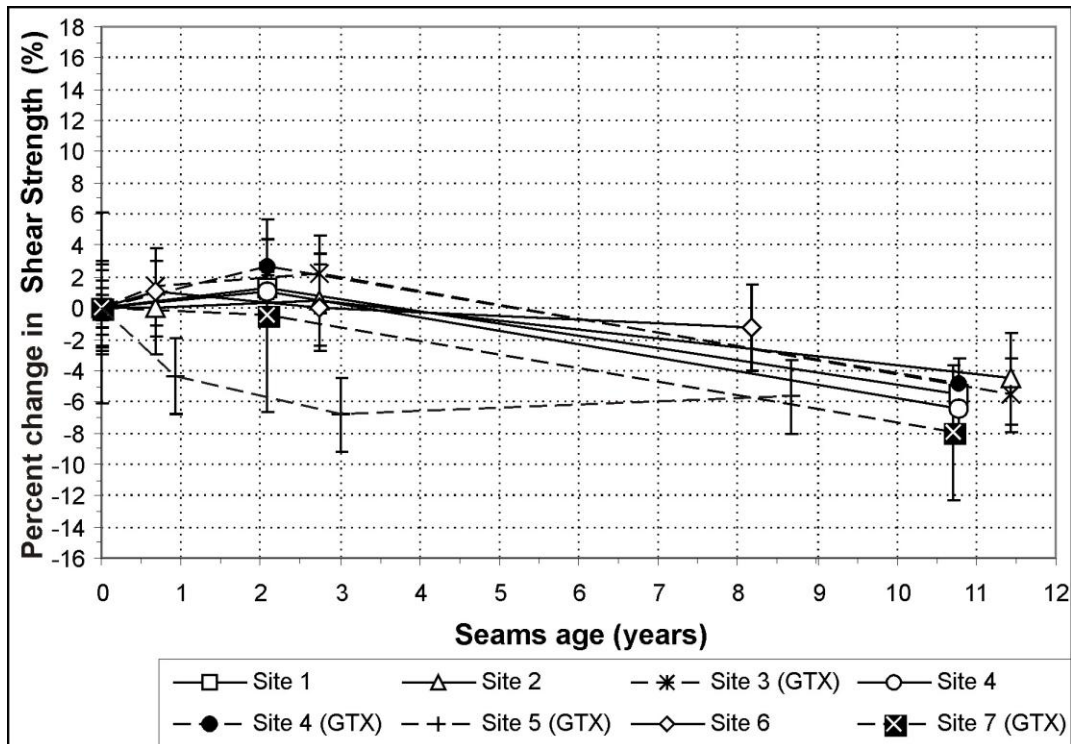
Figure 10. Shear strength as a function of seams age

The change, as percentage, in peel strength for each sample tested as a function of seam age is presented in Figure 10.

As can be seen, by taking into account the uncertainties associated to the measurements, the only visible trend is a small decrease in shear strength for all seams, especially after the second year of weather exposure. Again, it appears that the amount of antioxidants consumed has not yet reached Stage III of degradation of geomembranes, so the shear strength of the seams does not present a significant decrease.
