Measuring Inclinations in Cabril Dam with an Optoelectronic Sensor

Maria J. HENRIQUES, José N. LIMA and Sérgio OLIVEIRA, Portugal

Measurement of Inclinations of a Dam: Results of a Test Using an Optoelectronic Sensor

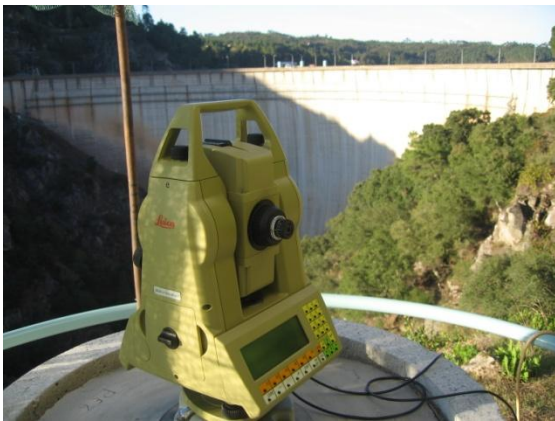
Figure 1 – Tacheometer set on a pillar during the continuous monitoring test

In order to improve the monitoring system of Cabril dam, in 2008, a set of tests (Figures 1 and 2) was performed for two days, to verify the response of the geodetic observation equipment (tacheometers and GNSS) and of software for the continuous monitoring of dam displacements (Henriques et al., 2009). During the test, an inclinometer was also used to measure inclinations at the top of the central cantilever, so as to evaluate some possible variations in the measured inclination throughout the day. The measurement of both displacements and inclinations at the upper zone is proposed because Cabril dam (132 m high concrete arch dam) presents significant horizontal cracking in that zone, between 10 m and 20 m below the crest, which highly influences the deformation of the dam. The deformation monitoring of that cracked zone has been performed only by the control of displacements, measured in geodetic campaigns carried out on an annual basis.

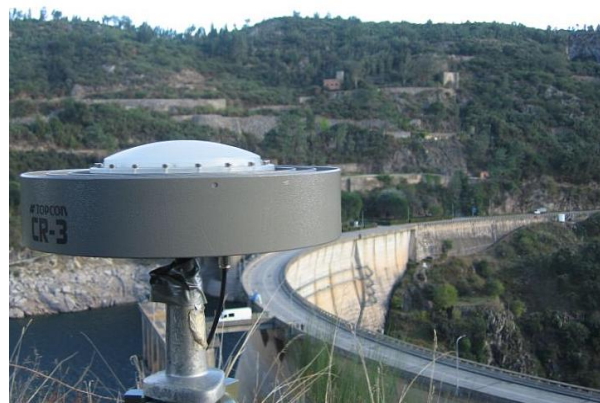
Figure 2 – GNSS antenna (reference point) during the continuous monitoring test

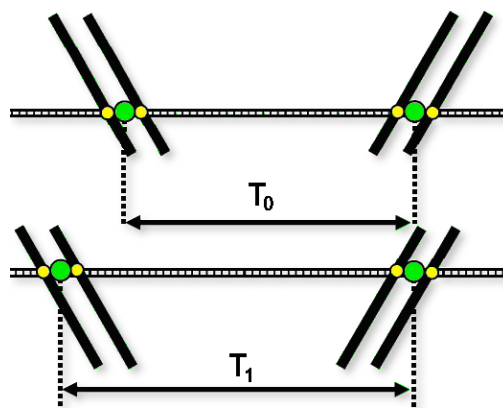
Figure 7 – Measurement of the transversal component

To determine the inclination, the image recognition system must establish the position of the line pattern, position that is compared with the reference position. The latter, which is established by the location of the line pattern when the inclinometer is horizontal, is done by the manufacturer. The inclination is measured along two orthogonal components. The value in one of these components is determined by the distance between the centroid of the line pattern and the reference value (component longitudinal, L – Figure 6); the inclination in the orthogonal direction is determined by the distance between the lines inclined (component transversal, computed from the difference between distances T_1 and T_0 – Figure 7). A single sensor measures, at the same time, the two components of the inclination. In Figure 8, the schema above represents the reference position of segments, while the lower schema represents their position when the inclinometer is not horizontal; the horizontal bar represents the CCD array; the small yellow circles represent the points of intersection between the lines and the CCD array; the larger circles (red or green) represent the centroids of each set of lines.

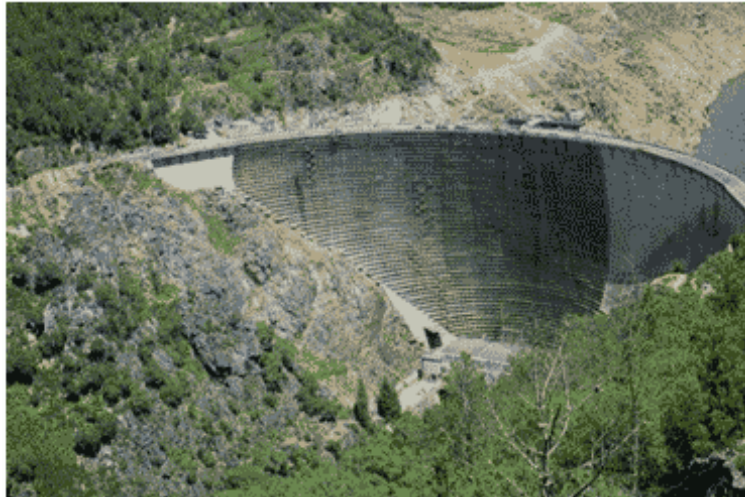
Figure 13 – Repair works in Cabril dam

Early in the first filling of the reservoir, a significant horizontal cracking was detected on the downstream face, located between 10 m and 20 m below the crest. In 1981, after analyzing the structural behaviour, a decision was made to carry out repairs for treating the cracks (Mora Ramos, 2008) with injections of resin after characterization of their openings and depths (Figure 12). With the refilling of the reservoir, it was observed that cracks would occur again in the same area. Figure 13 presents the cracking in 1996, and Figure 14 presents the deformation in the central cantilever (full reservoir) – observation data and numerical results, computed using a 3D finite element model, software DTDIN developed at LNEC (Oliveira, 2000) –, which shows the cracking influence on the structural dam behaviour (that can be simulated using a viscoelastic model with damage). A swelling process has been recently detected.

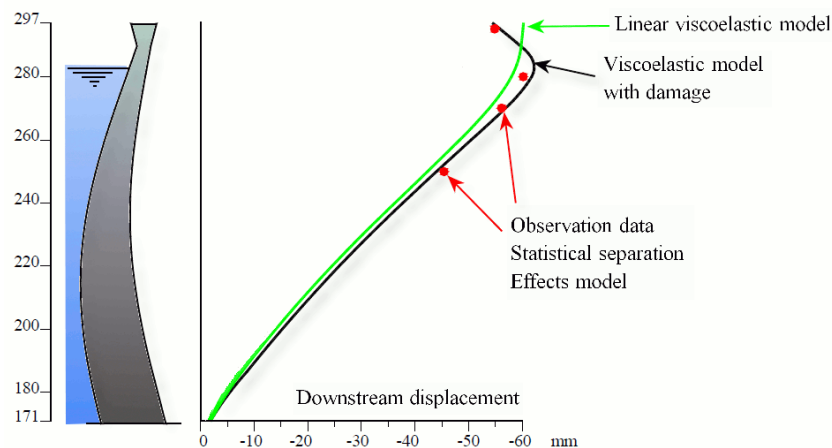
Figure 14 – Displacements at the central cantilever

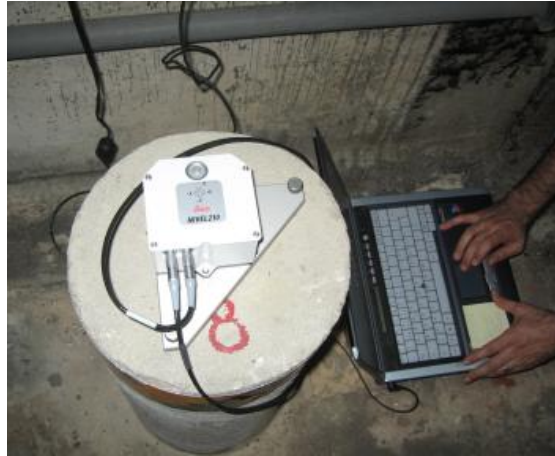
Figure 15 – Inclinometer setting up: computer

The inclination measurement was done with the inclinometer placed on a base with levelling bolts, mounted on the top of a small pillar located at the centre of the gallery (Figure 15), in the central cantilever. During the tests, the data was registered on a laptop, with software Leica GNSS QC. The two components of inclination and temperature (Nivel includes a temperature sensor) were registered with a sampling frequency of 1 Hz, during approximately two days (between 2 and 4 of July, 2008). The inclinometer was oriented in such a way that the axes were coincident with the radial and tangential directions (Figure 16). Also during that period, a digital thermo-hydro-barometer Comet D4130 was installed on the upper walkway of the downstream face (Figure 17). The data was recorded automatically every 10 minutes. Throughout those two days, one of the two electricity generators worked during four periods (see Table 2). The other generator was off due to conduit maintenance.

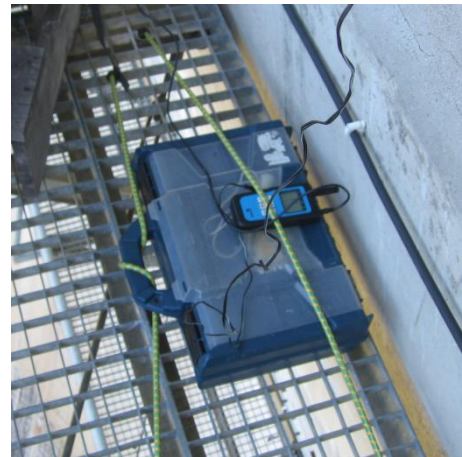
Figure 17 – Digital thermo-hydro-barometer on the walkway

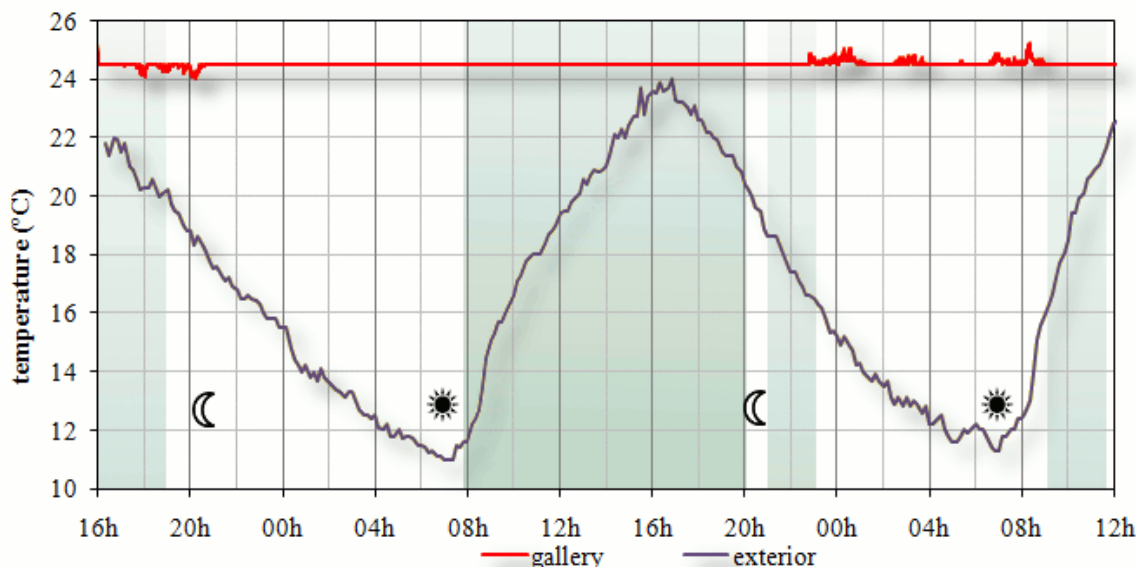
Figure 19 – Inside and outside air temperatures

The values recorded – inclination components, temperatures both inside and outside the gallery, the reservoir level, and the average turbinated flow – are presented in Figures 18, 19 and 20. Figure 18 shows the variations in the two components (radial and tangential) of the inclination. In this chart, positive variations in inclination correspond, in radial direction, to an ascent in the upstream side, and in the tangential direction, to an ascent in the left margin. Figure 19 presents the values of the temperatures measured both inside and outside the gallery, at the walkway on the downstream face. Figure 20 presents the reservoir level and flow turbinated. The charts also include the periods in which the generator worked (background shading), and the instants of sunrise and sunset (symbols ☀ and ☾, respectively).

In this study, the radial and tangential components were analyzed separately. To model the variations in each component, a regression model (eq. (1)) was considered. The latter includes a term for simulating the effect of the reservoir level (linear dependence), two terms (cosine and sine), which reflect a harmonic temporal variation within a 24-hour period and also two terms, which represent an identical variation but within a 12-hour period. These two periods, of 12 and 24 hours respectively, were identified as relevant through a Fourier analysis. The variations in the inclinations measured for a day are mainly correlated with the temperature variations measured near the downstream face of the dam. The behaviour of the temperature variation corresponds to a quasi-sinusoidal wave – the warming branch is not symmetric to the cooling branch (see Fig. 19) – which is described as a superposition of two waves in periods of 24 and 12 hours.

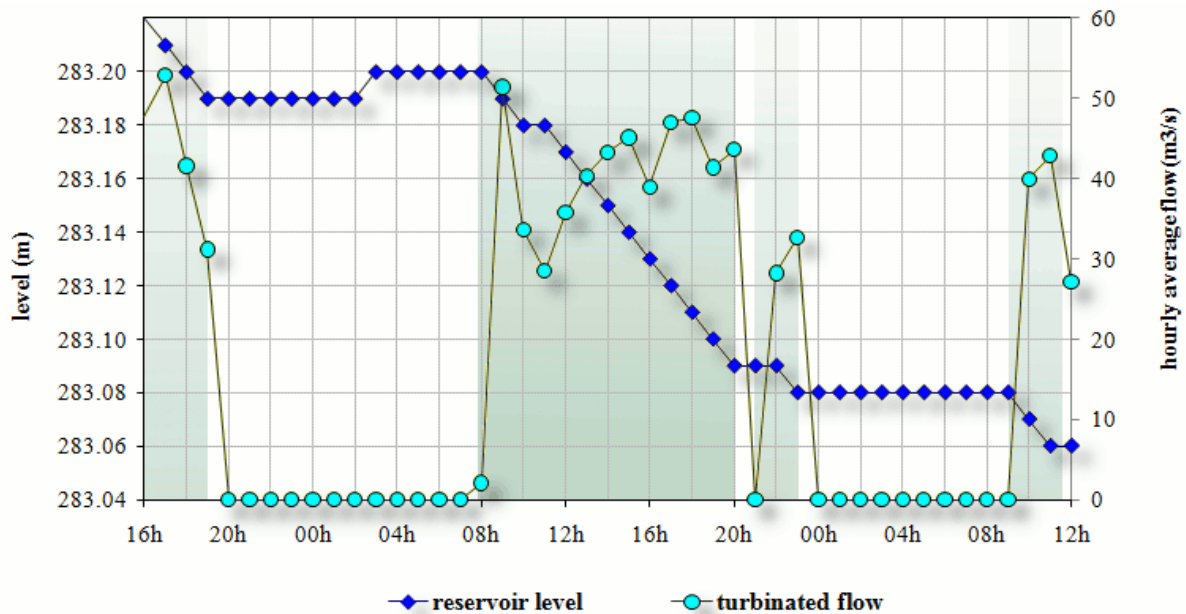
Figure 20 – Evolution in the actions "reservoir level" and "turbinated flow"

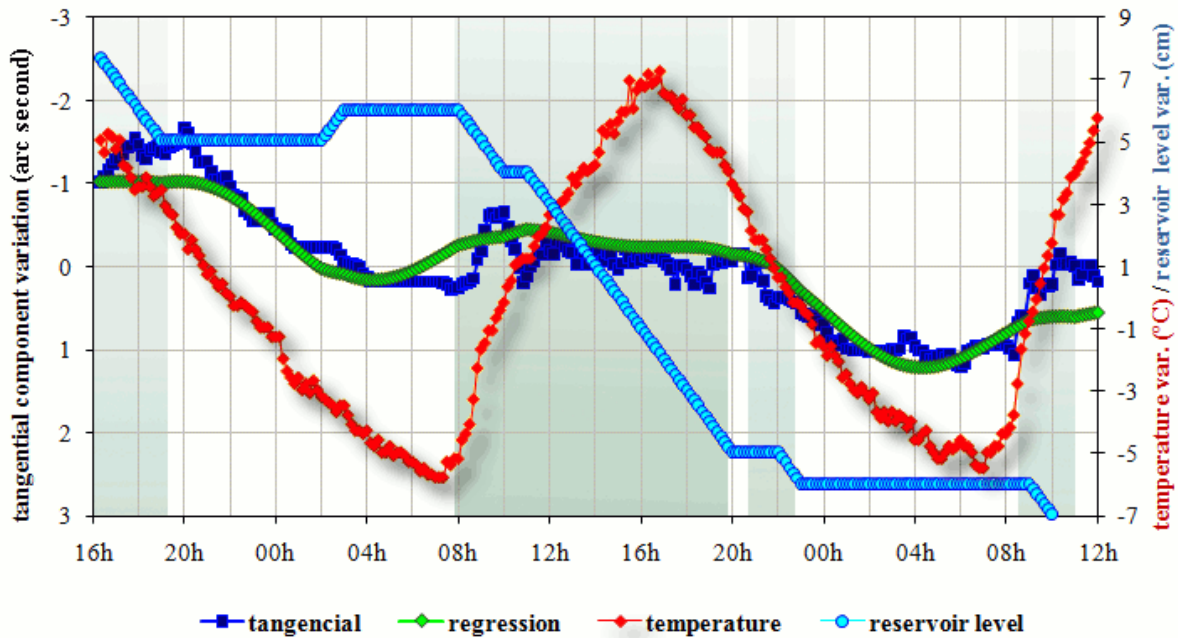
Unlike the radial component, the tangential component has a more obvious correlation with the variation in water than with the outside temperature (correlation coefficient equal to -0.70 and -0.50 , respectively). Figure 23 shows the regression curve chart along with the variation in the inclination, the outside temperature and the reservoir level.

The variation in the tangential direction has, in these two days, a progressive component, which translates into a correlation with decreasing reservoir level.

Figure 23 – Variation in the tangential component and regression curve

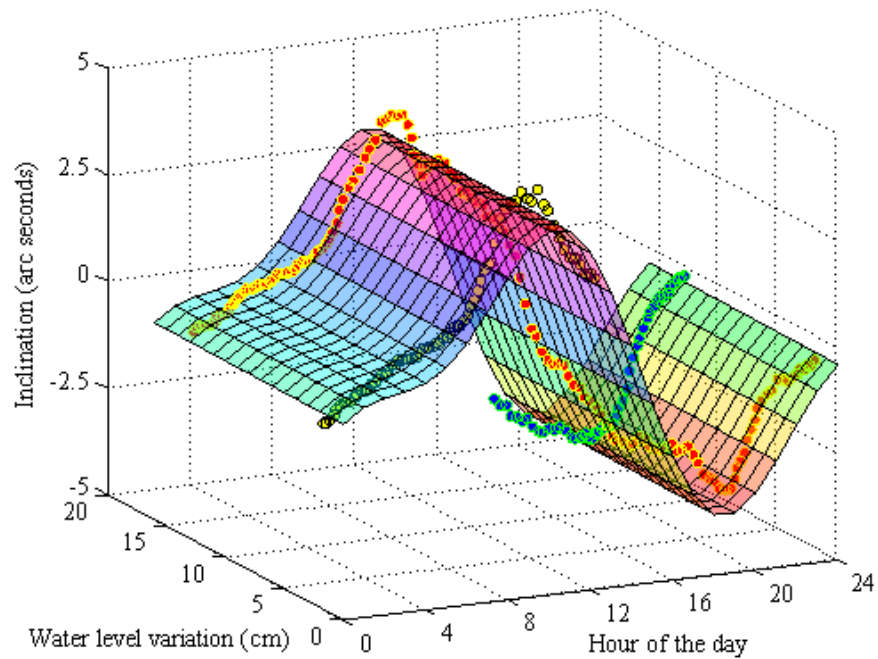
Radial
Inclination

Tangential
Inclination

Figure 24 – 3D plot of the inclination (radial and tangential) as a function of the hour of the day and of the water level variation. Multiple linear regression

As presented in (1), the regression model adopted establishes a relation between the variation in inclination i with the reservoir level (h) and the day hour (t) : $i = f(h, t)$. Two 3D graphs were drawn (Fig. 24), through MATLAB plotting tools, showing the inclination as a function of the hour of the day (from 0h to 24h) and of the reservoir level variation (from 0 cm to 20 cm). The measured variations in inclination (10 minute average) were also plotted.
